CASE NO.: 2020-024374-CA-01

**NOTICE OF FILING**  
**EXHIBITS “A” THROUGH “E” OF COMPLAINT**

***Re: 400 Sunny Isles Condominium East Association, Inc.  
Section 558.04, Florida Statutes, Notice of Claim of Construction Defects***

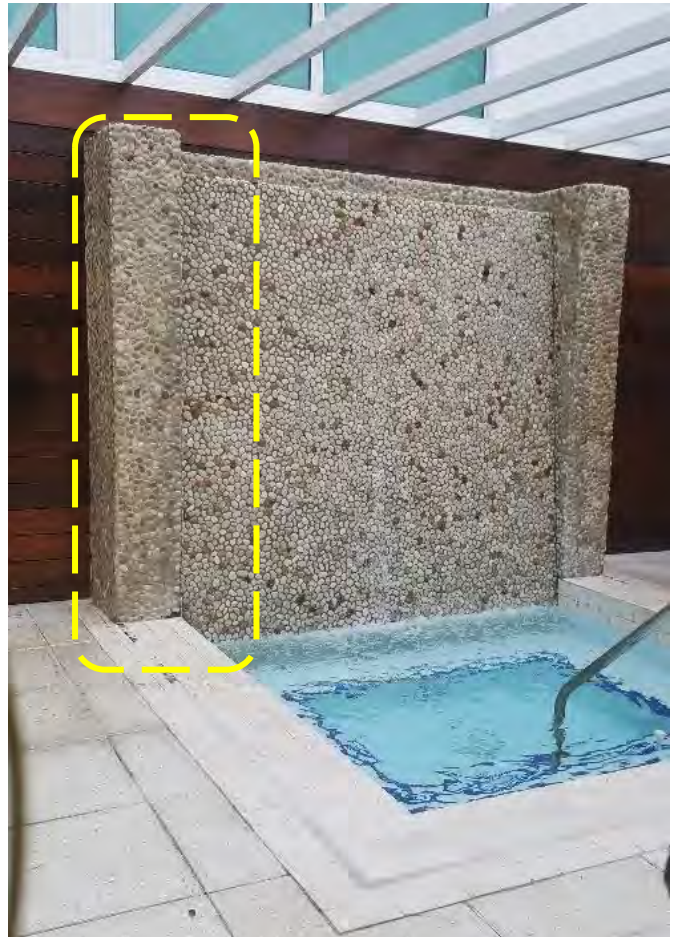
Figure 33

This is an overview of the spa on the pool deck. Areas of cracks and efflorescence were noticed in the cobblestone waterfall surface, indicating that water may be intruding behind the stones.

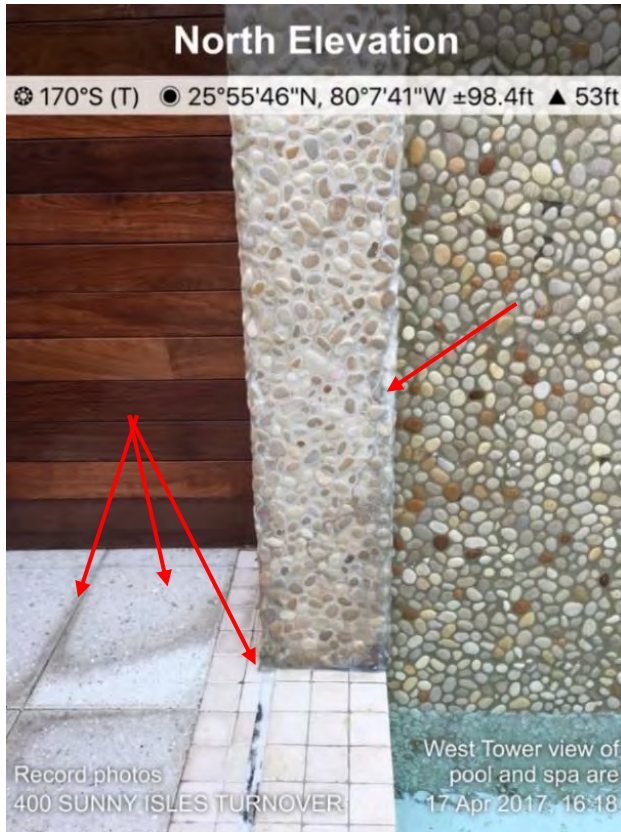
Figure 34

The following photos are close-up views of the problem areas on both the spa and the plunge pool, both constructed similarly. Cracks and efflorescence can clearly be seen in these photos.

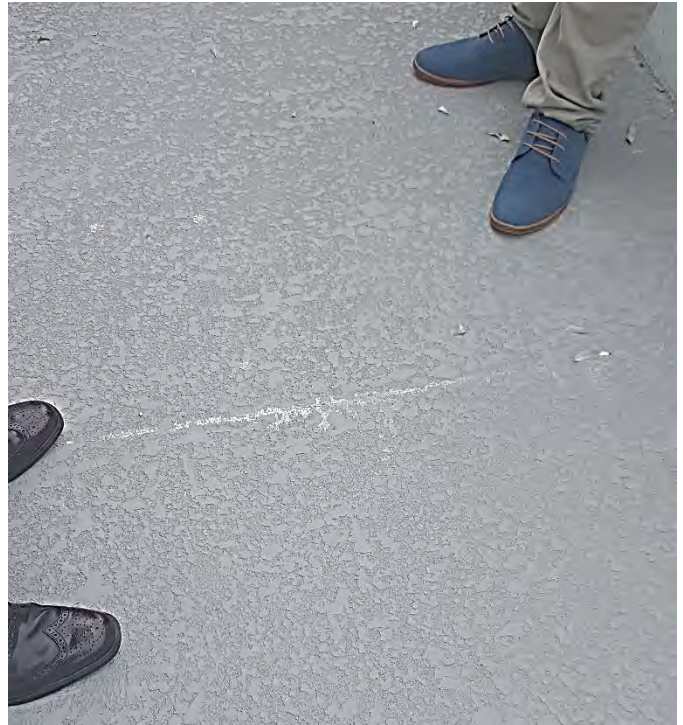
Figure 40

Cracking in the textured waterproof coating on the pool deck surface was found to occur at regular intervals along the north side of the Lanai Level (6<sup>th</sup> floor). The coating typically should have jointing at regular intervals to relieve stress. Manufacturer requirements for the actual material used should be identified and requirements for both jointing and adhesion should be evaluated for conformance.

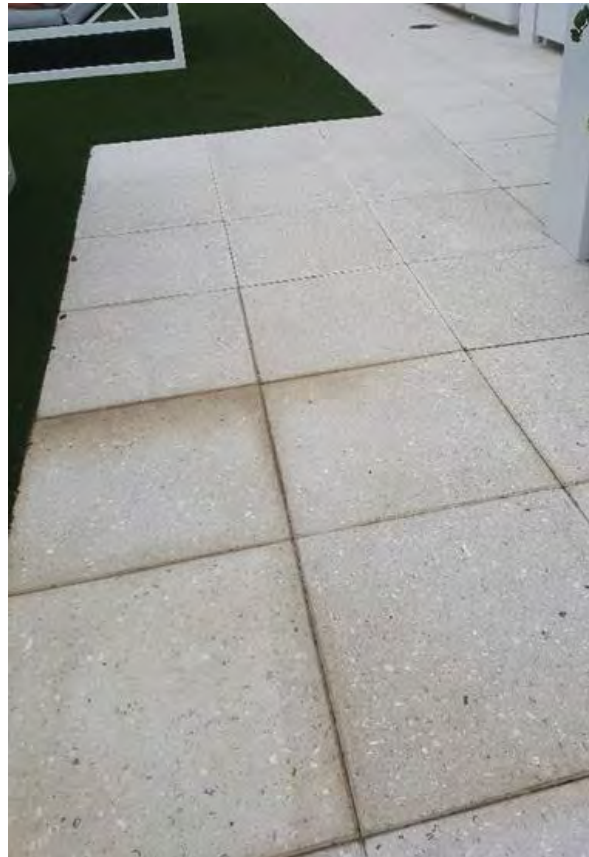
Figure 44

Tiles on the 6<sup>th</sup> floor terrace level show signs of water not draining correctly. Tile grout has become stained or blackened in areas. These conditions were considered to be caused by excessive moisture under the tile wearing surface.

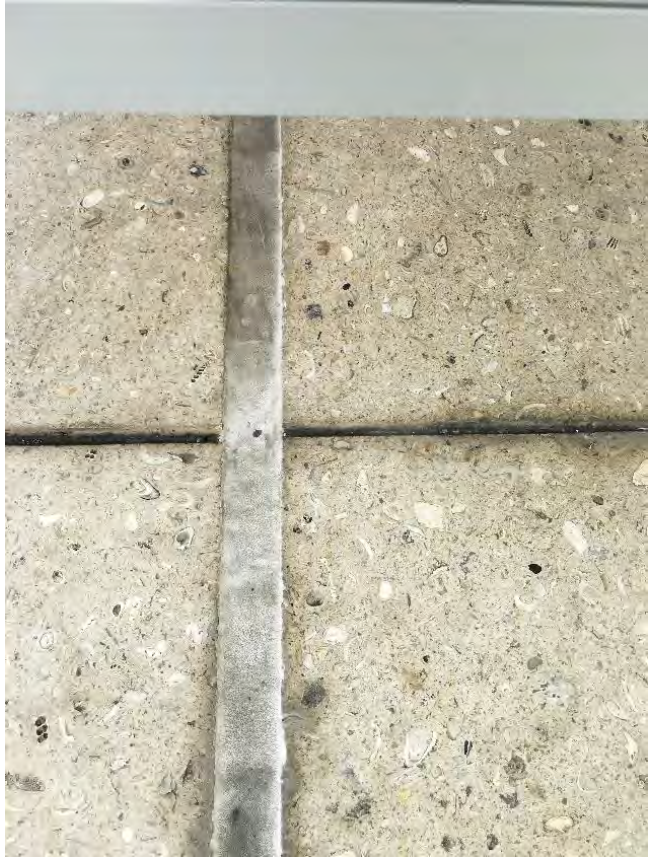
Figure 52

This is a similar example of efflorescence on the expansion joint. This example is an accelerated case compared to the last. The deposits have become so thick that they have spread up and down the joint.

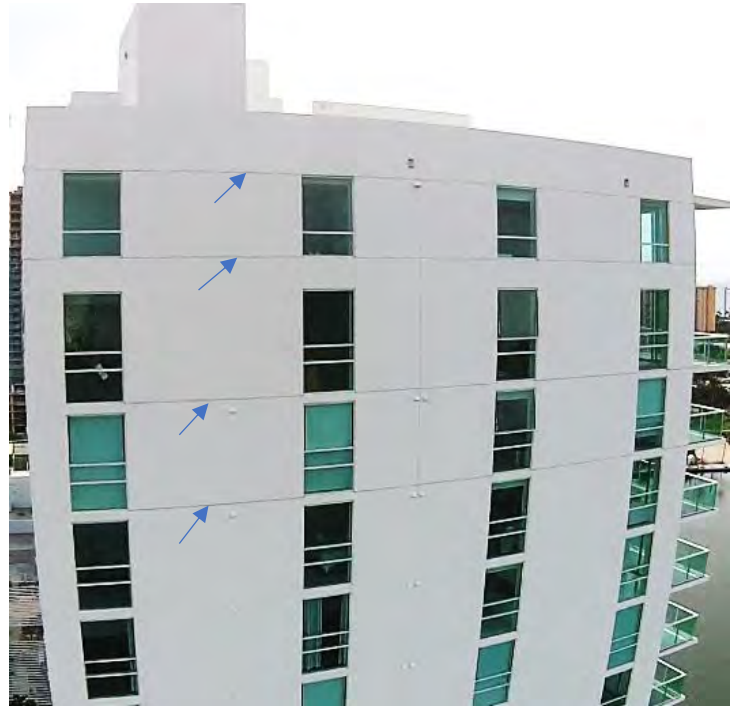
Figure 20

The top 3 floors of the west tower (west façade) have sealant along stucco joints, seen in these photos as darker horizontal joint lines. The cracking at the upper floors may be related to higher levels of creep in post tensioned slabs that could be related to inadequate curing prior to tensioning of cables. This could be reviewed in tensioning logs. The contractor should disclose if the sealant was applied to fill cracking or to address water intrusion problems, so the condition could be defined, and evaluated for future concerns.

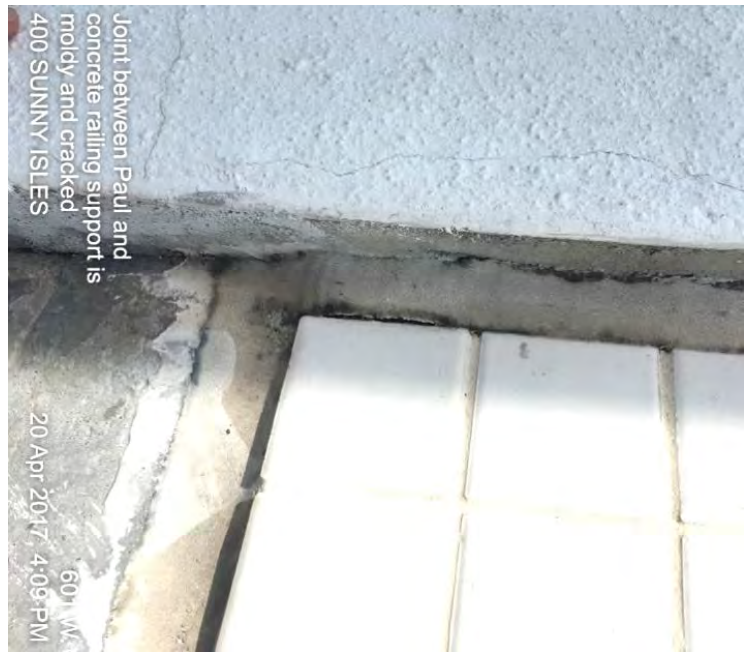
Figure 89

Another view of the organic growth between the pool and concrete/stucco wall below the railing.

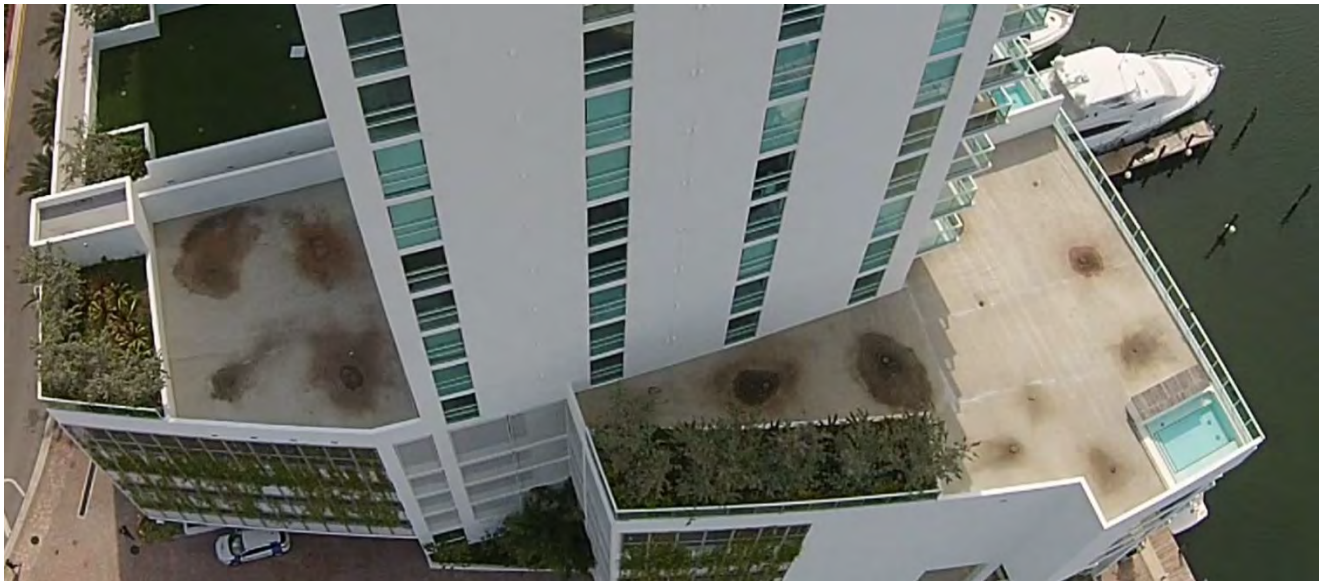
Figure 97

Drawings were reviewed and all require correct slope for adequate drainage. Therefore, poor construction and/or drains clogging due to inadequate openings at lower level (surface of slab elevation) are considered the cause.

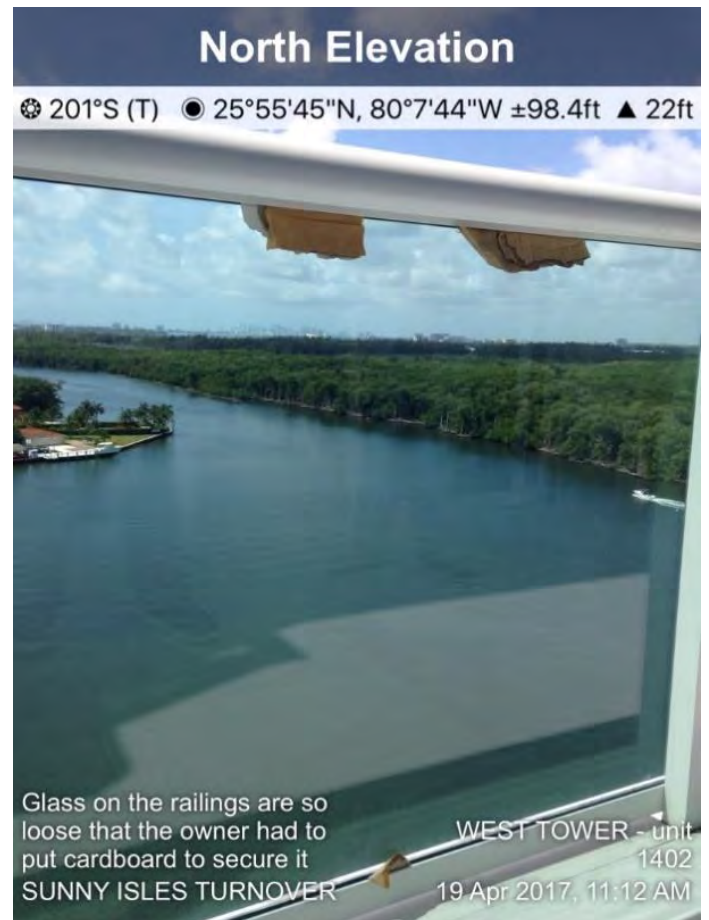
Figure 132

The glass on the balcony railing was extremely loose. The owner of the unit needs to put cardboard between the frame and the glass to secure it. Rubber gaskets were also found missing in the railing structure.

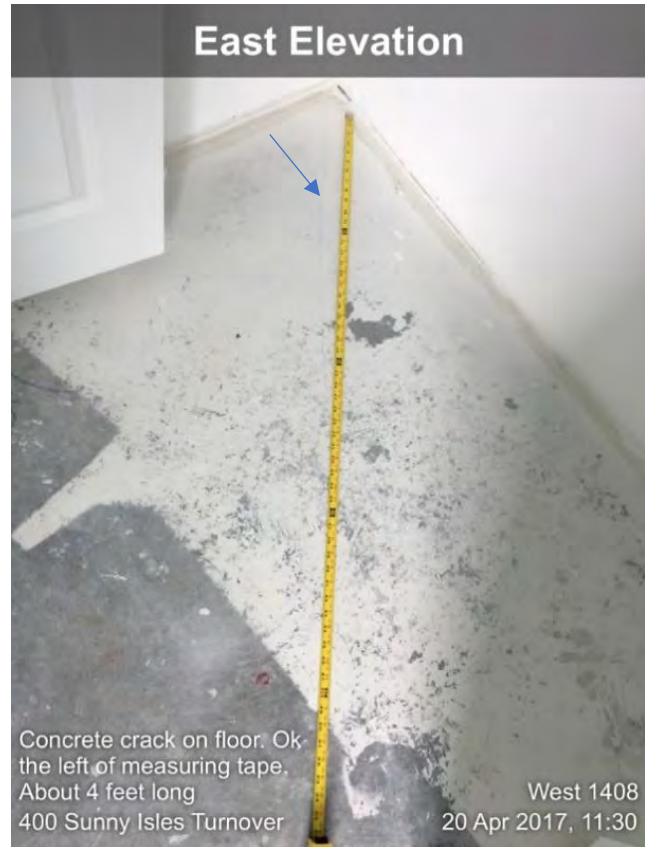
Figure 136

A hairline crack in the floor slab, about 4 feet long, was noticed in one of the rooms, shown in this picture to the left of the measuring tape. Gaps between the concrete slab and the wall were also noticed, shown here at the top end of the measuring tape.

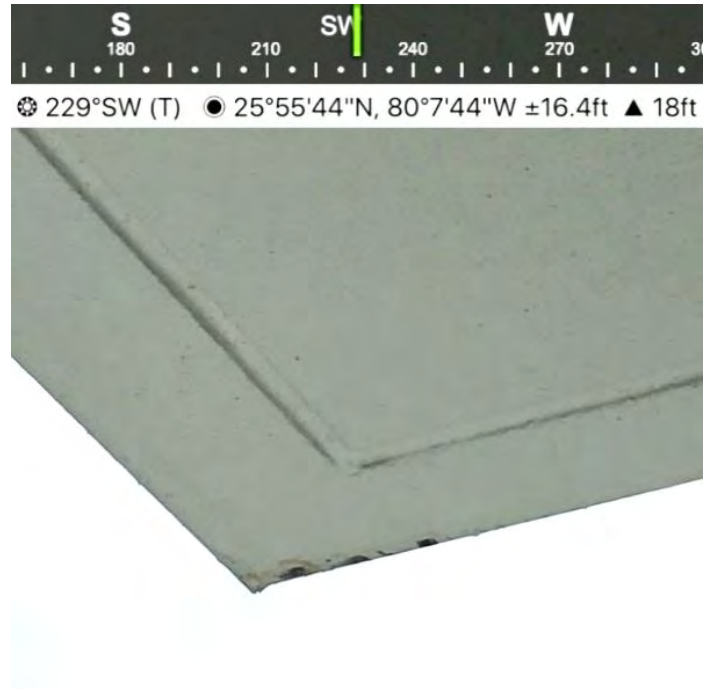
Figure 151

This was observed as a common condition of many (or most) balconies where due to non-uniform provision of correct and uniform slope to the balcony edge, small areas were caused to drain large areas of poorly sloped balcony surface over long time periods. The result is development of organic growth where edges remain moist for long periods. This is considered demonstration of the deleterious effect of improper slope of the balcony surfaces. Note that slope provided on tile downs not help solve problems with underlying slab and waterproofed surfaces improperly and non-uniformly sloped.

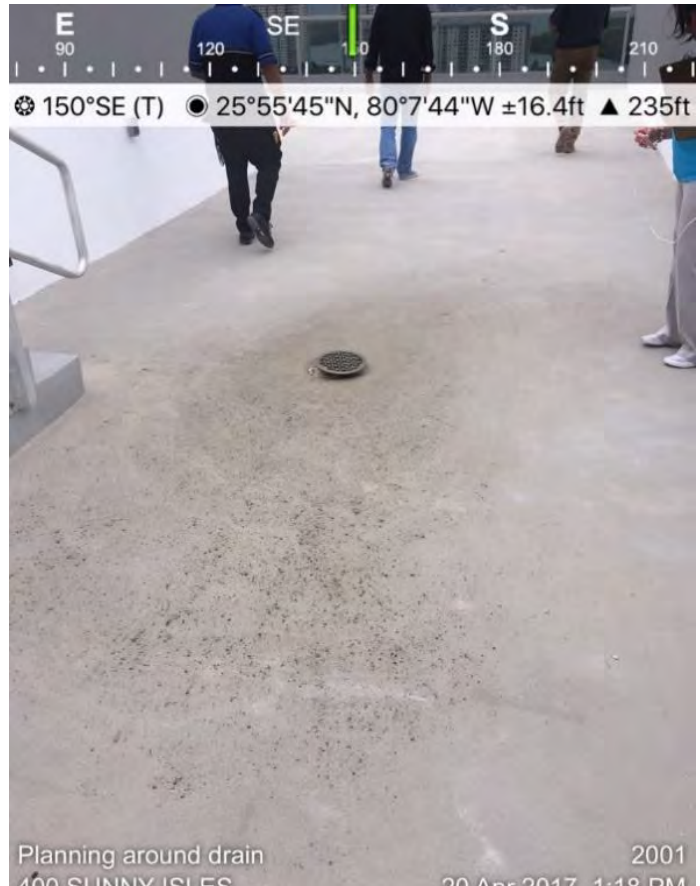
Figure 165

Ponding was noticed around drains, indicating they are not directing water along the surface or draining properly, allowing water to absorb into the concrete and corrode the rebar.

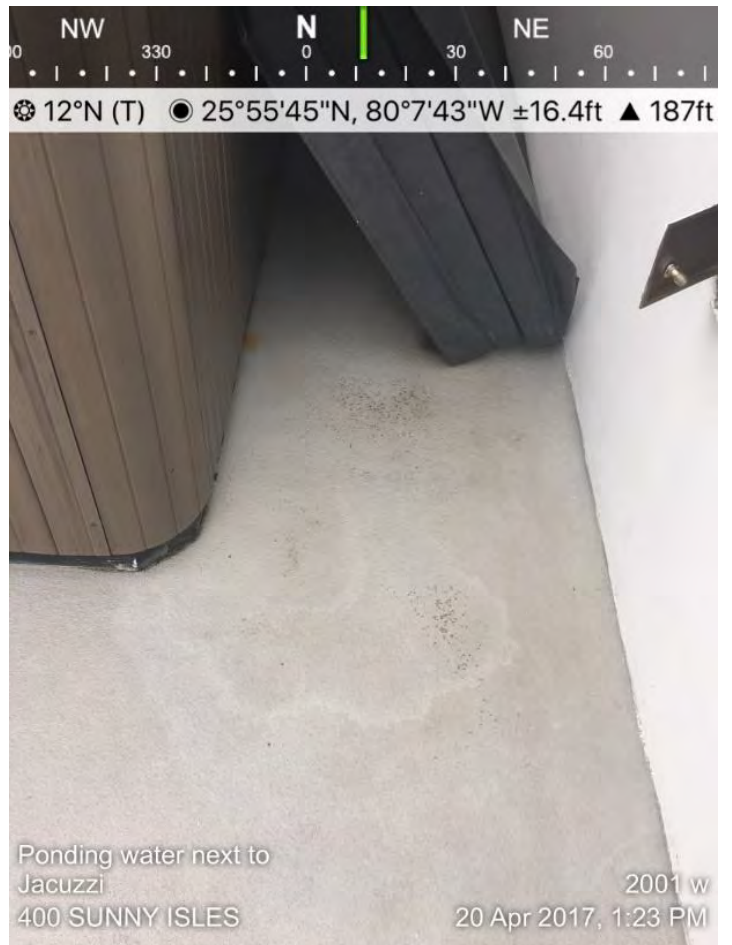
Figure 170

Ponding evidence was also found near the jacuzzi on the patio, This was considered an indication that the area is not draining properly.

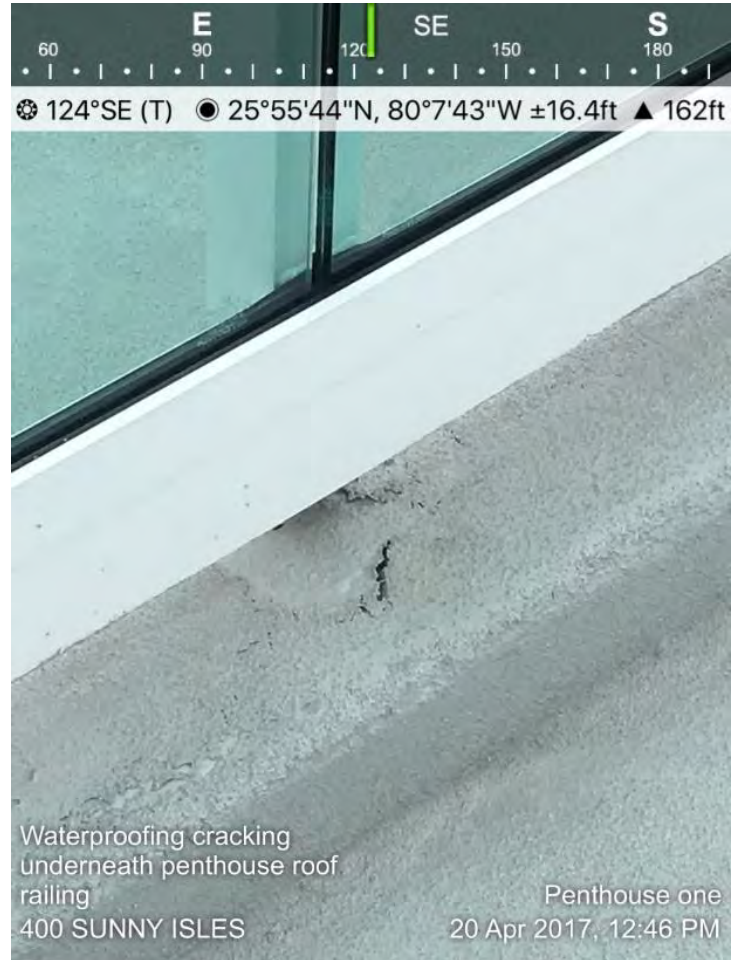
Figure 173

The waterproofing underneath the roof railing is cracking, allowing water to penetrate into the concrete below.

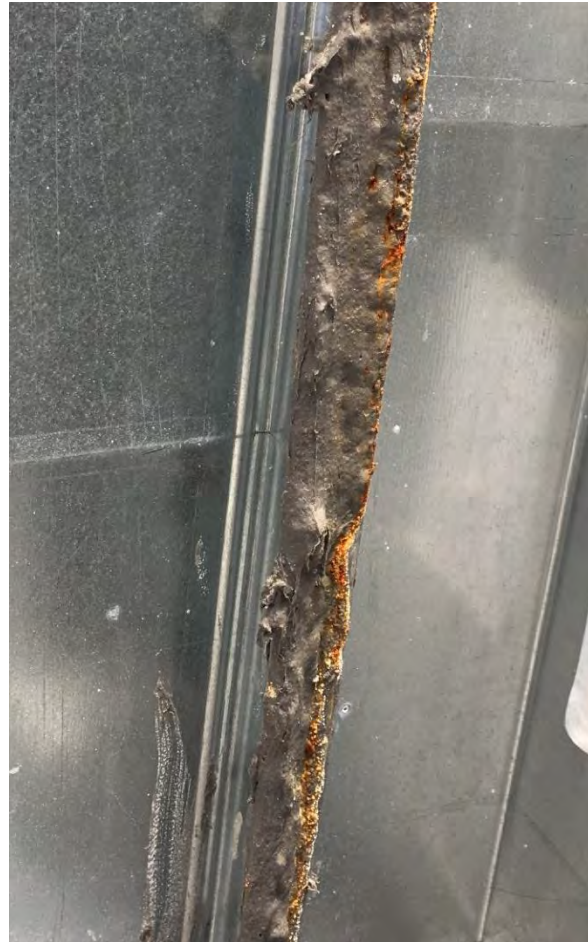
Figure 12

The application of black mastic failed to restore this ineffective workmanship detail. The resulting corrosion problem will shortly compromise the waterproof integrity of the ductwork.

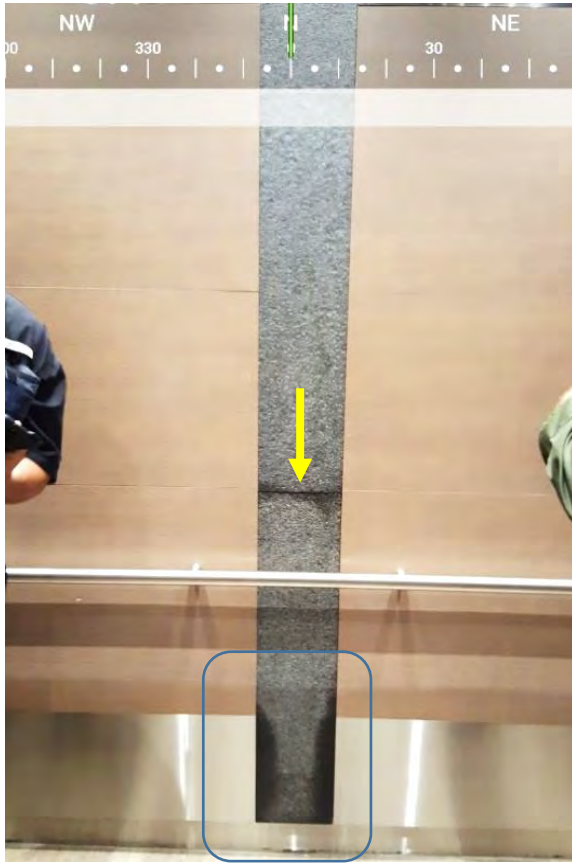
Figure 26

Staining at the joint between adjoining stones (yellow arrow), and at the sides beginning just above the metal lower cove (blue box). Excessive lippage in some of the stone blocks was evident at the upper condition. The dark areas appear to be a chemical infiltration into the stone matrix that will be researched further to try to identify the cause of the staining. The material specification problem as discussed previously would have avoided this condition.

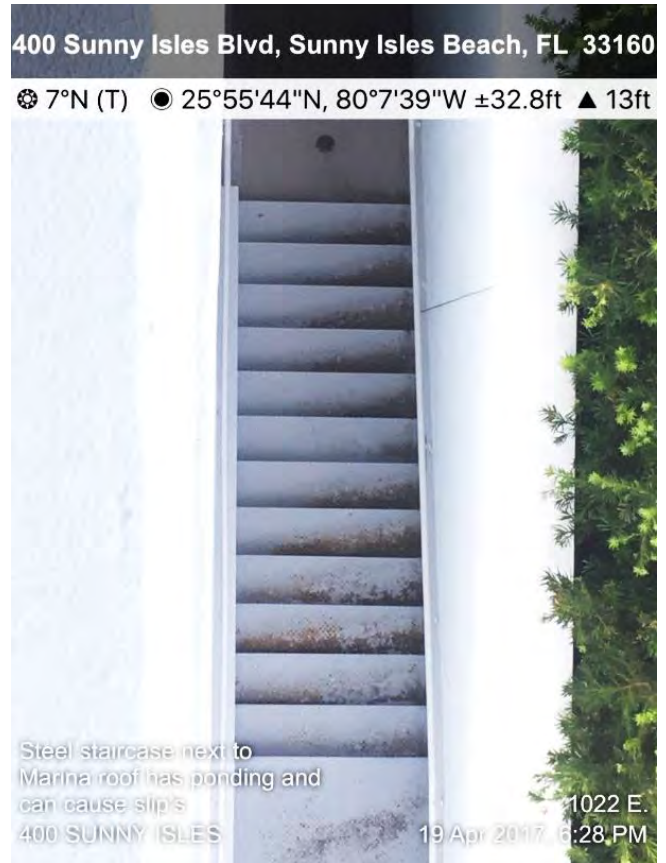
Figure 32

If the stairs are concrete or steel, the situation below the deck elevation is dark and exposed to rainwater entry. The organic growth due to moisture and lack of sun and air movement will result in the build-up of slippery organic material. This situation requires re-design and construction in a manner that provides code required slope to remove water from stair treads.

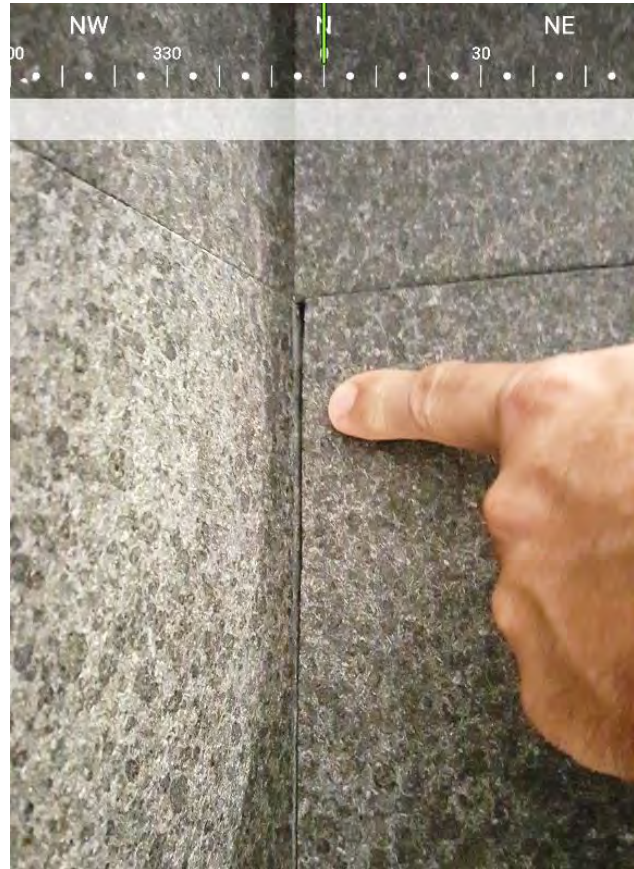
Figure 36

Both the inconsistent joint spacing and provision of joint material were considered poor workmanship.

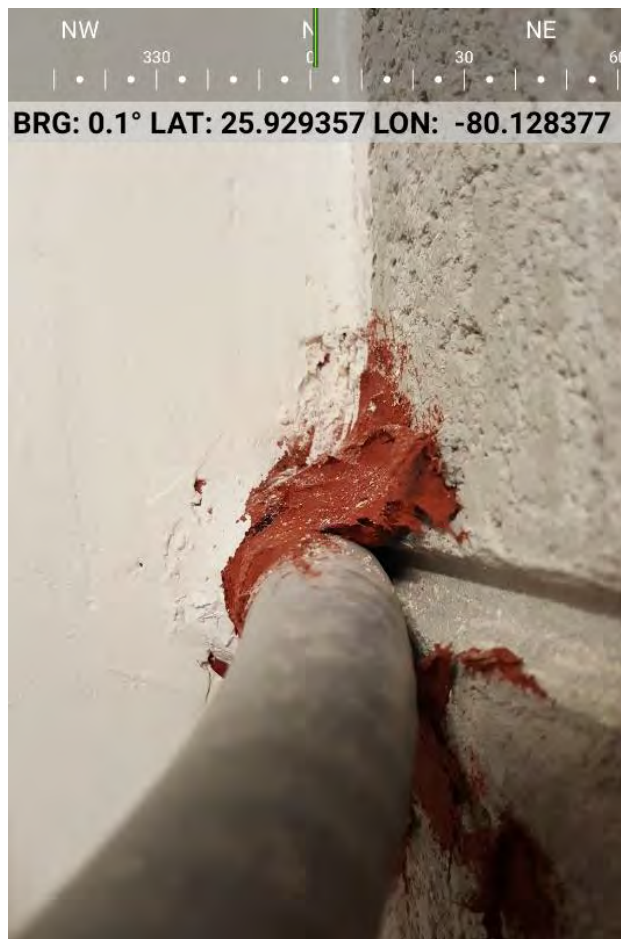
Figure 37

Poorly applied fireproofing around this pipe in the electrical room has caused gaps and openings to occur. This allows for a possible fire to exit through these holes and into the next room or area.

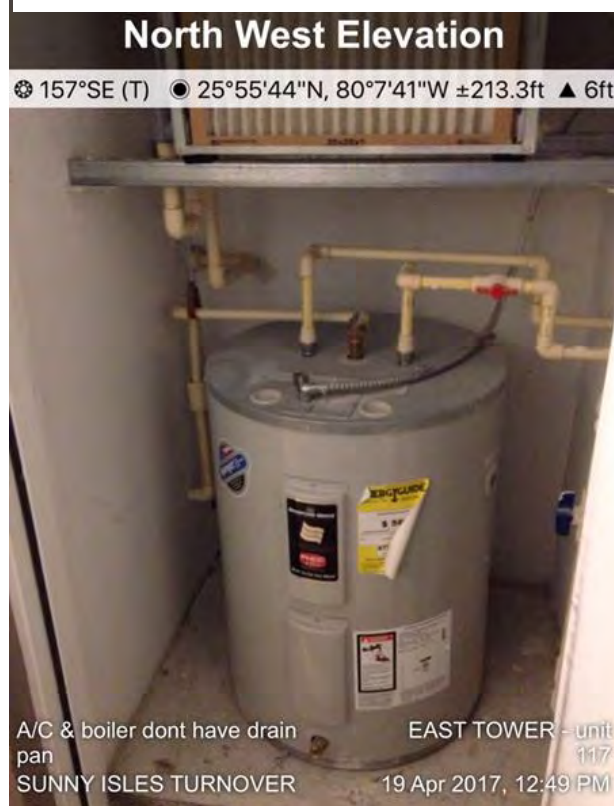
Figure 39

The water heater was found to have no drainage pan underneath it to collect moisture.  
This unit does have a pan under the water heater.

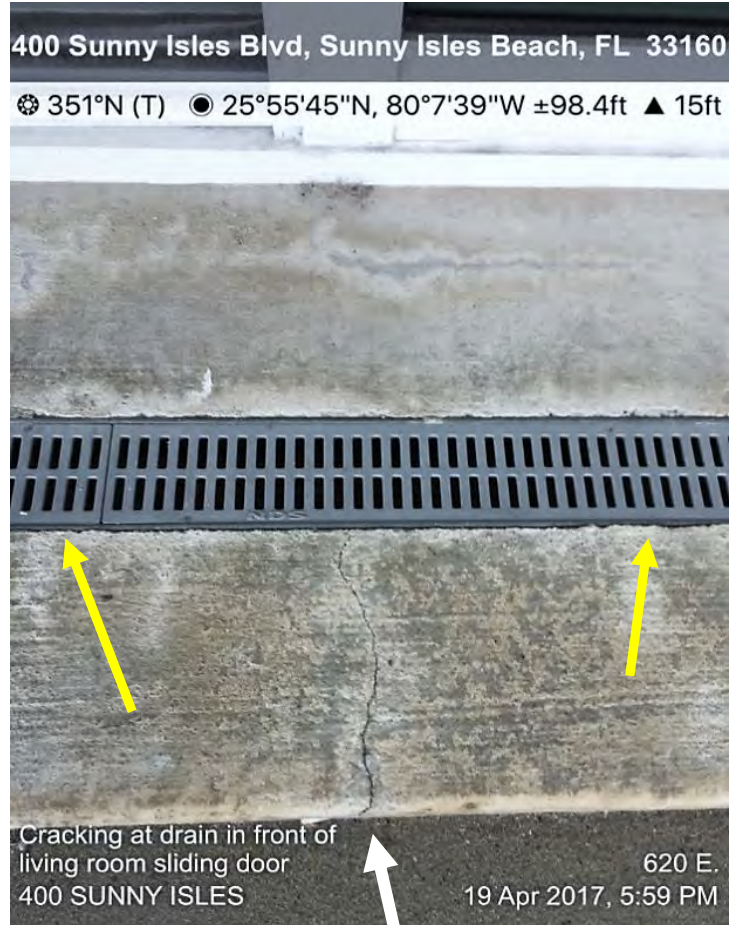
Figure 62

How can water on concrete surface run in to trench drain and not run **down** into segregating crack at plastic drain/concrete juncture (yellow arrows)?

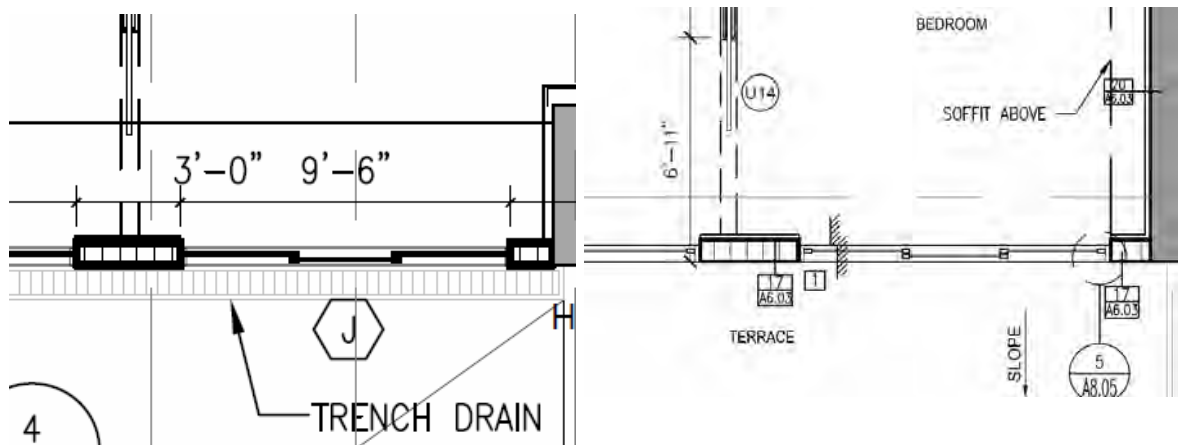
Figure 67

The two architectural plans shown below either label the area as “trench drain” with no further details (left), or leave the trench drain area off the plans (right). No indication of sloping is present for the trench drain, whereas all other slopes are present for the terrace slab. Neither drawing resembles the constructed condition detail or jointing. Further investigation of is recommended.

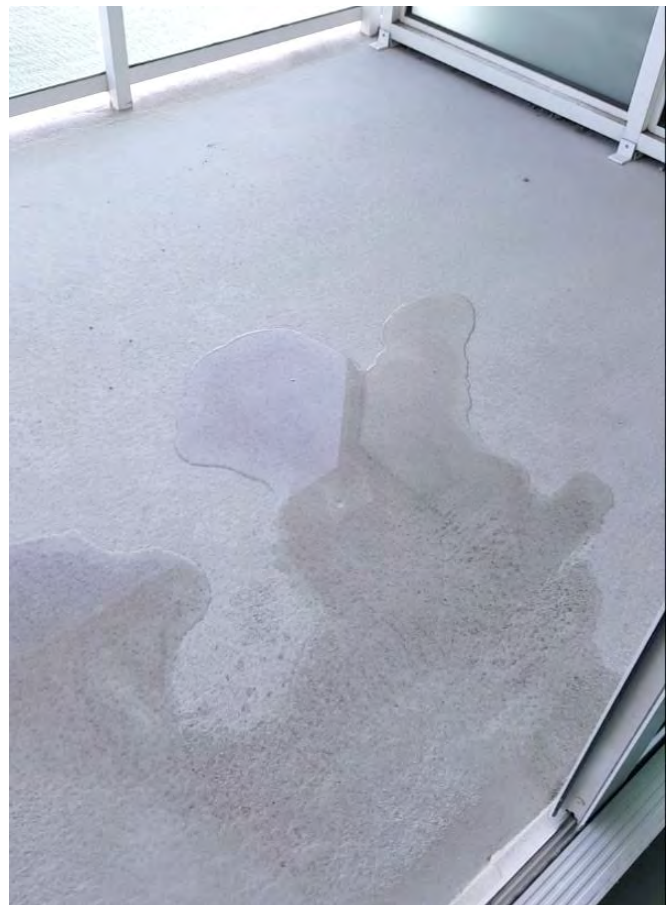
Figure 74

A water test was performed on the balcony in three different locations. This area did not drain well, instead ponding water in the middle of the balcony and near the sliding glass door. Tile and mortar bedding do not correct improperly placed concrete slab, as the puddles seen here would similarly persist as moist areas of the tile-setting bed. These perpetually wet mortar bed areas, under damp conditions and entrapped below nearly impenetrable porcelain tile, would possibly void the membrane warranty if not detailed to allow water to exit the assembly.

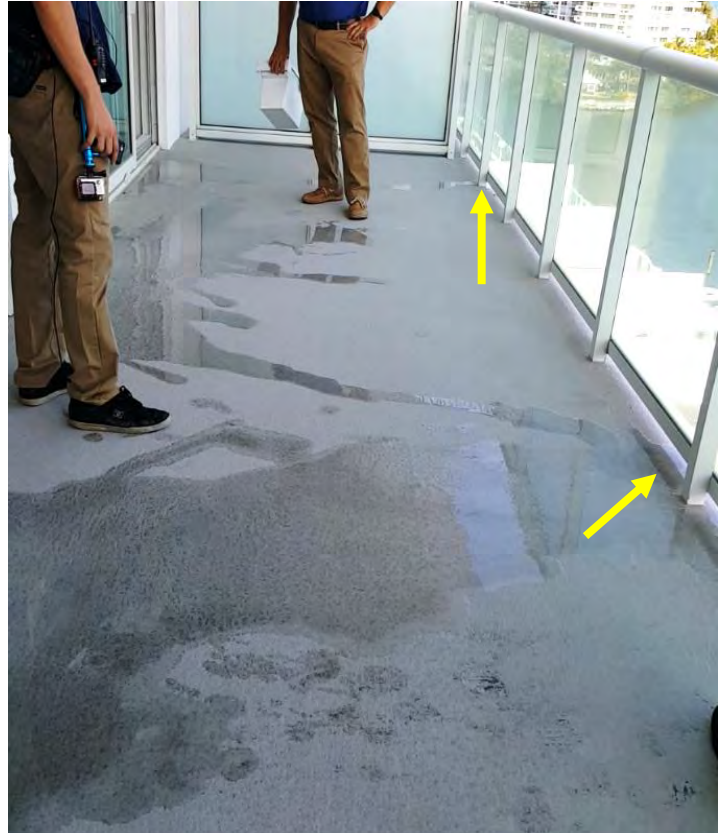
Figure 75

Also, when the water from the balcony drips slowly at only a few small locations, these areas will develop the black organic growth we observed at the bottom lower edge of the balcony slabs (see 1015 E, 1<sup>st</sup> photo).

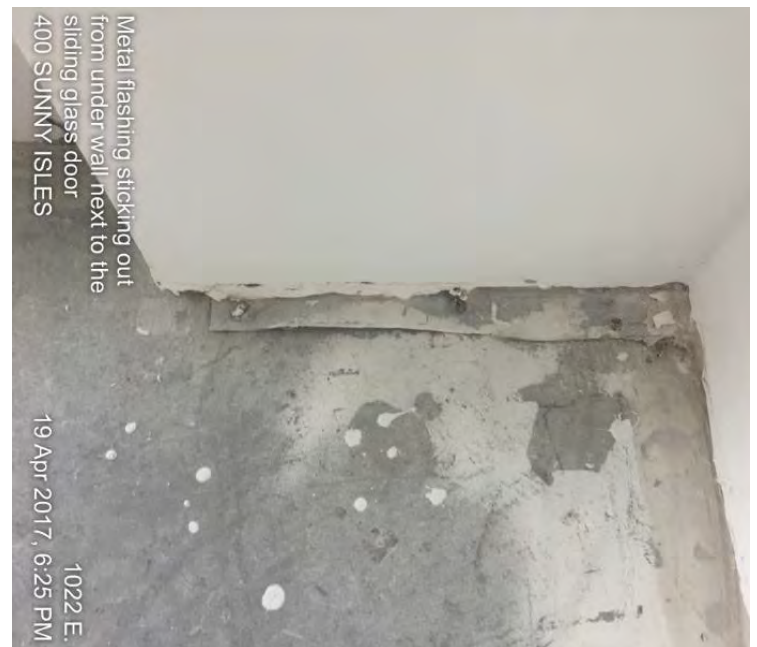
The metal flashing was found sticking out from underneath the wall next to the sliding glass door to the balcony. This is not considered a watertight condition.

Metal flashing sticking out from under wall next to the sliding glass door  
400 SUNNY ISLES

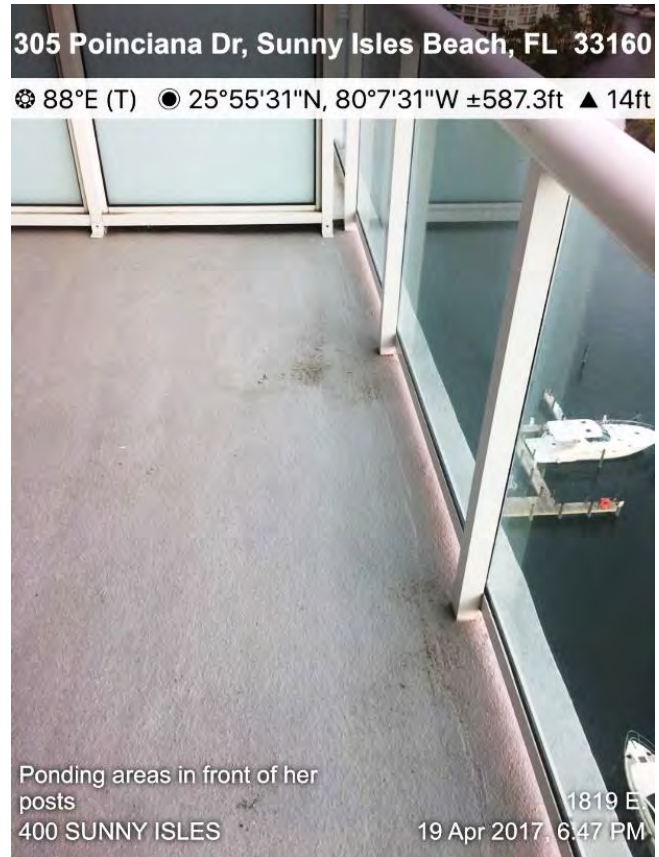
Figure 95

There was high elevation along the perimeter of the balconies in many cases.

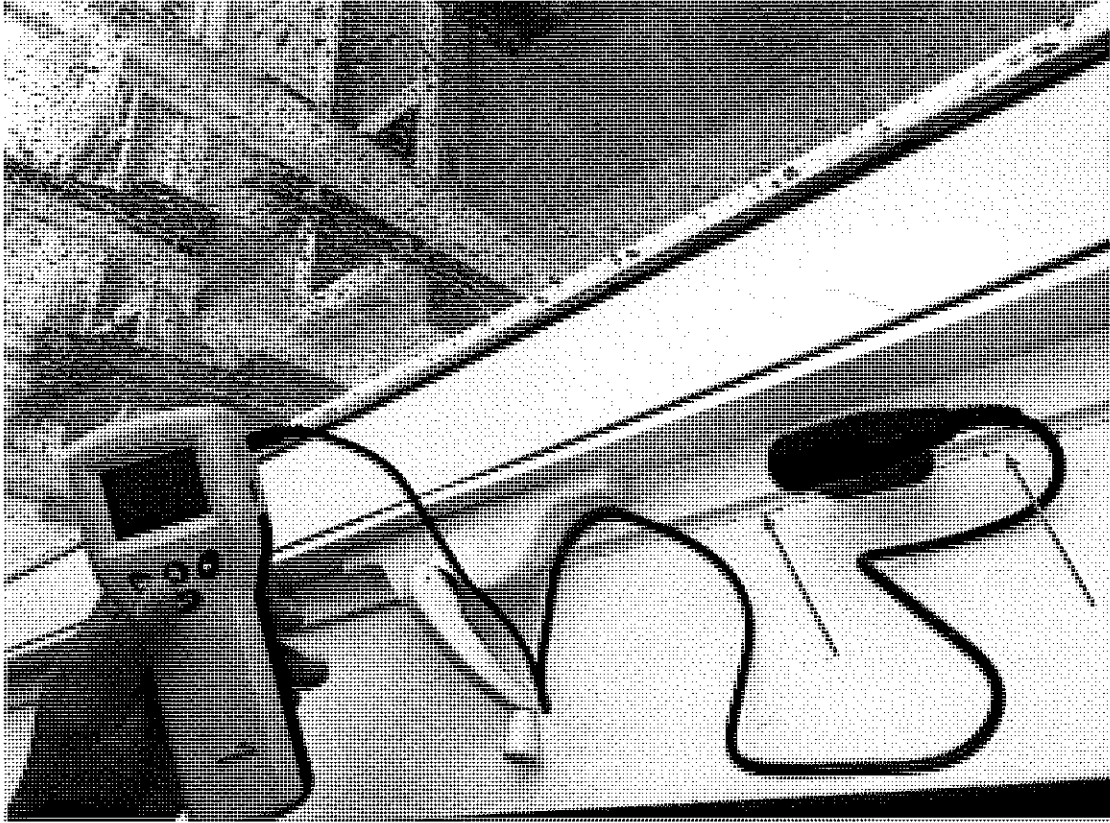
At the window on the west facing façade (see cabana and spa in view), moisture and paint cracking were detected. The moisture reading of 15.8 was substantially higher than the 7 to 8 readings in dry control areas. The photo below shows water retained between the sealant and glass.

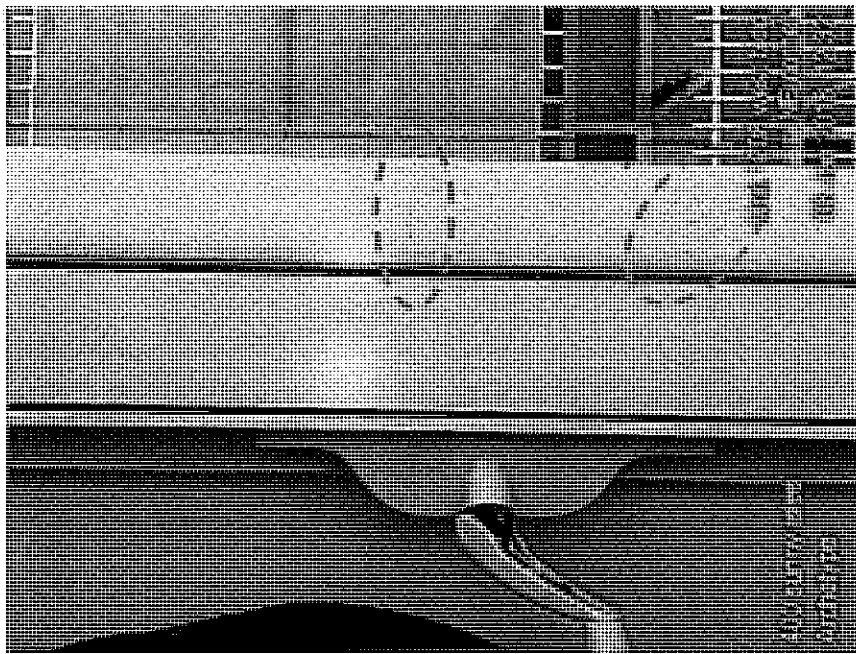
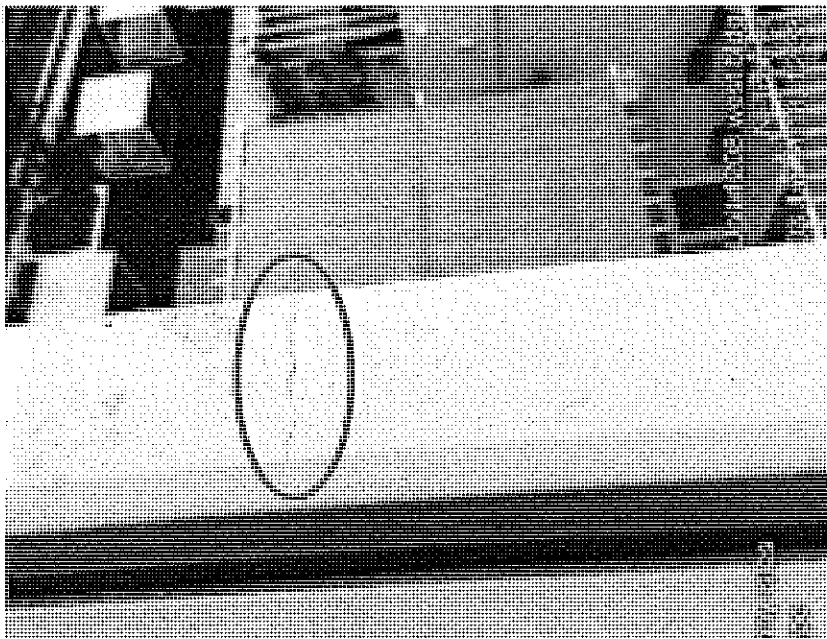
The areas circled showed cracks in the stucco sill on the nearly flat sill surface. A third crack was also noted to the left of the center fractures. These indicate the problem of stucco delamination along the PVC corner bead reinforcing that will not be corrected long term with surface sealants. Rework of the sill is required.

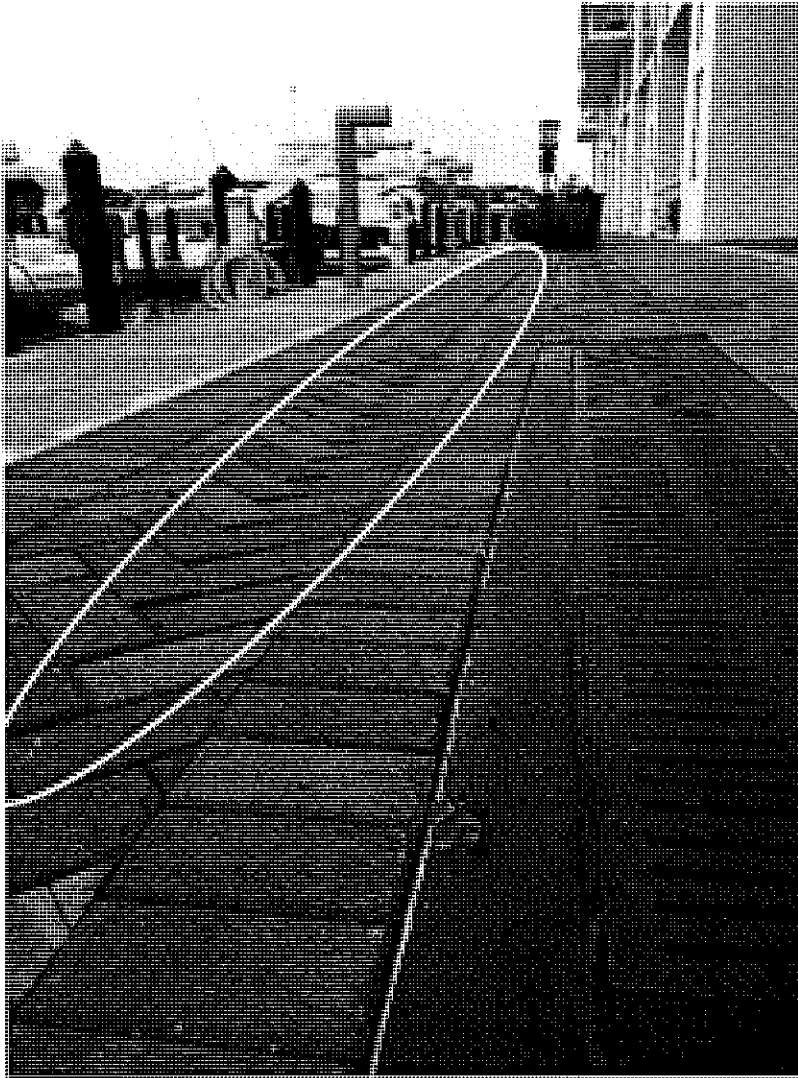
The concrete paver bricks along the seawall and running parallel to the trench drains of the sidewalk are settling in the interstitial zone between. This has created a trip hazard that must be addressed. The cause is considered to be due to lack of adequate compaction of the soil and the condition could be corrected by taking up the pavers, compacting the soil to the required elevation and resetting the pavers.

The measured lippage between pavers far exceeds the standards of the tile council of North America and the Interlocking Concrete Paver Institute.

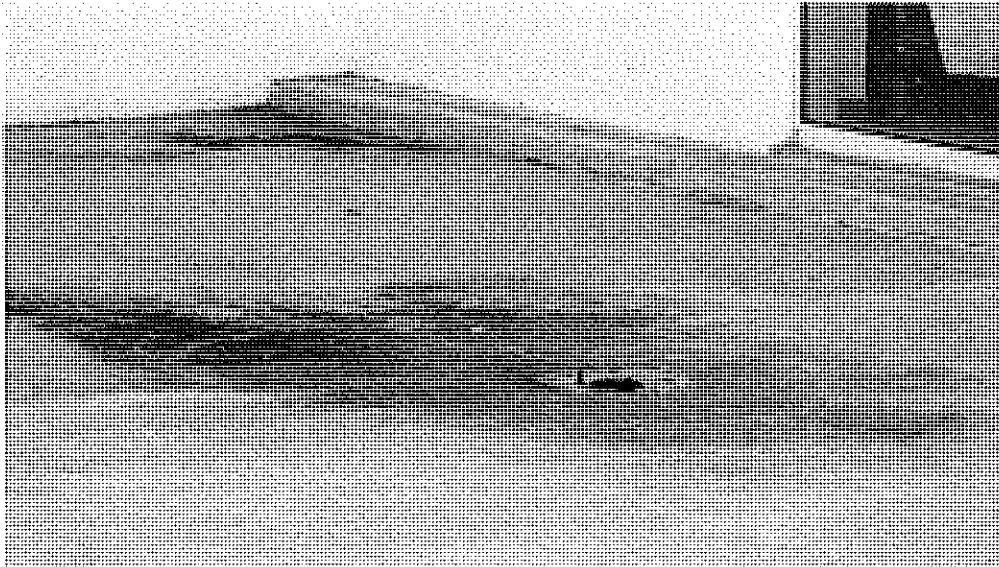
Provided drains are not BI-level; not functional for water removal at surfaces. Retained water is corroding Steel drain fixture provided.

Water retained on terrace surfaces allow organic growth to develop as well as dissolve and deposit minerals from the setting beds. These are a direct result of dysfunctional water flow through the provided drains.

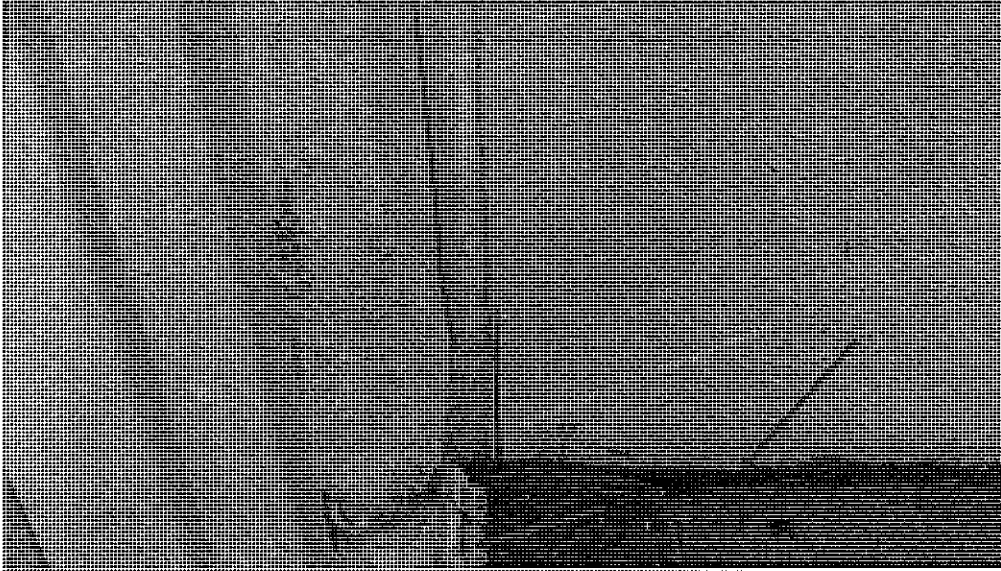
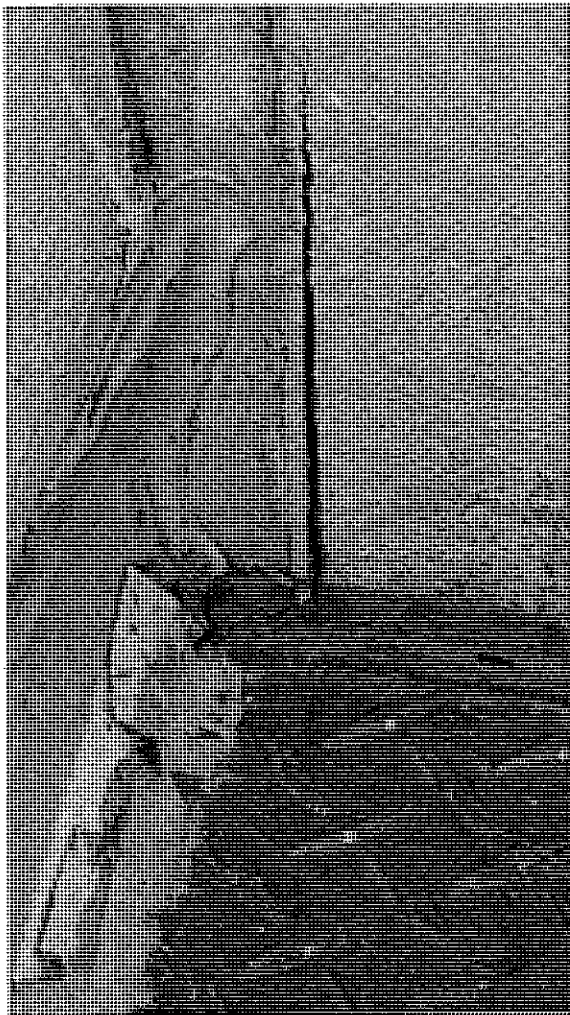
Block staining of retained water residue and organic growth resulting from retained water (yellow arrow) are visible at bottom stair landing. The cover plate at the expansion joint is moving and is a source of water entry.

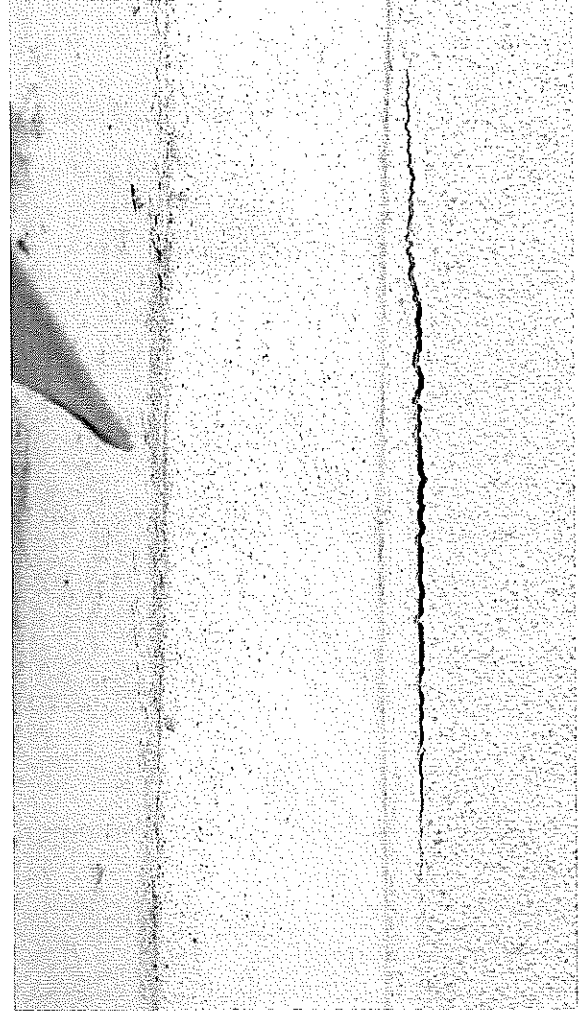
The crack above and at left is at the stucco wall perpendicular to the east façade, which is at the landing of the stair, at the expansion joint between the two buildings. The vertical expansion joint has had additional sealant material (see blue arrow). The open cracks at the vertical juncture of the stucco and joint as well as the steel plate juncture with the bottom of the east façade wall are not considered a permanent expansion joint condition. Sealant is only a secondary or short-term mitigation of water intrusion and the application of sealant is far beyond the material ability to accommodate multidirectional movement. Sealant on a horizontal line of juncture where subjected to water lying on the surface is not a condition approved by backer rod and caulk manufacturers, particularly when movement of the joint is present. (see purple arrow)
