CASE NO.: 2020-024374-CA-01

**NOTICE OF FILING**  
**EXHIBITS “A” THROUGH “E” OF COMPLAINT**

***Re: 400 Sunny Isles Condominium East Association, Inc.  
Section 558.04, Florida Statutes, Notice of Claim of Construction Defects***

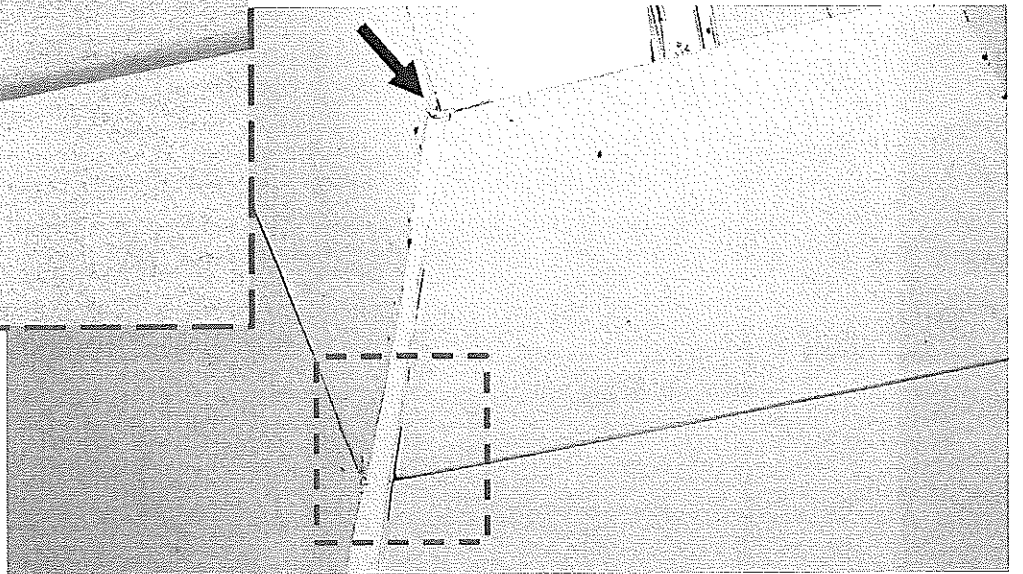
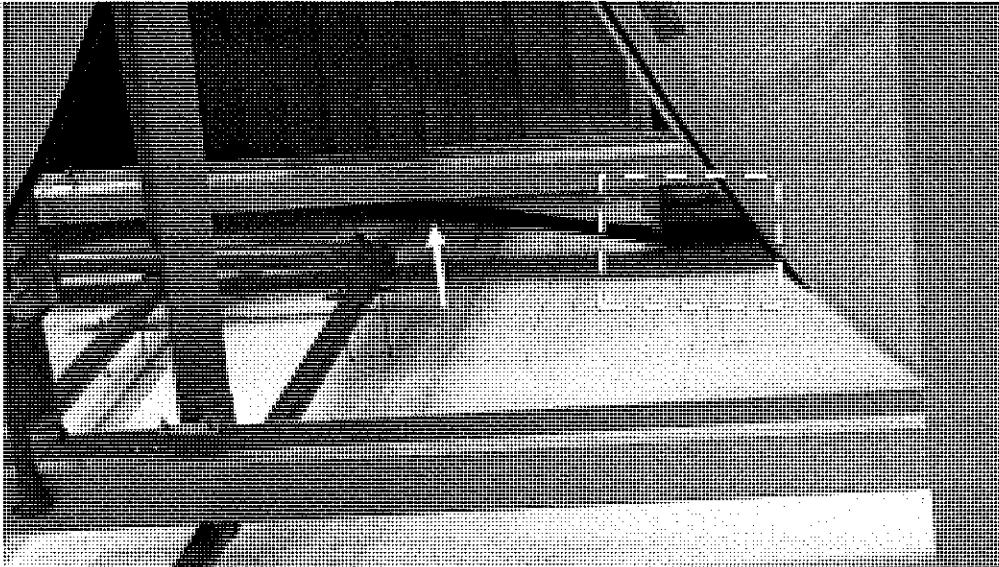
The photos on this page show the failures along the expansion joint near the head of the door above the stair landing shown on the previous page. This condition is a multi-directional expansion joint between the buildings which is not accommodated by the joint provided. Note the top of the stairwell wall at the east façade wall is also a water intrusion problem.

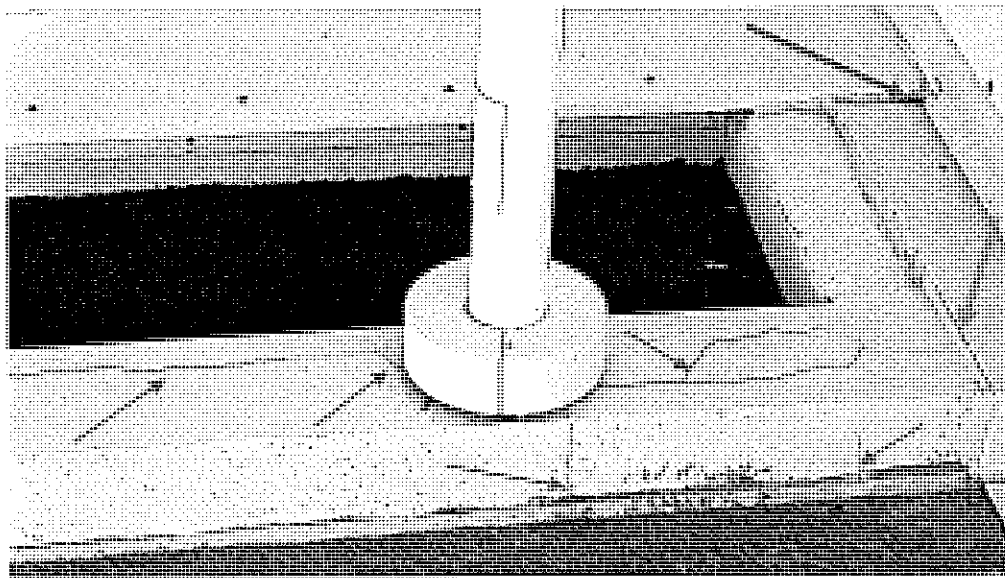
The yellow arrow shows the expansion joint at the upper walk landing of the stair. The enlarged view below shows the crack void at the metal to stucco curb juncture, and the multi-directional fracturing of the curb stucco.

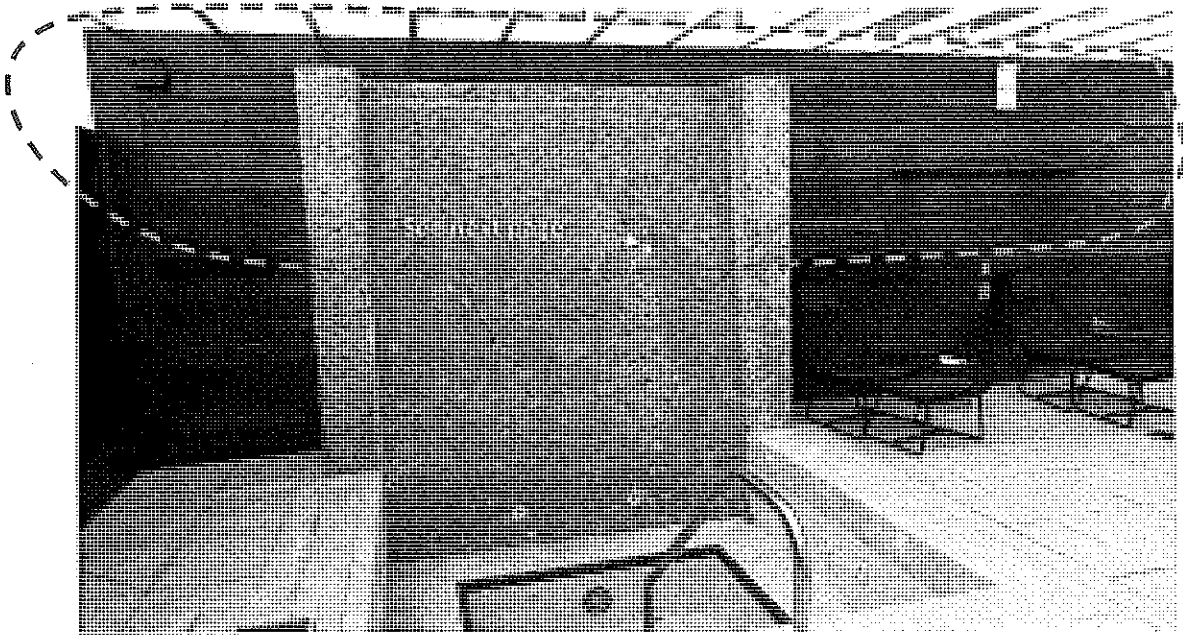
While the curb deterioration at the roof of the metal frame marina building is not on the Association property, the tennis court is considered a hereditament for unit owners, and the failure is considered related to the expansion joint problem hared by both properties.

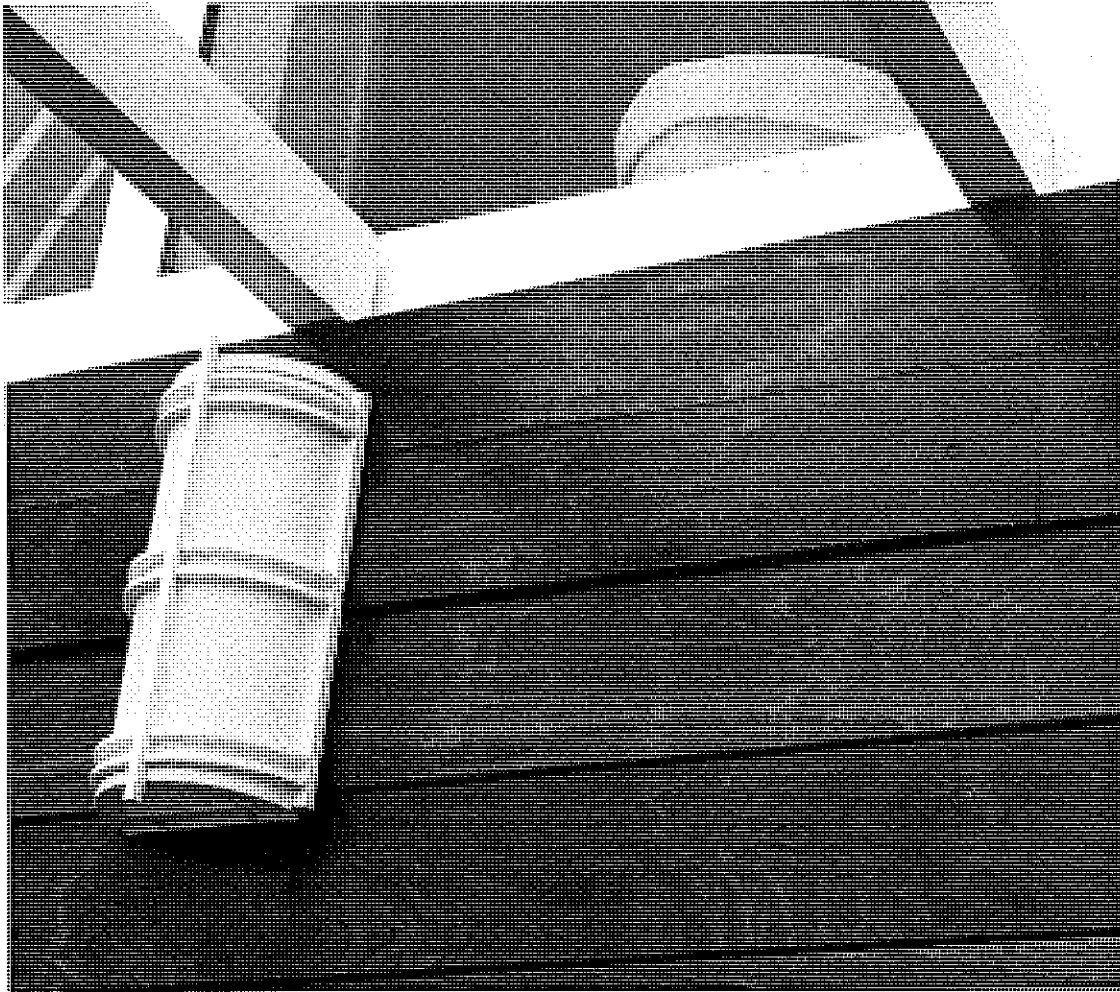
The pool deck hardwood accent walls continue to experience accelerated deterioration, as the surface finish failures as the wood is unfinished and exposed to moisture swelling as top, back and between board surfaces are largely unfinished. Different material is recommended.

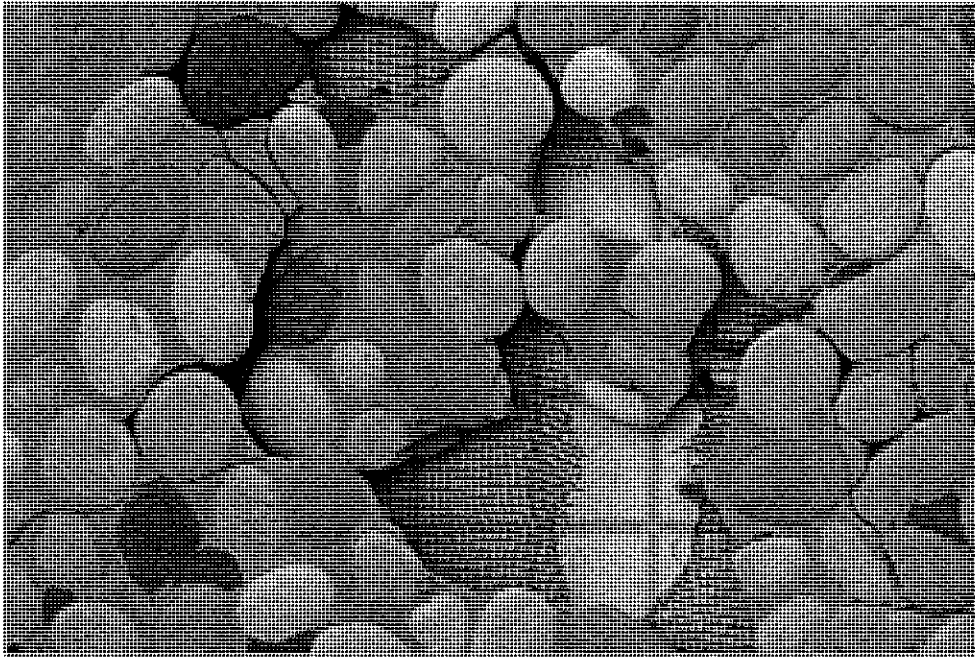
The pool deck waterfall fountains finished with smooth river-stone finish course is experiencing rapidly accelerated failure as the lack of bond of the surface stone through a polymer mesh and to the underlying tile surface is impossible.

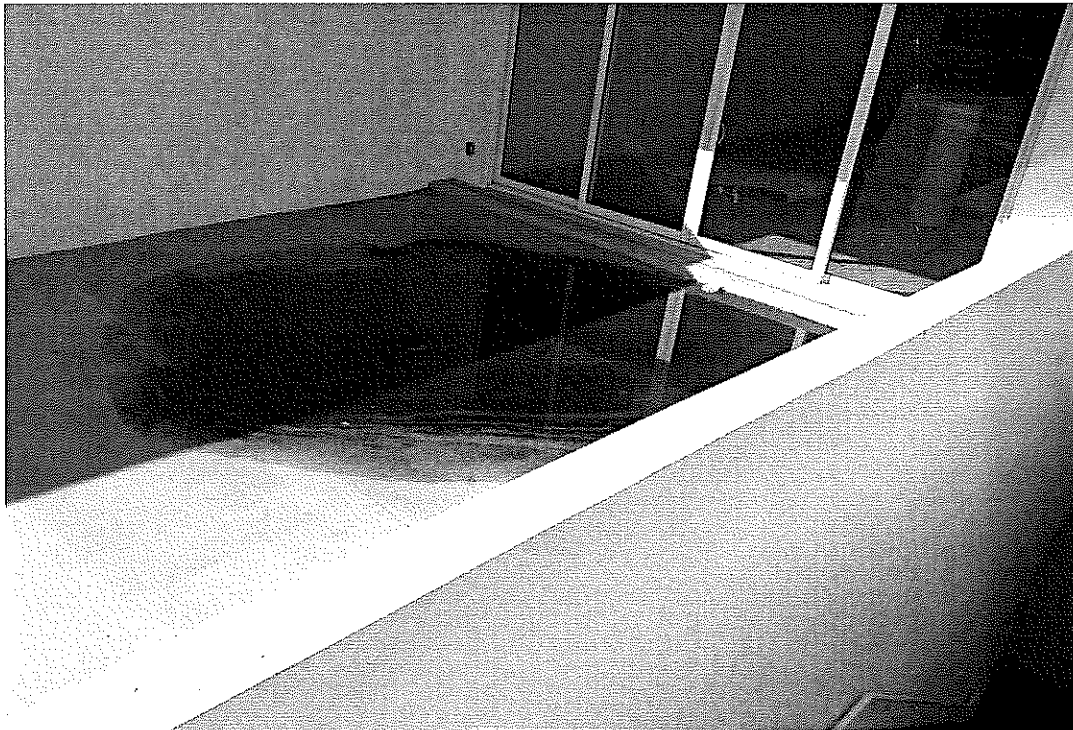
The sixth-floor pool decks where paved, walkways where coated, and unit terraces where tiled or unfinished all share the common problem of moisture accumulation on the deck surface while inadequate drainage has been provided. All of these surfaces require re-design and reconstruction.

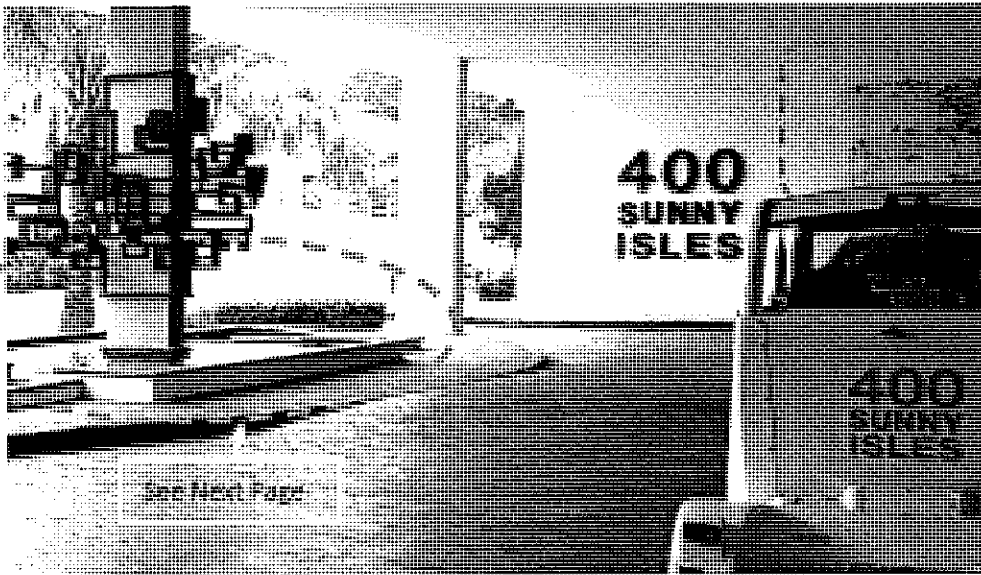
The lobby fountains have an electrical junction box located in the water filled, bottom trough, which powers the multi light underwater fixtures. These fixtures regularly short out and it is not certain whether the light fixture power load is a bit too high or if there is a leak into the junction power box, but the problem is recurrent and applies to the various lobby and outdoor fountains.

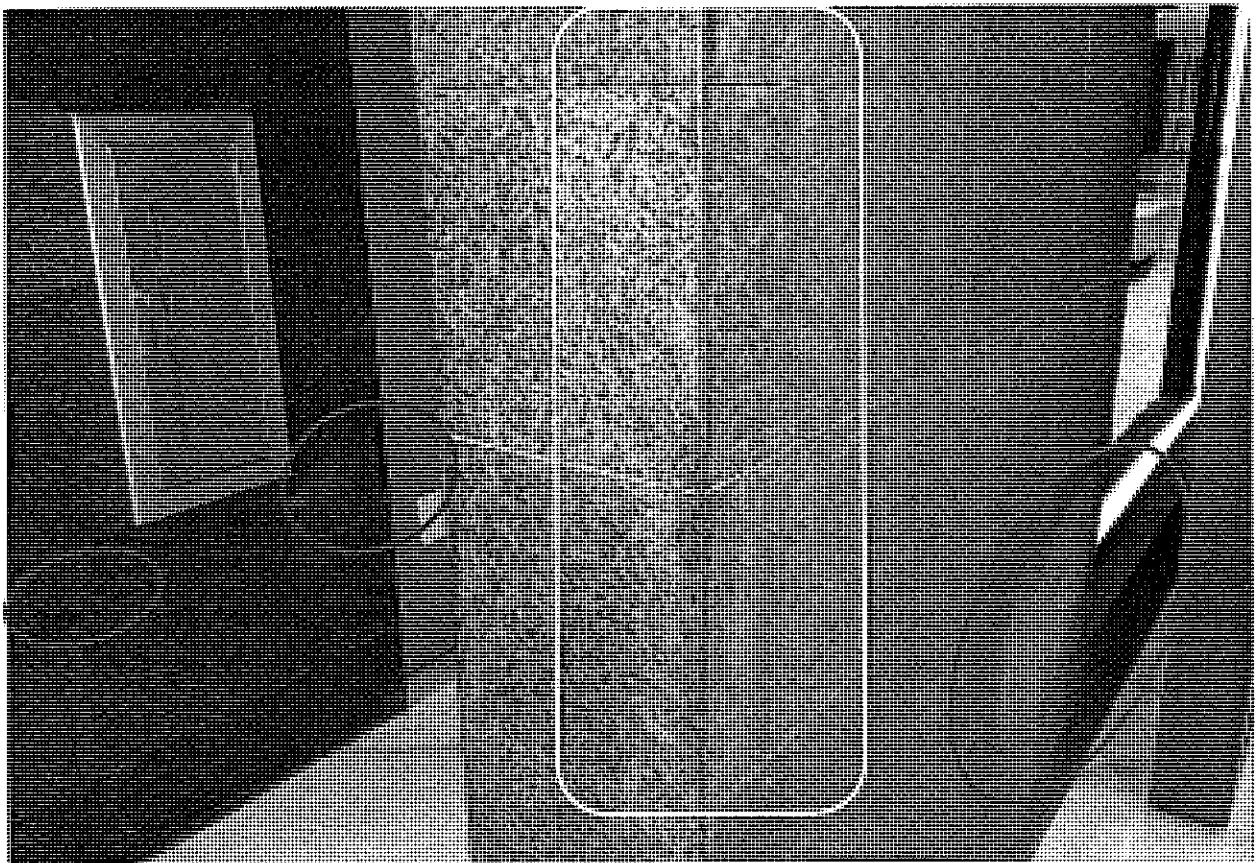
Light stone surfaces are typical around these joint locations as it appears harsh muriatic acid or other highly caustic cleaning application was used to remove the surface staining. This may also have been related to abrasive cleaners.

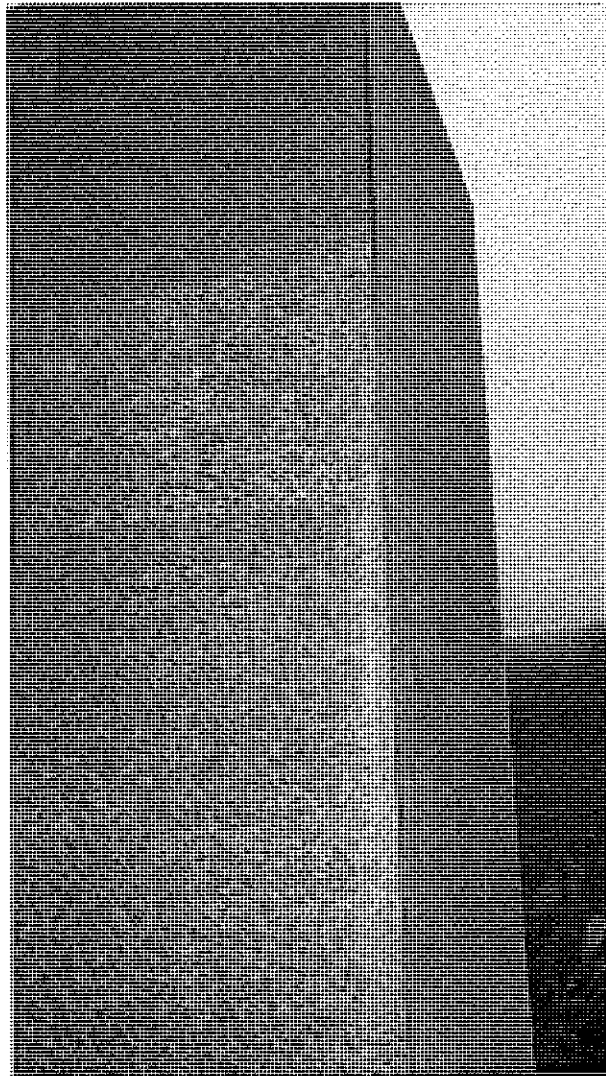
Some dark staining appears to be continuing in areas that have been "lightened by previous cleaning and/or abrasion.

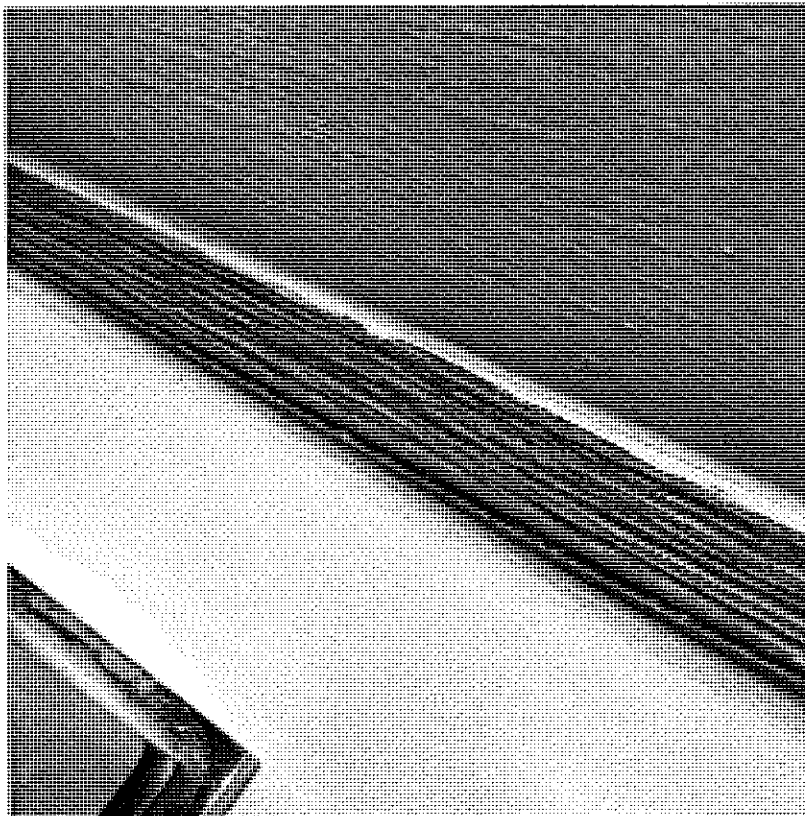
There is insufficient dimension provided at the back splash to protect the finishes at the juncture with the wall.
