CASE NO.: 2020-024374-CA-01

**NOTICE OF FILING**  
**EXHIBITS “A” THROUGH “E” OF COMPLAINT**

***Re: 400 Sunny Isles Condominium East Association, Inc.  
Section 558.04, Florida Statutes, Notice of Claim of Construction Defects***

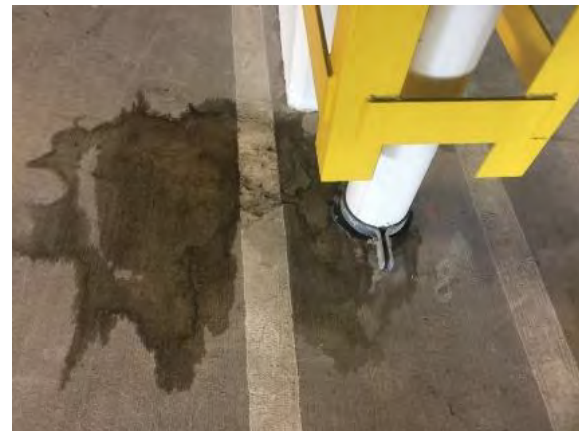
Figure 6

Another view of the ponding water on the 4<sup>th</sup> level. The exact location of the issue can be noted by the parking space 4043.

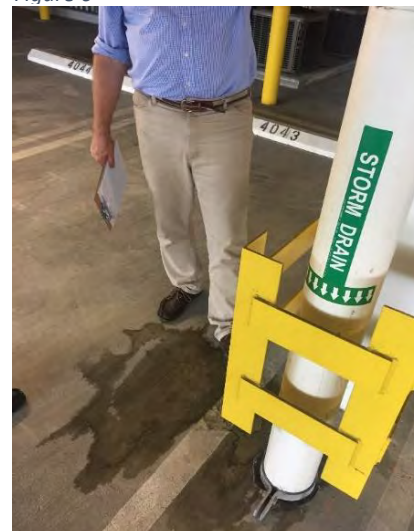
Figure 7

Close view of the water seeping down this storm drain pipe, pooling on the garage surface, and the continuing down to other levels of the garage.

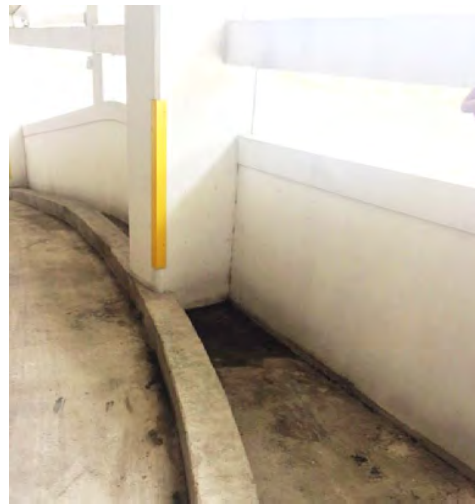
Figure 9

An improvised conduit for water to drain from the ponding location noted above can be seen here. It does not appear to be draining, likely due to clogging. A possible solution might be the installation of a stainless steel or PVC pipe sleeved through the exterior wall to drip water away from the façade. This would also prevent the deposition of black water onto the driving surface of the deck as is seen elsewhere (see picture below).

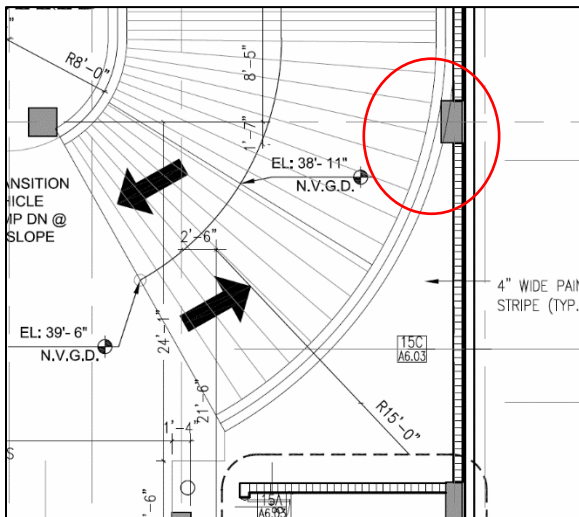
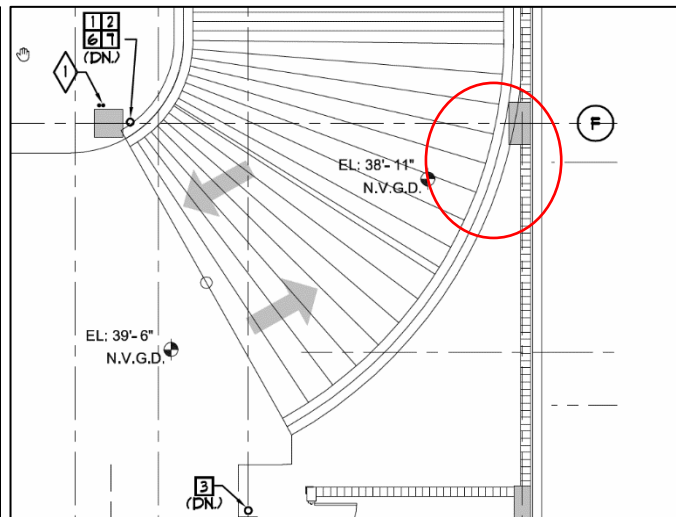
Neither the architectural plans nor the plumbing plans included a way for this water to drain. Improvised tubing was found to have been installed in some locations, but often was not performing adequately in terms of drainage.

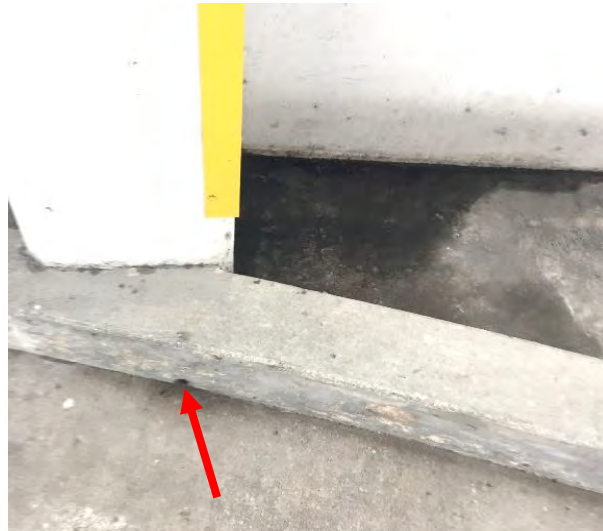
Figure 10

Another location of ponding water in a corner of the parking ramp. Cracking has already begun in the concrete. While there does appear to be a channel for the water to drain from this location, it is not draining properly and therefore the water is still ponding (see at right).

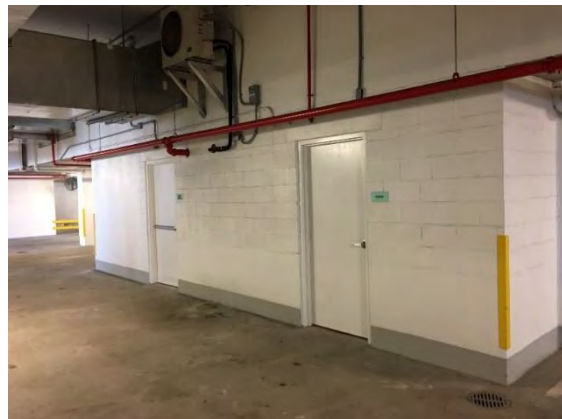
Figure 14

Another view of the doorways opening at the driveway of the parking garage. This angle clearly shows the ramp in the background and the location of the doors in relation to where cars would normally drive by. Code research of this issue is required, as this is not a fire egress pathway, but as an exit from the elevator lobby 10, and the pedestrian corridor to the south, users are stepping from an interior corridor lobby space, directly into the pathway of vehicles as they step through the door. Even if allowed by the code, Archetype would like to suggest modification of this condition.

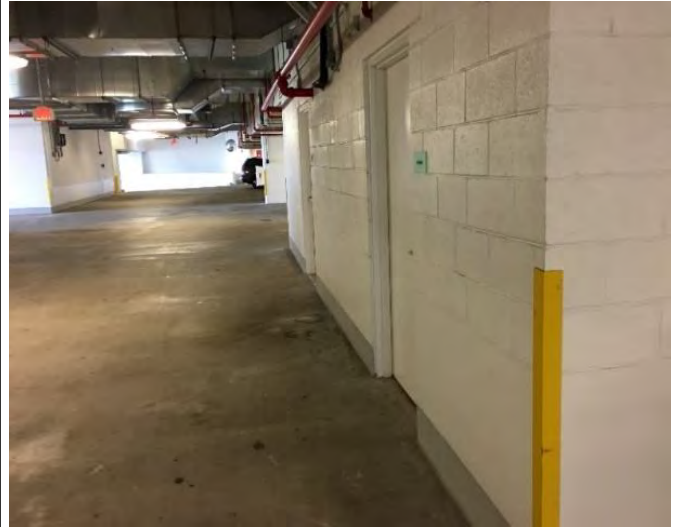
Figure 15

The figure below shows the architectural plans which include no recessed area or safety barriers for anyone entering or exiting through the two doors.

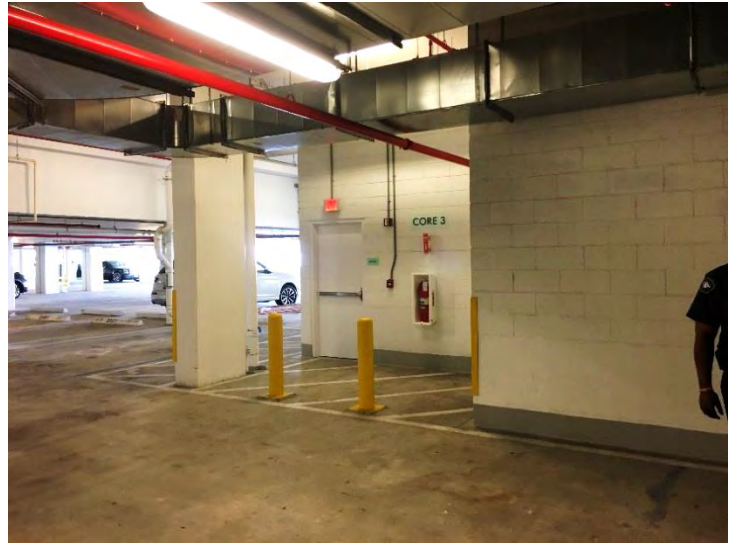
Figure 16

Another doorway, clearly marked and blocked off.

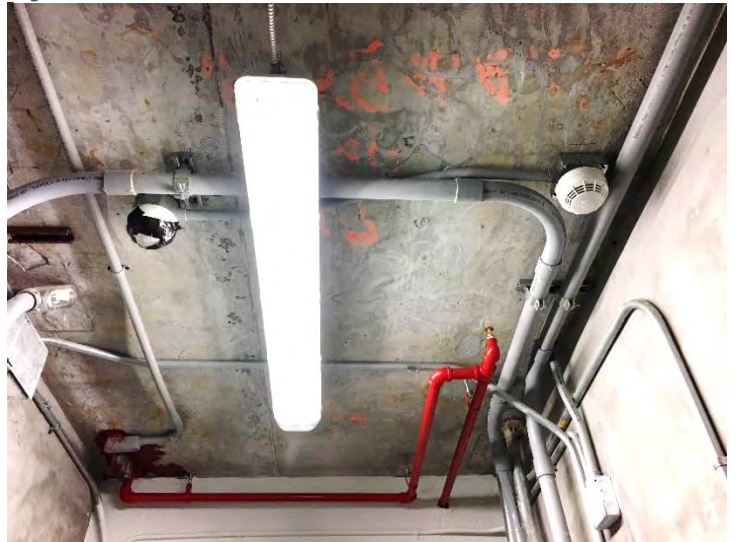
Figure 17

There appears to be two smoke detectors in the fire pump room. One of the two smoke detectors is taped. It is possible that the smoke detector in question was beeping at one point and this was a quick solution.

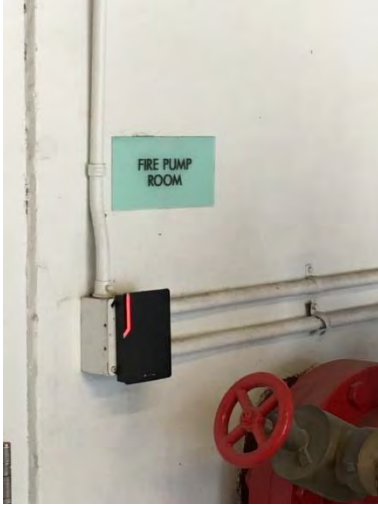
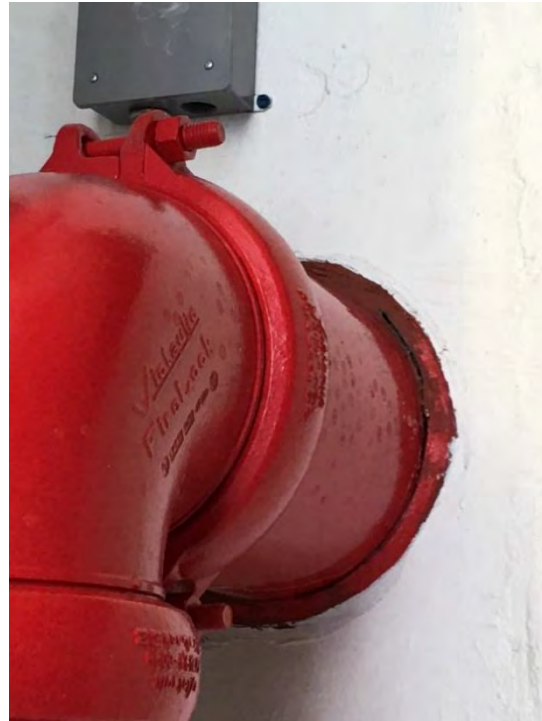
Figure 18

Fireproofing around this pipe has gapped at the perimeter of the pipe. Many instances of defective or damage fireproofing were found throughout the fire pump room area.

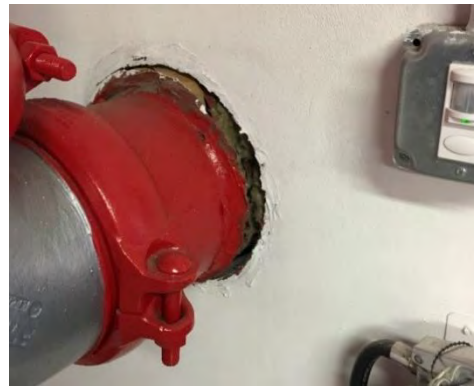
Figure 19

Fireproofing around this pipe has failed, exposing the insulation on the inside.

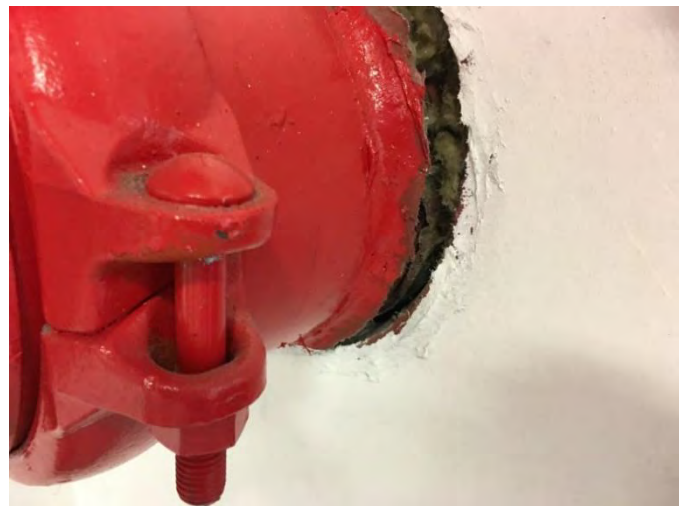
Figure 20

A close-up view of the cracked fireproofing from the location above.

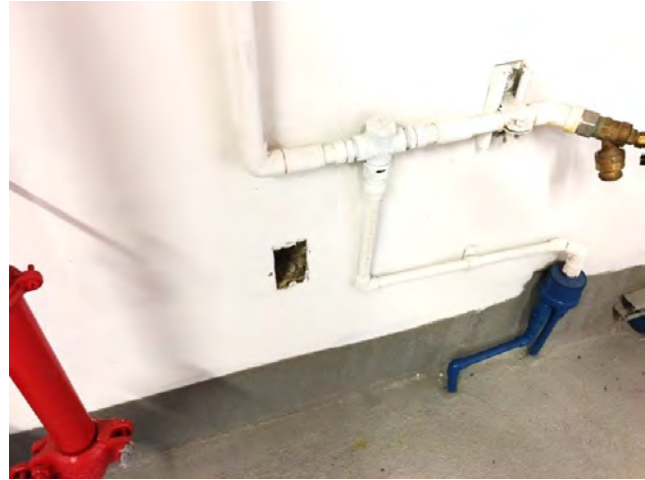
Figure 21

This hole in the wall appears to be the intended location of an electrical outlet. This outlet should be installed as indicated on electrical drawings. Verification of the fireproofing of this condition should also be performed. The electrical contractor should survey all outlets. All similar cases throughout the building should also be properly verified for completeness per plans, fire rated where appropriate, and provided with covers.

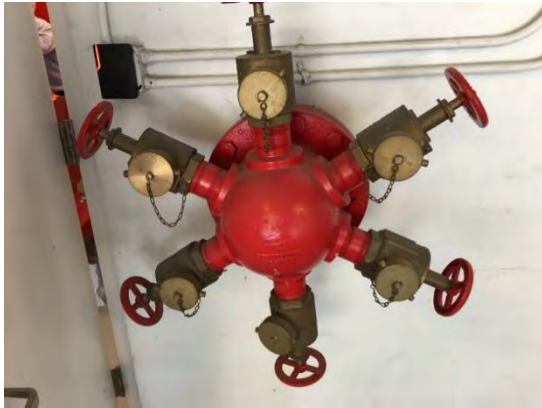
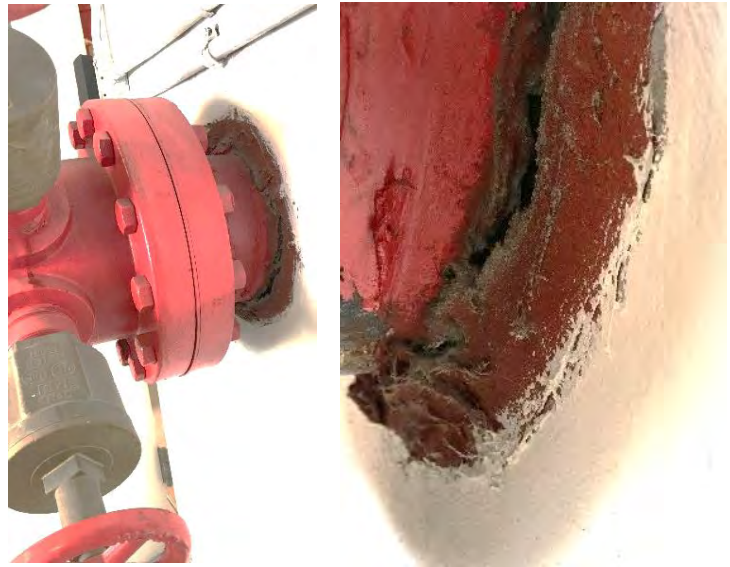
Figure 22

An overview of the fire pump just outside the fire pump room. Side view at right.

The fire pump just outside the fire pump room, above right. The fireproofing has cracked along the perimeter of the pipe.

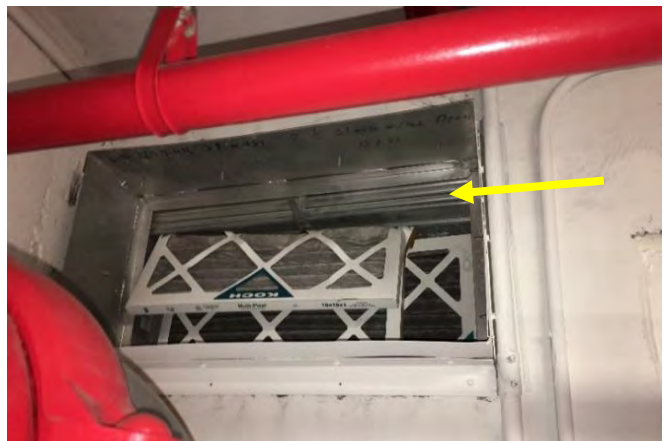
Figure 23

In the event of a fire, this fire damper shutter must be able to close in order to prevent the fire from spreading further. However, the air filter placed and folded in the opening obstructs the door from closing. Proper storage of these filters is necessary to ensure proper fire safety.

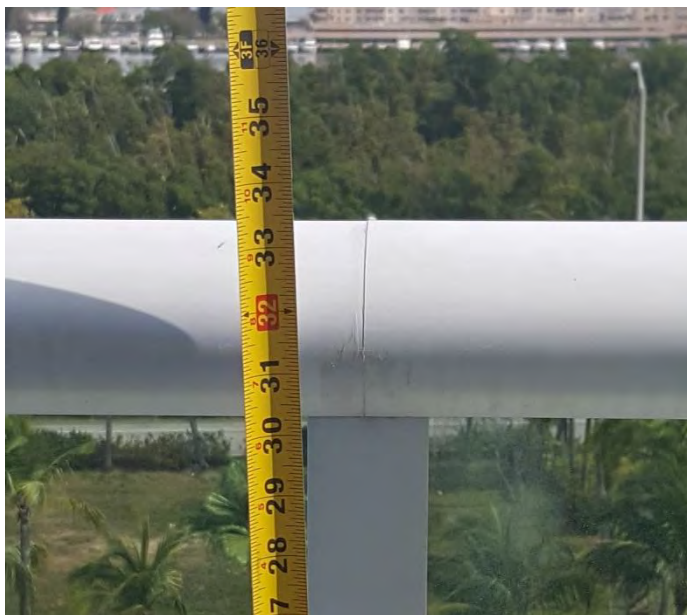
Figure 26

The north side of the pool deck is provided with a glass and aluminum fall-prevention railing system. Unfortunately, the railing has an integrally cast concrete curb. The curb creates a step condition rising to an elevation above the main deck level. This creates a step to top of railing dimension of only 33 inches (approximately 10 inches less than the desired 42 to 44-inch dimension). This is highly dangerous because it fails to provide adequate fall protection. It is not considered reasonable that children or careless persons would not be in danger of falling.

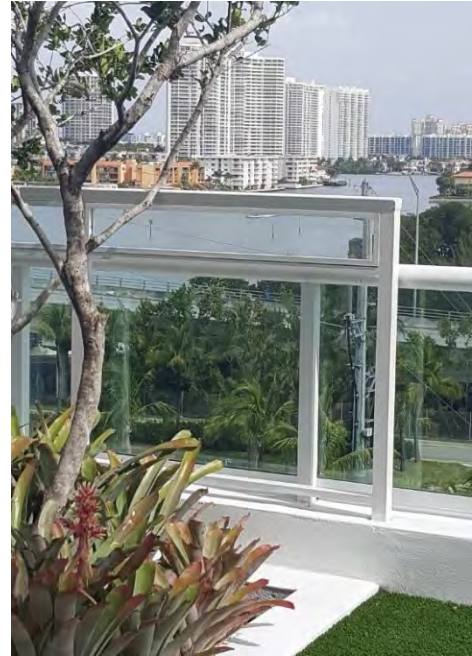
Figure 27

Note that someone had installed a second, higher railing of proper height located only at the planter areas.

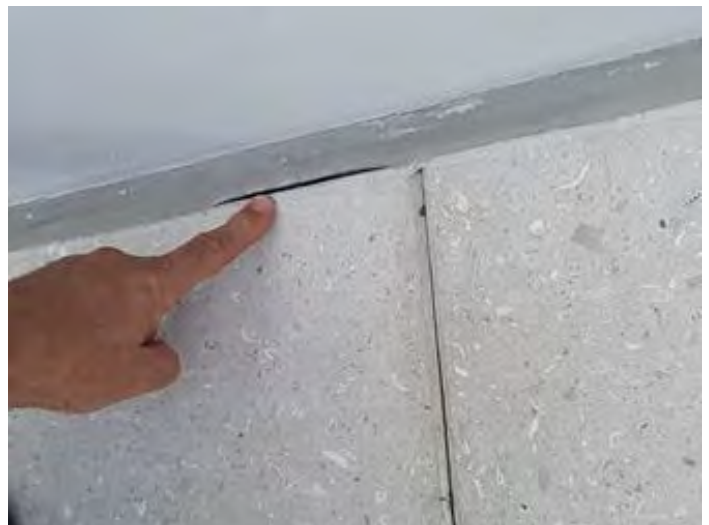
Figure 30

The expansion joint located between the concrete pavers and the vertical stucco walls of the towers was failing in terms of adhesive. The joint is considered aesthetic only, as the tiles are not a watertight surface and therefore any openings do not compromise the flooring. These areas of adhesive failure are expected where backer rod and caulk is used at a wearing surface, as this is not a recommended horizontal joint.

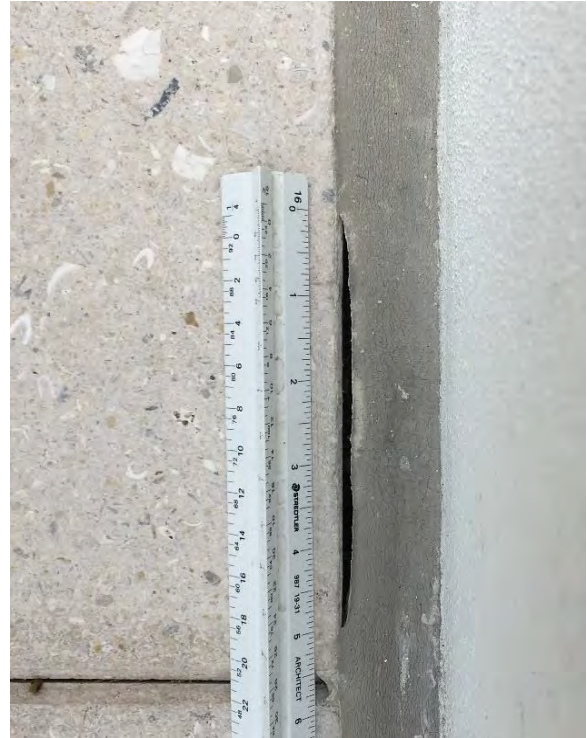
Figure 31

This is a close-up view of the adhesion failure shown above. The gap was measured to be about 5 inches in length.

Failure of the expansion joint at the paver surface elevation will allow water to enter into the space below the pavers above the waterproofing membrane, where the lower level of a bi-level drain must remove the water. This has shown to be a problem at tile in the spa pool and at pavers in lower areas around drains.

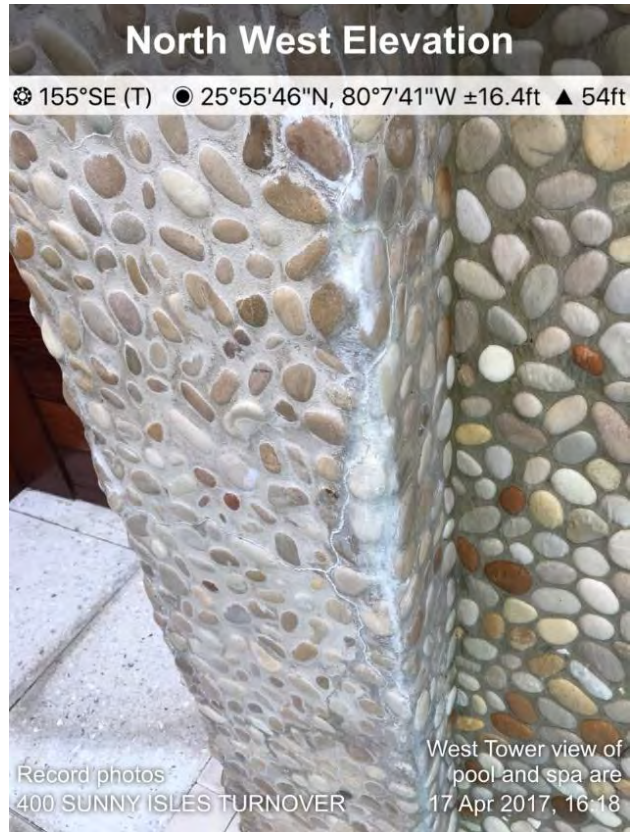
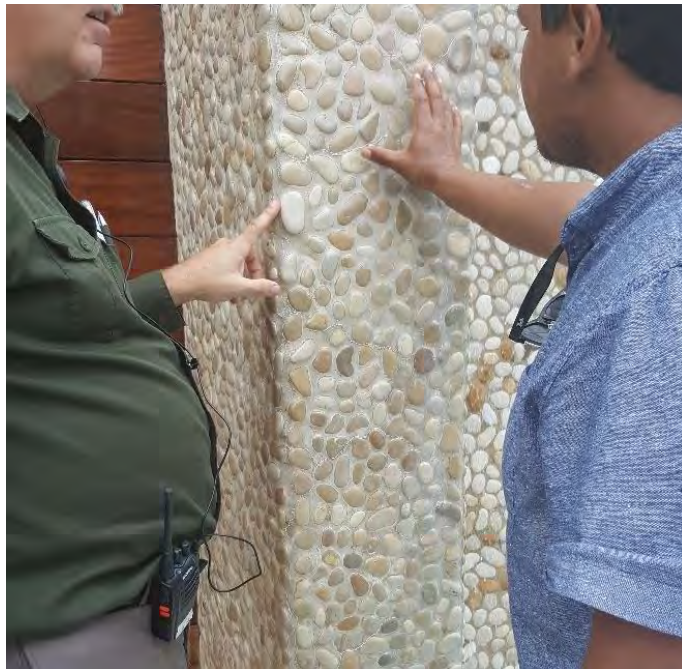
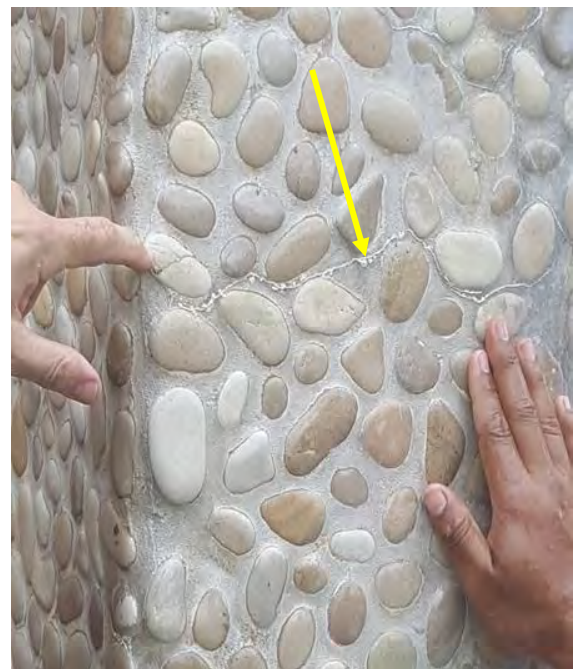
The following photos are close-up views of the problem areas on both the spa and the plunge pool, both constructed similarly. Cracks and efflorescence can clearly be seen in these photos.

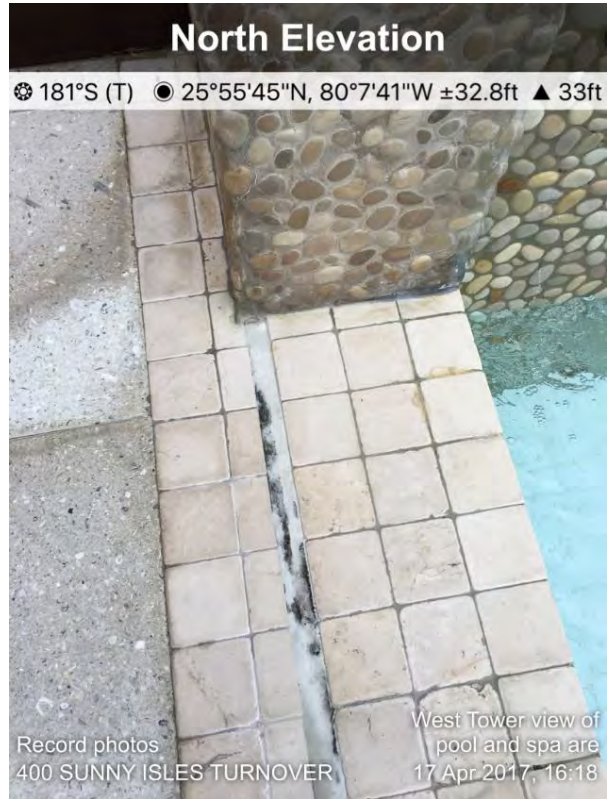
Figure 37

Organic growth was also found between the tiles, at the soft expansion joint, indicating that the moisture is under the joint and the concrete tiles are not draining properly. Areas on both the spa and the plunge pool are not draining properly, giving rise to these organic growth areas.

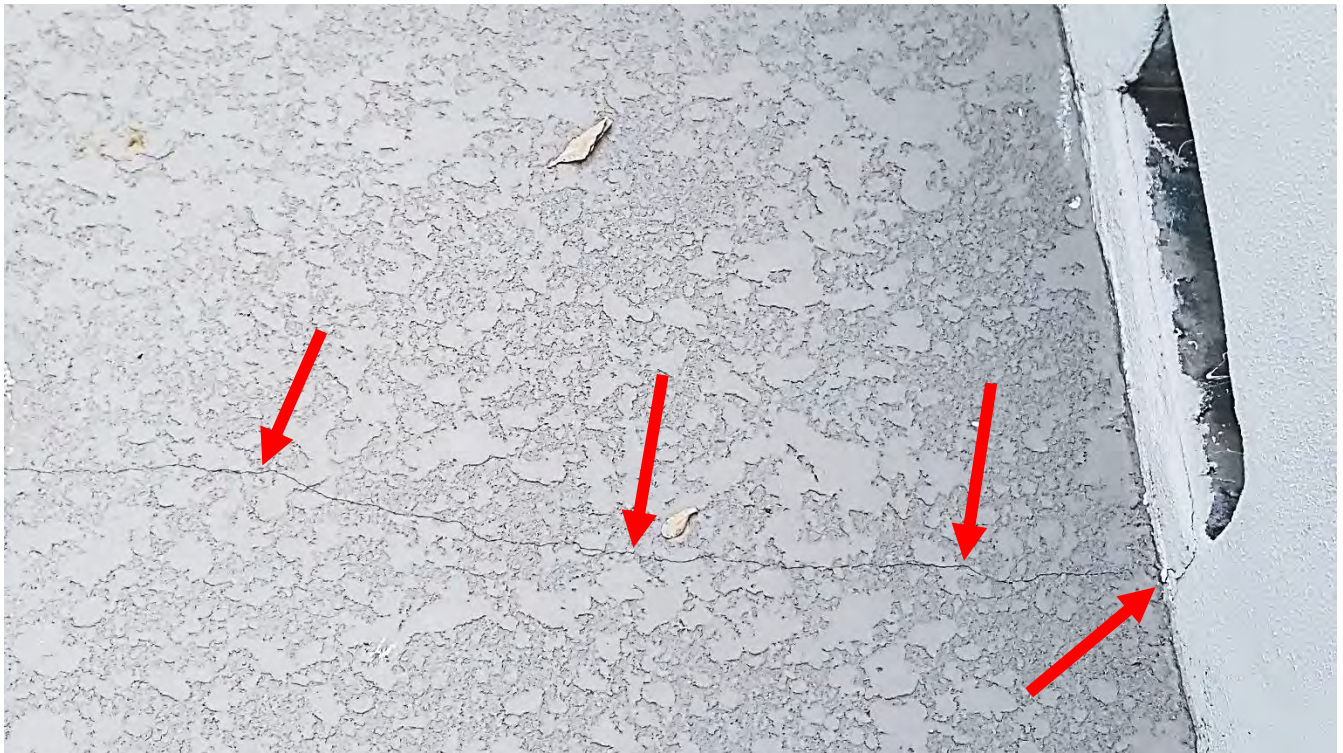
Figure 40

Cracking in the textured waterproof coating on the pool deck surface was found to occur at regular intervals along the north side of the Lanai Level (6<sup>th</sup> floor). The coating typically should have jointing at regular intervals to relieve stress. Manufacturer requirements for the actual material used should be identified and requirements for both jointing and adhesion should be evaluated for conformance.

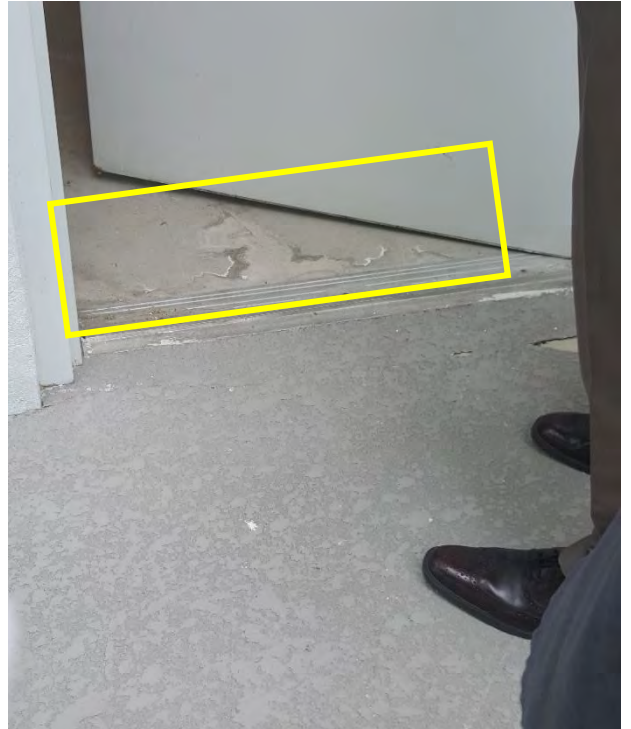
Figure 41

This stain was noticed just inside the doorway leading into the stairwell (yellow box). This indicates that water is coming into the interior from under the door threshold and underneath the waterproof texture coating. The moisture is ponding on the concrete, unable to drain. This will cause damage to the concrete and reinforcing if not mitigated.  
Note in the photo below that the coating is cracked and delaminating (red arrows).

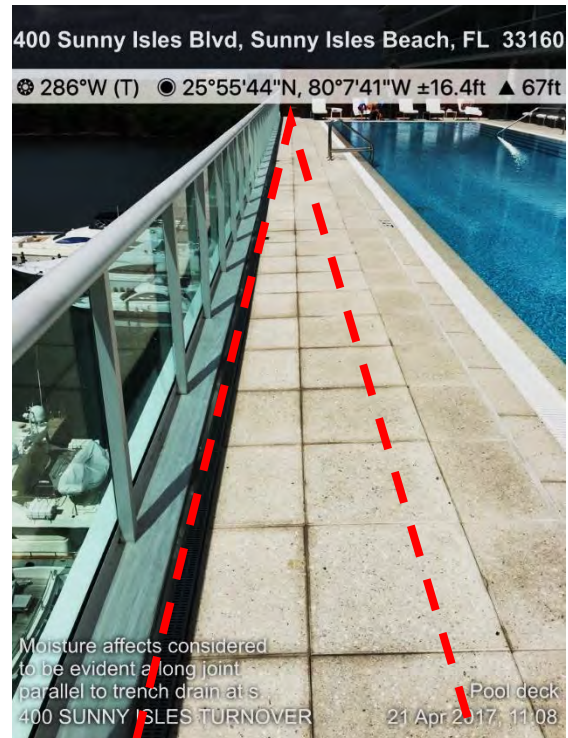
Figure 44

The tiles to the south of the pool have similar staining throughout the pool deck. The slab that the tile sits on is improperly sloped.

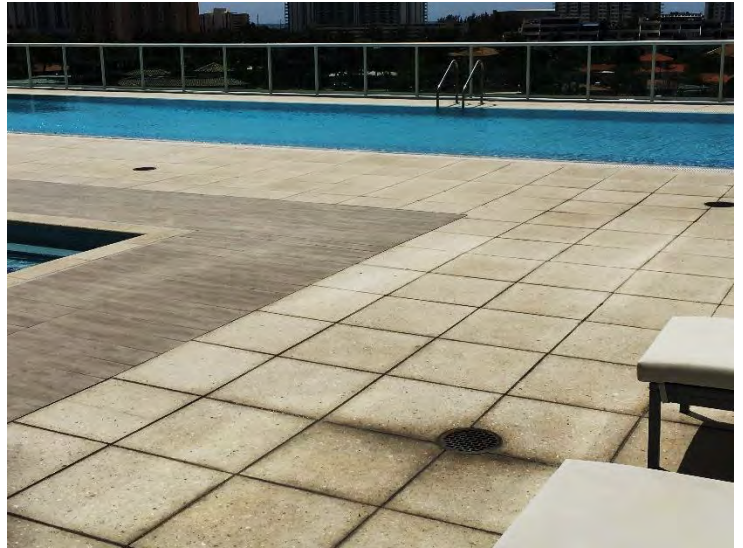
Figure 45

The tiles on the pool deck have also become blackened in the tile joints. Staining is particularly worse around drain, indicating it may not be draining correctly. The slab underneath the tile is believed to be improperly sloped, which is causing water to stay under the tile indefinitely. This is causing the water to leach minerals out of the deck tiles and deposit dirt and other materials on the surface.

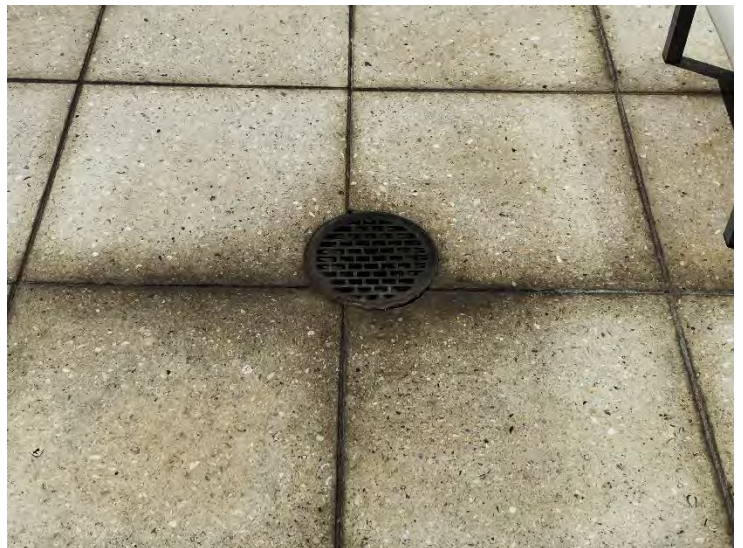
Figure 46

This is a close-up view of the drain shown above. The joints around the drain are darker than the surrounding area suggesting that the drain may be clogged on the lower bi-level, inhibiting the water from flowing into the drain from under the tile.

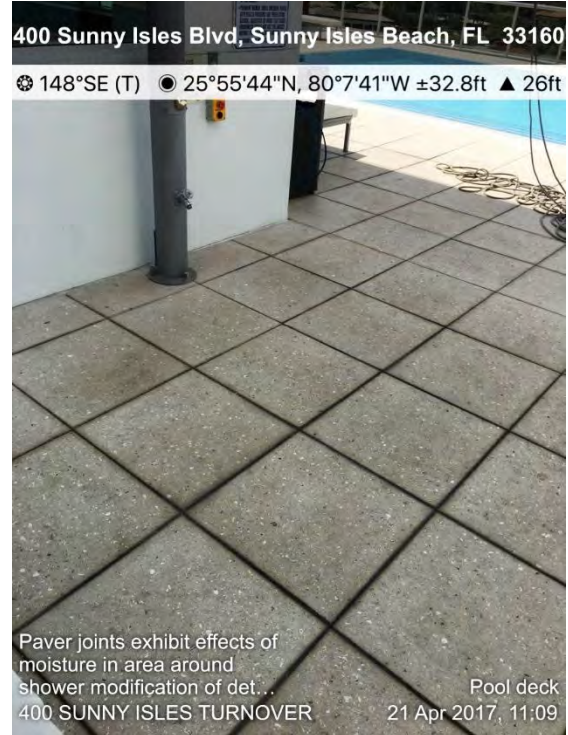
Figure 47

The tiles around the pool shower also have particularly dark grout joint staining. This dark grout in and adjacent to the joints were considered to have been caused as a result of moisture under the tile wearing surface. Grouted joints remaining moist or saturated due to retainage of excessive moisture was considered to be caused by poor/inadequate drainage.

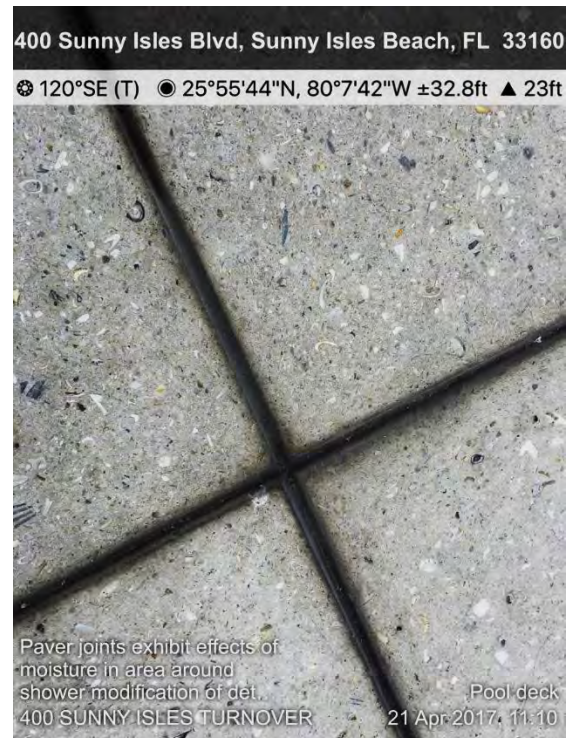
Figure 48

When the shower pictured above is used, more water is added to the surrounding area which explains why the grout around it is generally darker than other areas.

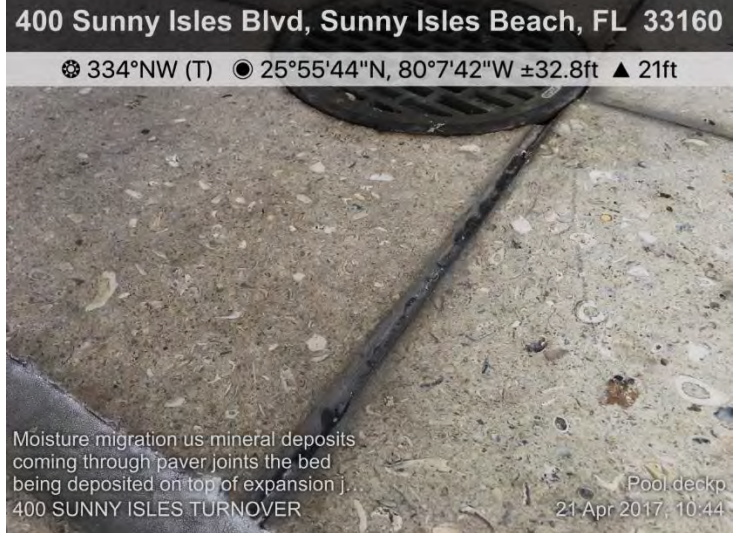
Figure 49

In other locations, organic growth has begun to form as well as mineral deposits along expansion joints and other structural systems.

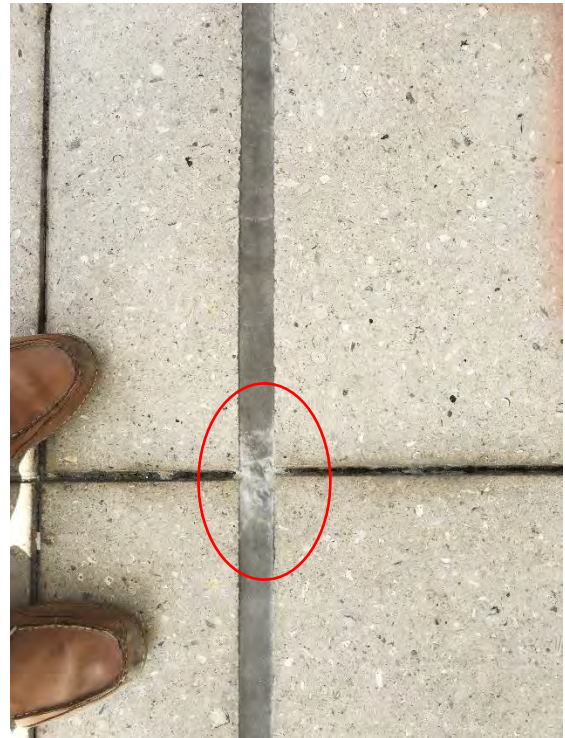
Figure 50

This saturated joint is acting as an outlet for moisture onto the expansion joints between the two structures. The moisture under the tile is causing efflorescence on the expansion joint, which confirms that moisture is dissolving the grout and tile from underneath and depositing the particles on to the expansion joint as it evaporates.

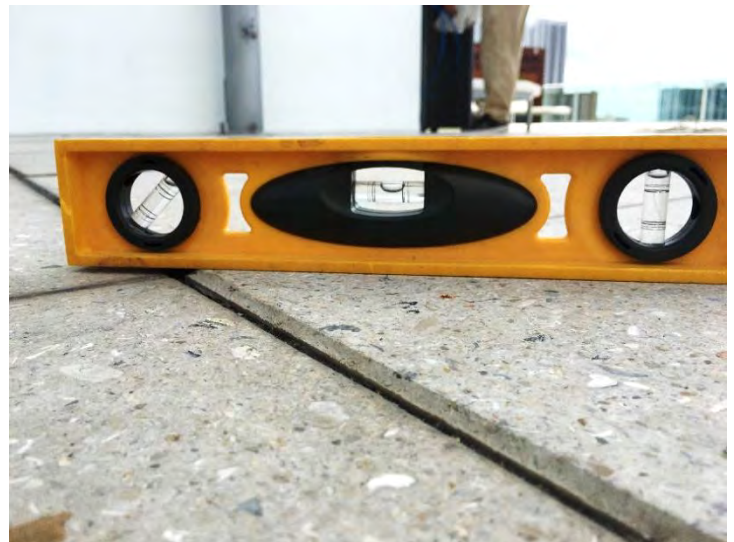
Figure 52

The tiles are out of plane and have lips throughout. These can be hazardous to children or the elderly due to the possible trip hazard they pose.

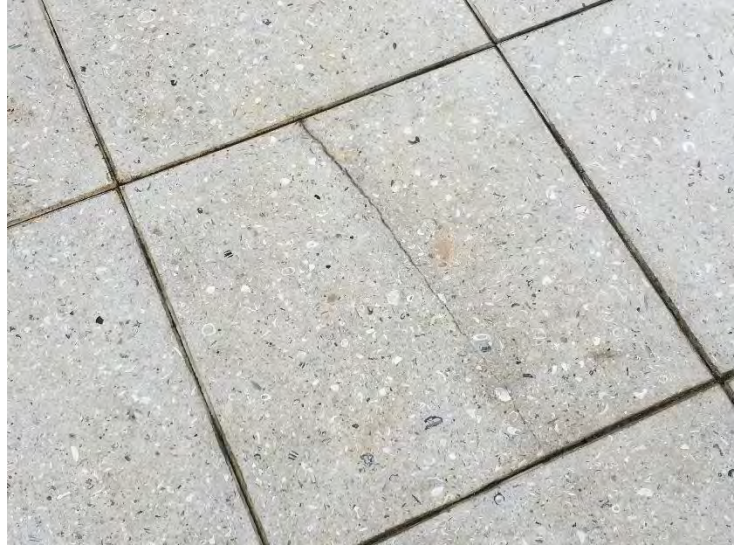
Figure 53

This tile has cracked. This is considered to most likely be caused by problems of deterioration of the grout bed and the bedding not being due to properly support the tile uniformly. This suggests that water may have dissolved/eroded the grout underneath. It is also possible that the bedding was not installed properly. Further investigation of this condition is highly recommended.

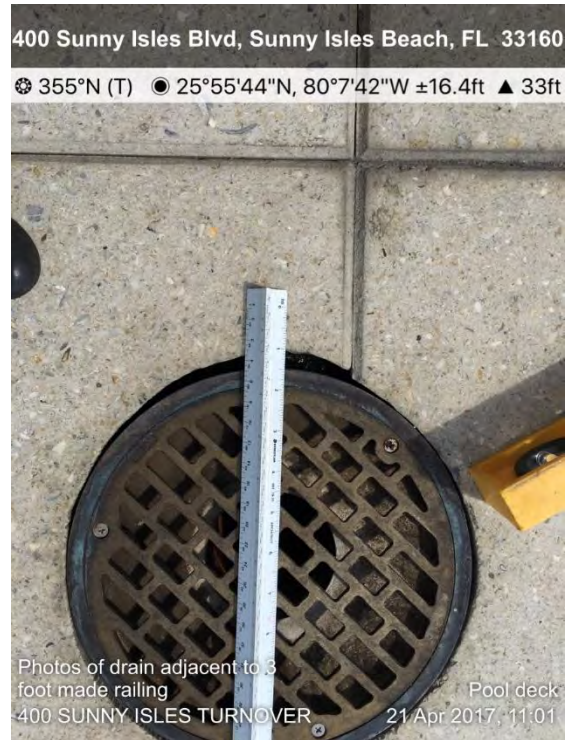
Figure 54

This roof drain has poorly cut tiles all around, leaving a space for organic material and water to accumulate. This is considered poor workmanship by the contractor. A close-up view is shown below, detailing the half-inch thick gap between the tile and the drain.

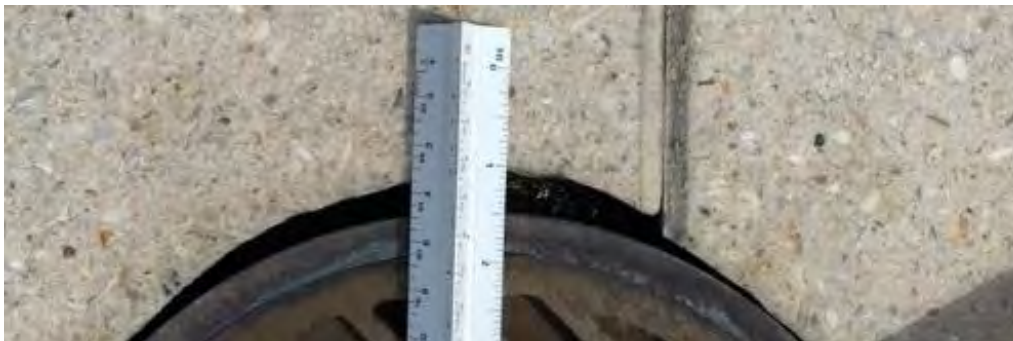
Figure 55

This is another view of the gap pictured above. The gap is approximately 1/2 inch across, which is excessively large for a small drain. Further investigation of the condition is recommended.

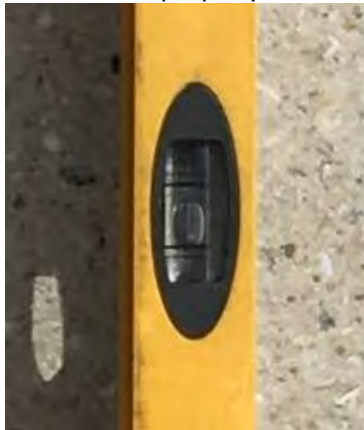
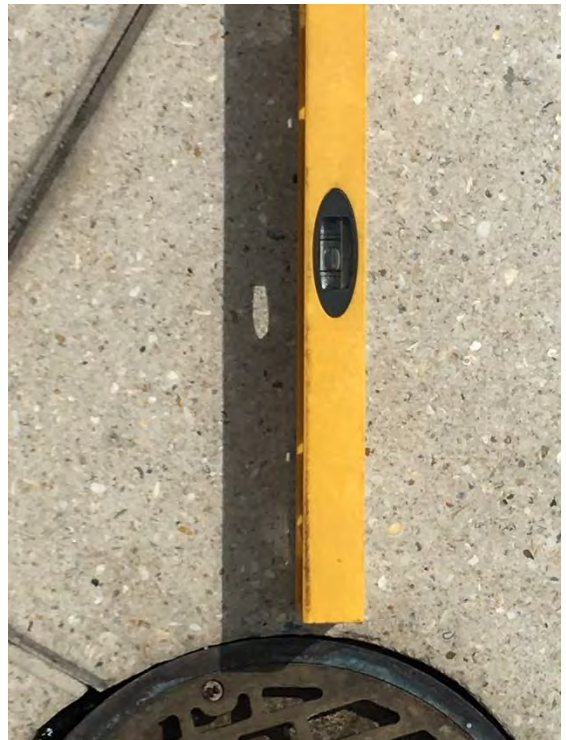
Figure 57

The slope of some of the surrounding tiles are also pitched away from the drain, which will direct water away from the drain in a rain event and not allow the floor to drain properly.

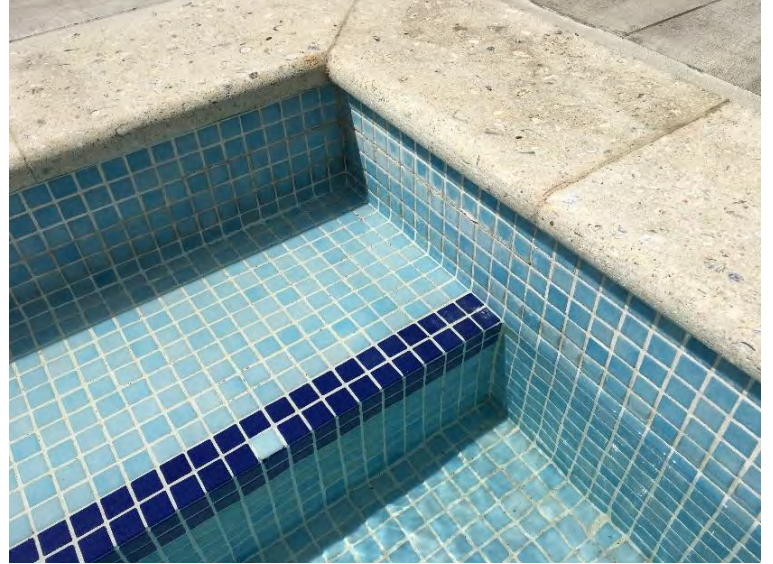
Figure 58

Spa tiles are cracking at the grout line. Water underneath the deck tiles is draining into the spa and causing severe damage to the tile grout. Moisture is dissolving the grout and mortar behind these tiles. The evidence of moisture is the dissolved grout left as particles, known as efflorescence, on and behind the tile. The grout being dissolved away loses strength which causes cracks and tiles to fall away from the wall. The runoff generated from the pool shower is believed to contribute to the decay of the spa since it is the most active contributor of water to the pool deck, besides normal rain events.

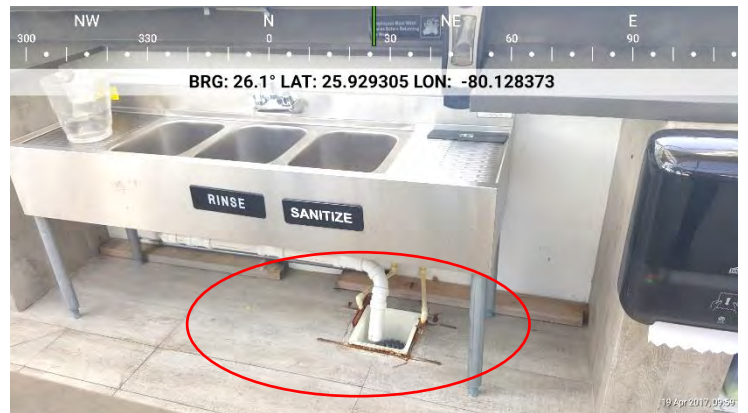
Figure 70

The cabana bar drain for the sink surrounded by rusted rebar in the concrete tile. As the rebar continues to rust it will break the concrete tiles. This condition should be reconstructed.

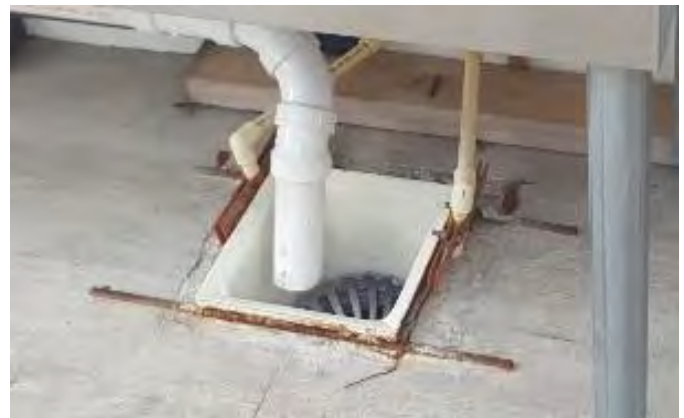
Figure 71

Rebar/steel should be fully imbedded in concrete to protect them from rusting and spalling.

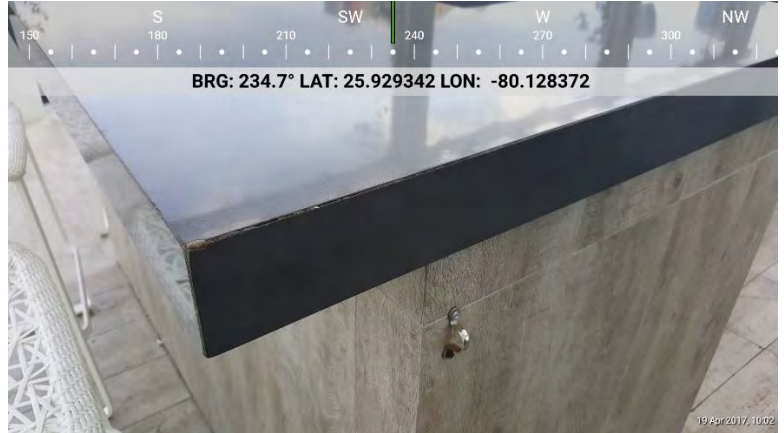
Figure 72

Counter edge was completed with poor workmanship. The seams are not completely sealed, which will allow water to seep into the joint and dissolve the bond. A close-up view is shown below for clarity. This counter should be refabricated with thicker through body porcelain, properly diamond cut and assembled with beveled corners.

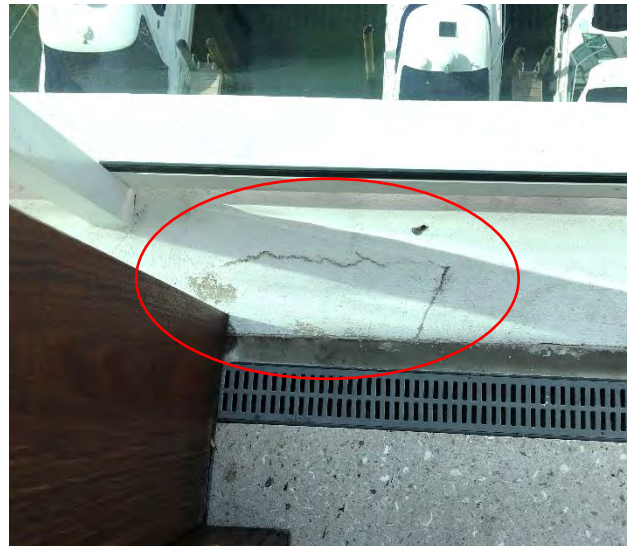
Figure 74

Cracks in the top of the concrete edge are a result of an unsealed penetration, such as the rail post pocket. Once open, the cracks allow more moisture to enter the concrete, causing more cracks to form. This photo taken next to the wood-panel partition.

All cracked areas of parapets, knee walls and curbs that are subject to water intrusion should be repaired with an approved architectural protocol.

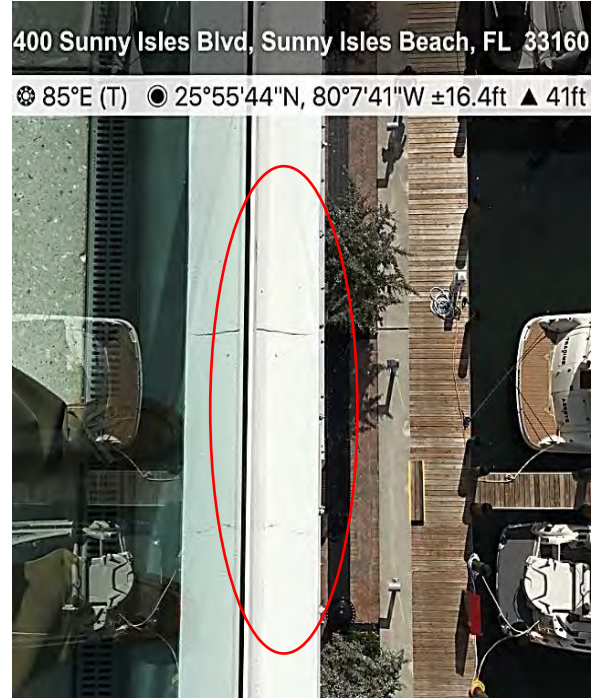
Figure 75

This is another view of a crack in the concrete underneath the railing on the marina side of the pool deck.

All cracked areas of parapets, knee walls and curbs that are subject to water intrusion should be repaired with an approved architectural protocol.

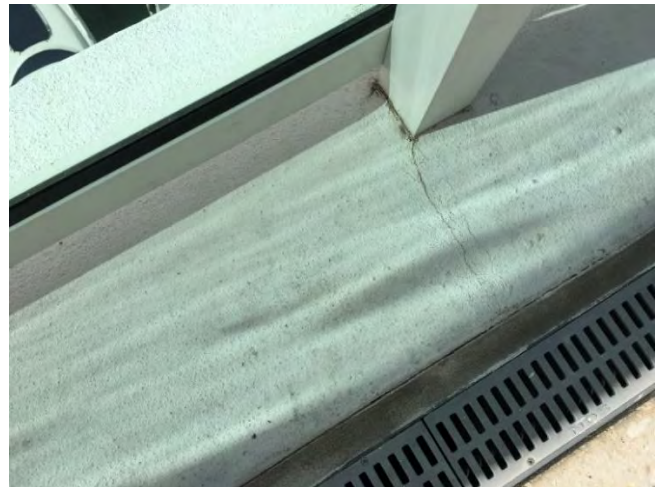
Figure 76

Rail post pockets are a typical location for water intrusion. Figure 78 shows a rail post pocket on the pool deck that has cracking running from the corner of the rail post, perpendicular to the concrete edge.

All cracked areas of parapets, knee walls and curbs that are subject to water intrusion should be repaired with an approved architectural protocol.

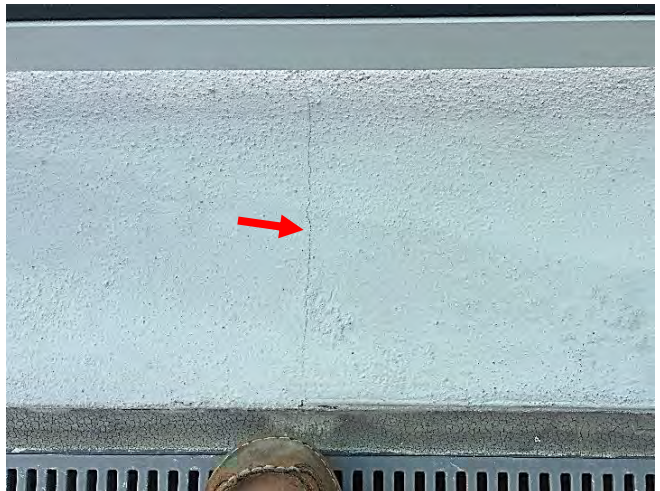
Figure 78

Another example of cracking in the concrete perpendicular to the edge.

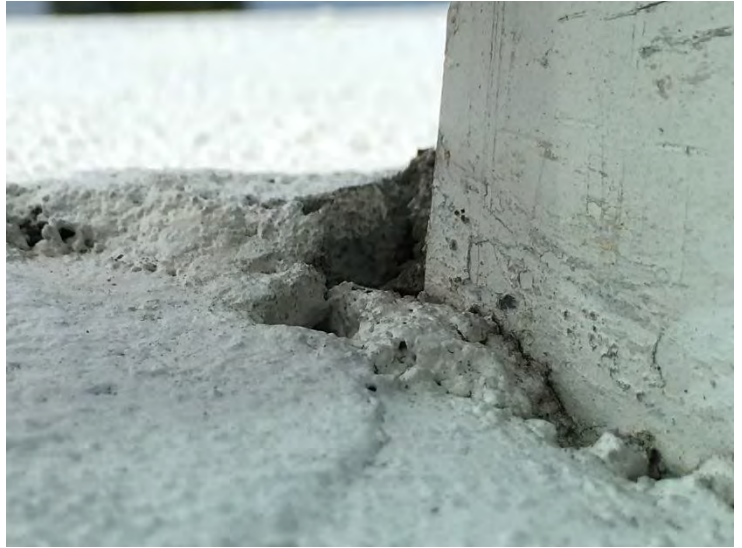
Figure 80

Rail post pockets are considered surface penetrations and should be waterproofed so that water cannot intrude into the surrounding concrete. The several images shown are just a few examples on the pool deck where rail post pockets are not properly waterproofed. All open voids of parapets, knee walls and curbs that are subject to water intrusion should be repaired with an approved architectural protocol.

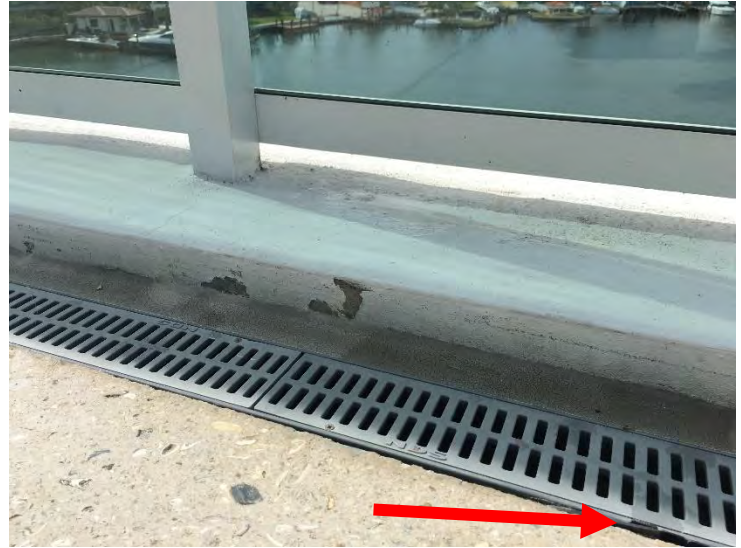
Figure 88

Spalling, which is the result of water intrusion in concrete, is occurring at the pool deck edge. The moisture in the concrete expands and contracts with temperature, causing the surface to peel off.

All open areas around drains, or at parapets, knee walls or curbs that are subject to water intrusion should be repaired with an approved architectural protocol.
