CASE NO.: 2020-024374-CA-01

**NOTICE OF FILING**  
**EXHIBITS “A” THROUGH “E” OF COMPLAINT**

***Re: 400 Sunny Isles Condominium East Association, Inc.  
Section 558.04, Florida Statutes, Notice of Claim of Construction Defects***

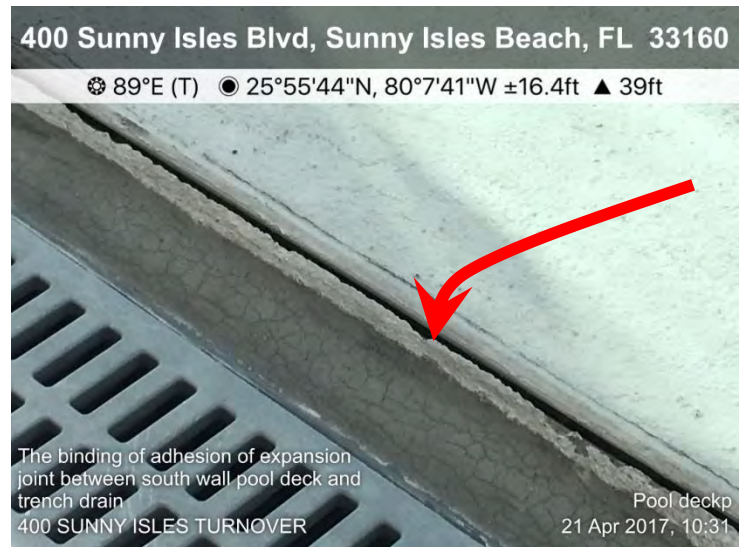
Figure 89

Expansion joint at the drain also has issues with water intrusion. The expansion joint has lost adhesion with south wall pool deck, causing a large gap to form. Water running off the horizontal top of the railing curb/parapet must enter the gap and become entrapped within the wall/deck assembly (water path indicated by red curved arrow).

All open areas around drains, or at parapets, knee walls or curbs that are subject to water intrusion should be repaired with an approved architectural protocol.

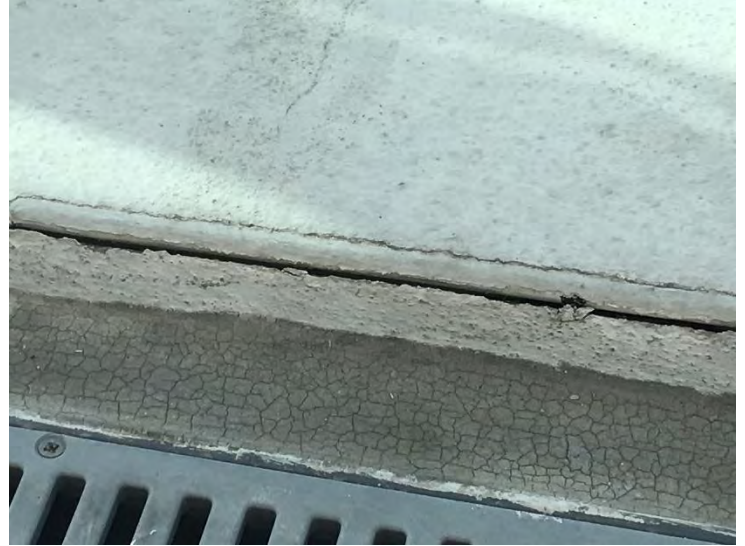
Figure 90

The opening is approximately ¼" wide at its maximum gap and will allow moisture into the joint. This expansion joint may be aesthetic, but if so the actual expansion joint below will be susceptible to water damage.

All open areas around drains, or at parapets, knee walls or curbs that are subject to water intrusion should be repaired with an approved architectural protocol. Cracked and failing backer rod and caulk joints should be replaced with Emseal joints.

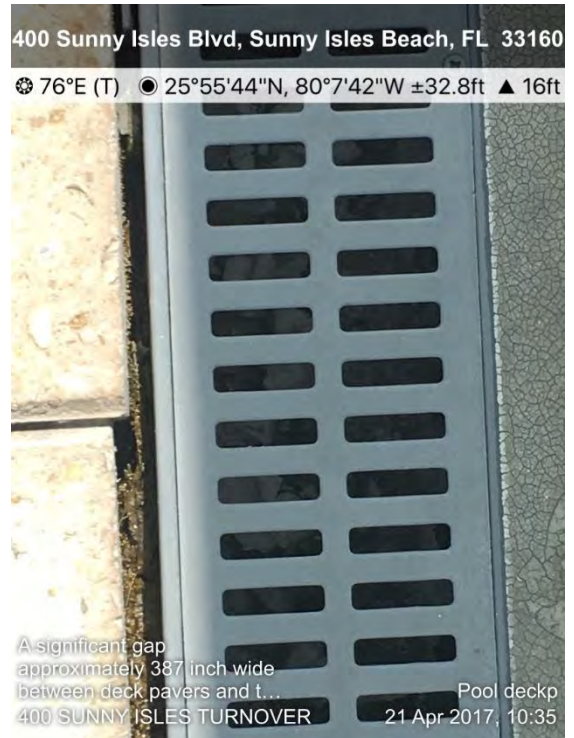
Figure 91

Joint between tile and drainage grate has a large gap approximately 3/8" wide. This is due to poor workmanship during construction.

All open areas around drains, or at parapets, knee walls or curbs that are subject to water intrusion should be repaired with an approved architectural protocol.

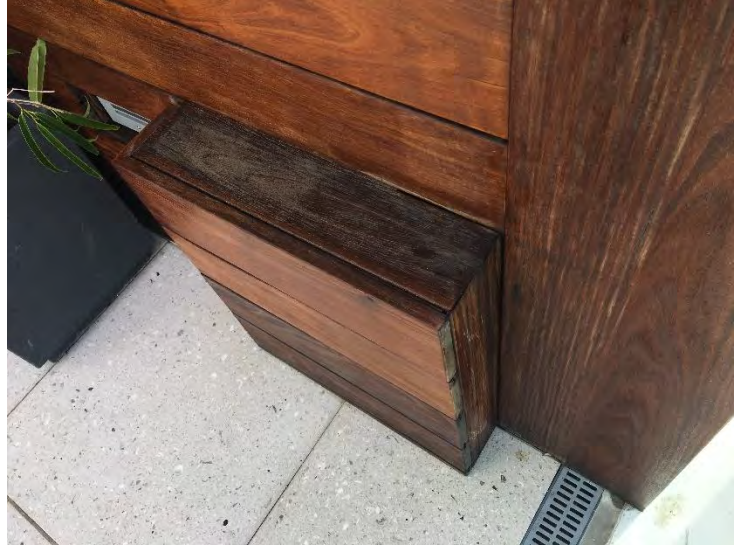
Figure 92

The edges of some of the wood planks are beginning to turn green, possibly due to being detreated or never treated in the first place.

The wood will require an unreasonable amount of maintenance, and will never provide the intended finish.

Recommend that this wood should be replaced with a high quality through body porcelain, large format material.

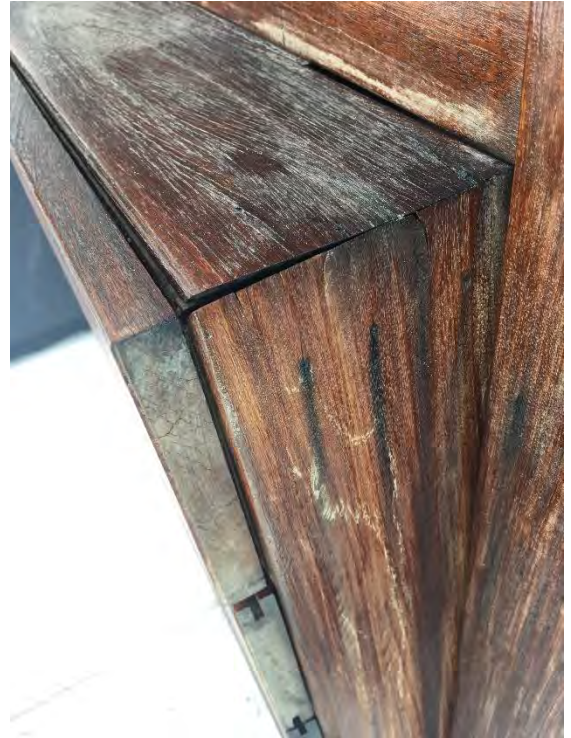
Figure 93

Wood structure finish surfaces deteriorated and separating, especially in the corners as shown in this photo. Note fasteners staining wood at side due to corrosion.

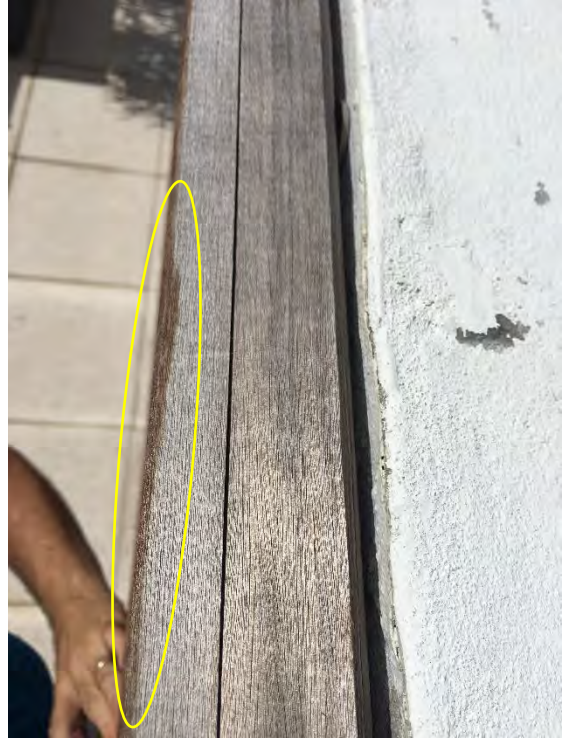
Figure 94

The top of wood façade is unfinished.

The wood should be replaced with a wood style, high quality, through body porcelain tile.

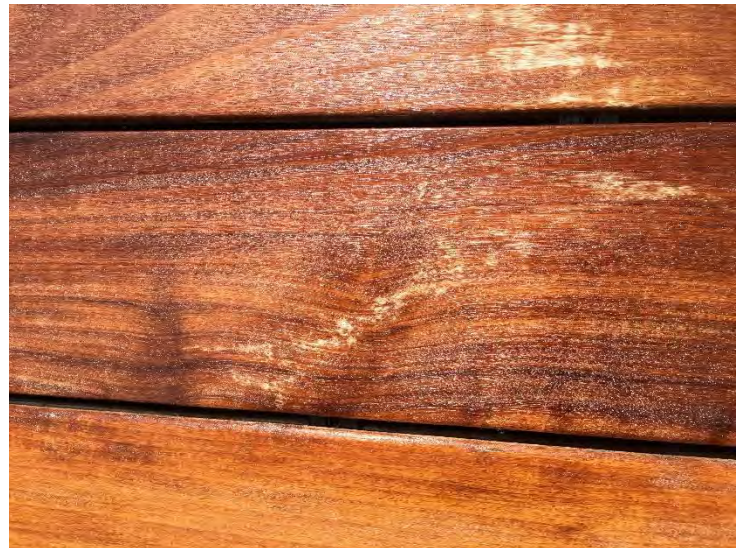
Figure 95

Areas where the finishing is rubbing or coming off were present over the wood façade, such as this area shown to the right.

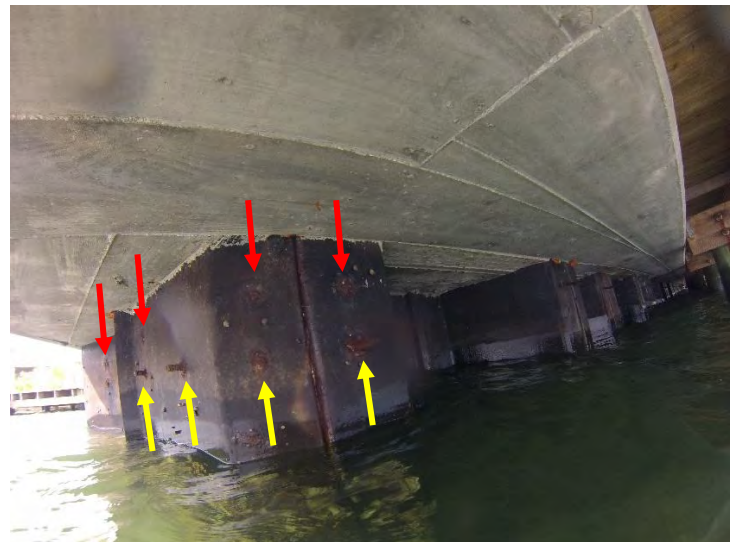
Figure 97

It appears that some of the exposed reinforcing bars were welded off (red arrows) while others were not (yellow arrows). None of the bars, whether welded off or not, seem to have a coating applied in order to mitigate corrosion between the bars and the piling, and thus severe rusting has started in these locations.

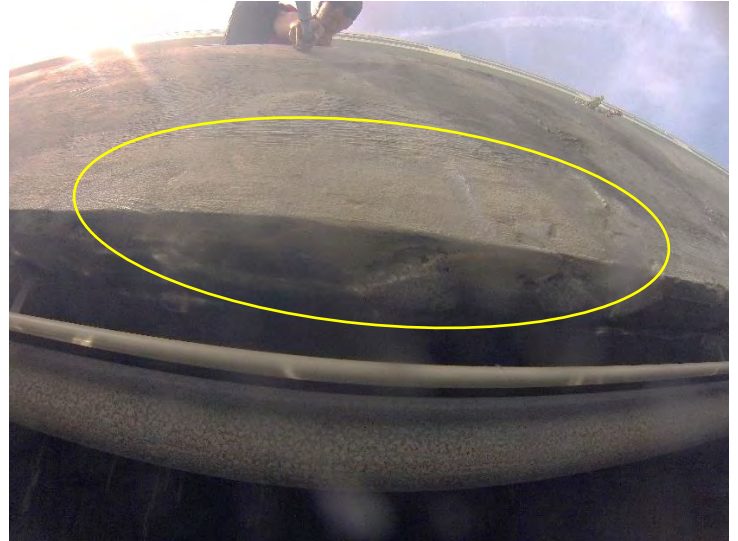
Figure 98

A different texture of the concrete surface and discoloration that appears to be efflorescence around perimeter of the area indicates it may have been patched in the past. These areas should be monitored in the next few months for changes that may indicate the patch remains a problem.

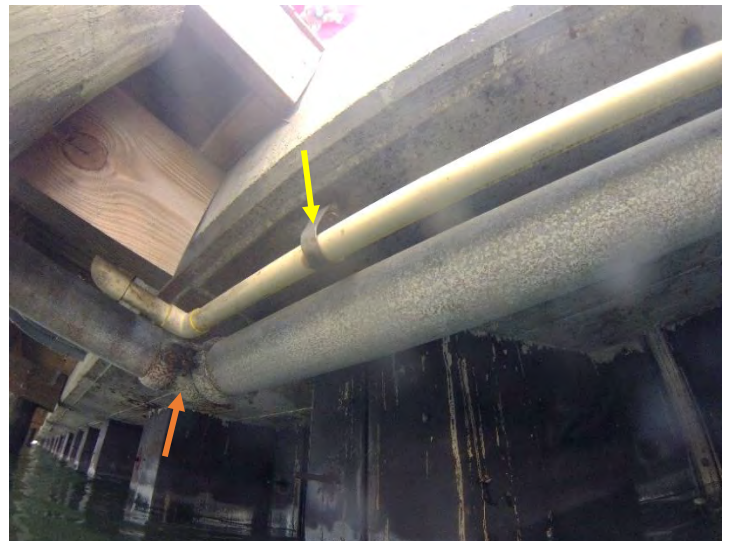
Figure 99

The metal strap holding the PVC piping has begun to rust. Elbow of steel pipe is also corroded and thus a potential area for failure.

A coating of a Zinc rich, thick surface application may extend the life of the pipe hanger and pipe fittings. This should be periodically monitored post re-coating. The best solution would be to replace the pipe hanger with ones made of a noncorrosive material.

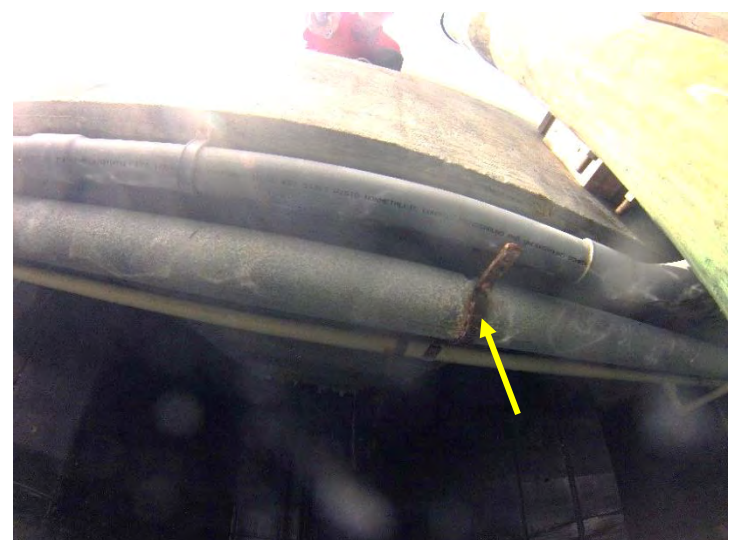
Figure 101

Bracket holding the pipe is severely corroded, as was common along the length of the pipe underneath the dock area. The best solution would be to replace the pipe hanger with ones made of a noncorrosive material.

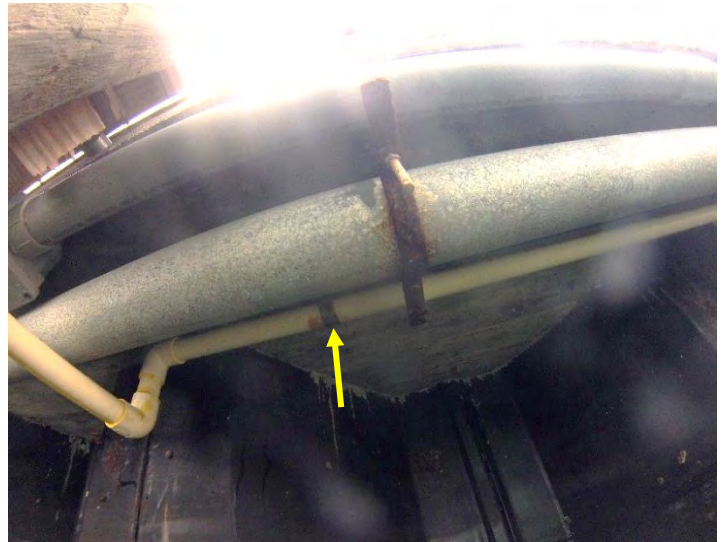
Figure 103

Another corroded bracket, as was common along the length of the pipe on the dock. In addition, there is another case of corrosion on the strap holding the PVC pipe. The best solution would be to replace the pipe hanger with ones made of a noncorrosive material.

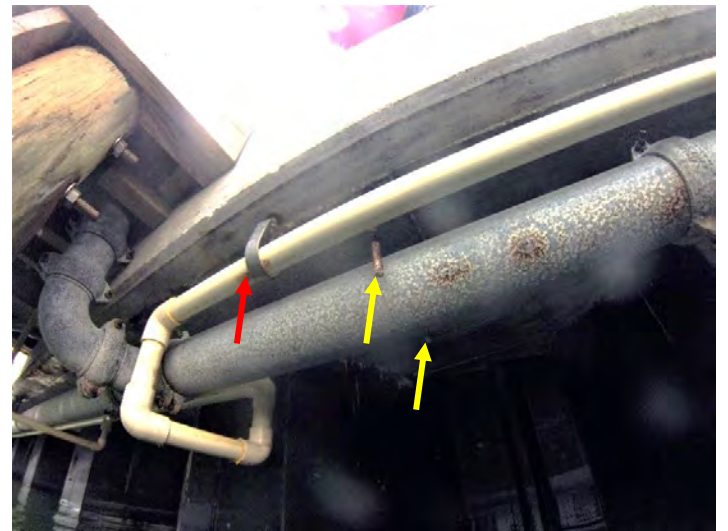
Figure 104

In this case, the bracket that was intended to hold the larger pipe is completely missing, possibly due to extensive corrosion, as evidenced by the exposed rods where the bracket would be mounted (yellow arrows). More corrosion effects on the PVC piping is also noted. The best solution would be to replace the pipe hangers with ones made of a noncorrosive material.

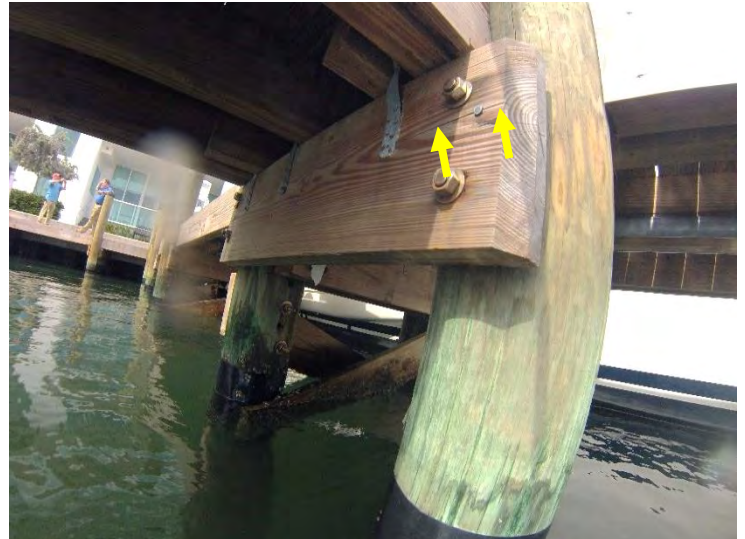
Figure 114

Another view of the crack beginning to propagate along the wood and through to the other side of the hurricane strap.

Red arrow indicates the current length of the crack. The inspecting engineer could not see the purpose for the large nails driven (too) close to the end of the wood beam unless this was a temporary spike to hold the wood member until the bolting could be accomplished. (Subsequently left in place.)

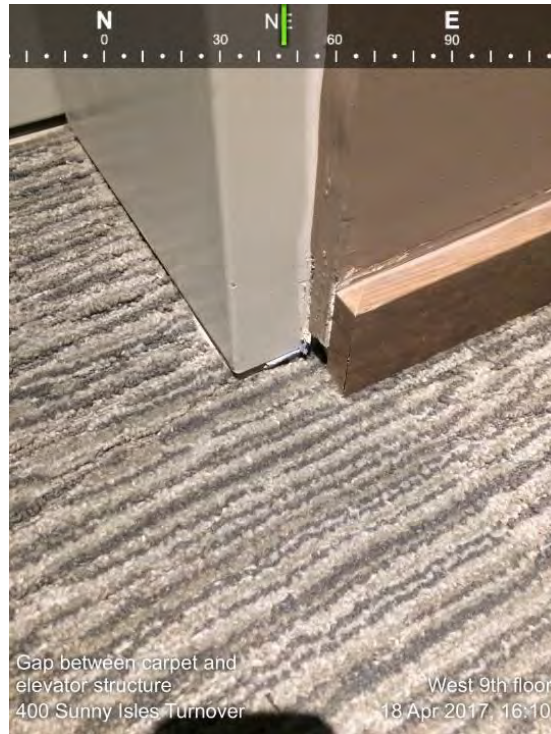
Figure 1

There is a gap between the carpet in the corridor and the elevator structure, here on the 9<sup>th</sup> floor.

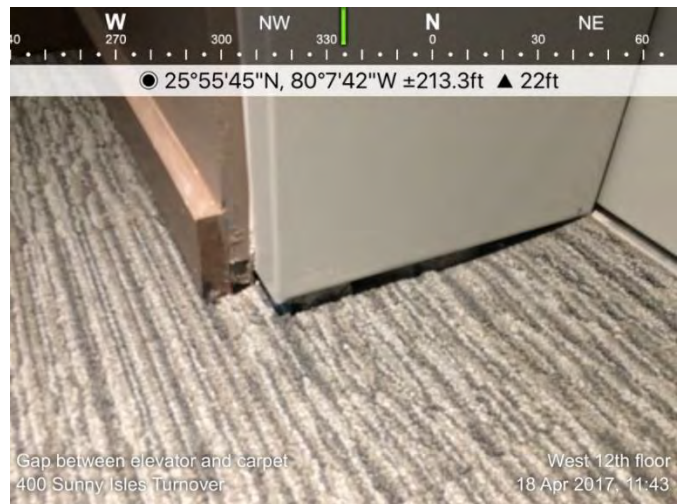
Figure 2

Another view of the gap between the elevator door jamb and the carpet in the corridor, here on the 12<sup>th</sup> floor.

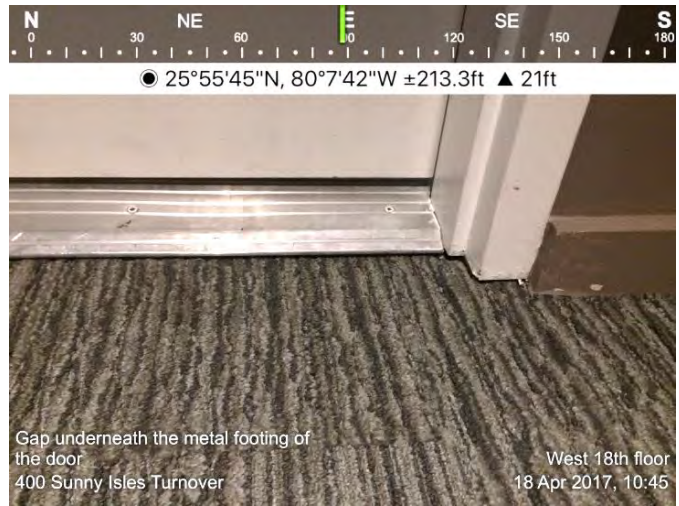
Figure 3

Gaps underneath the metal thresholds of doors, including the elevators, were noticed throughout the building.

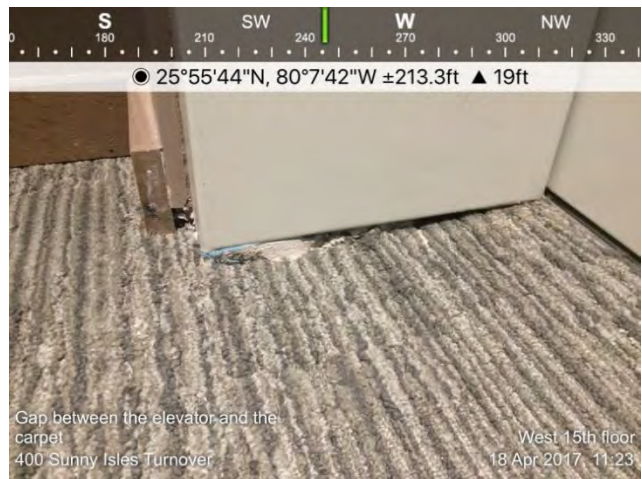
Figure 5

Another example of gaps between the elevator door jamb and the floor, here on the 15<sup>th</sup> floor.

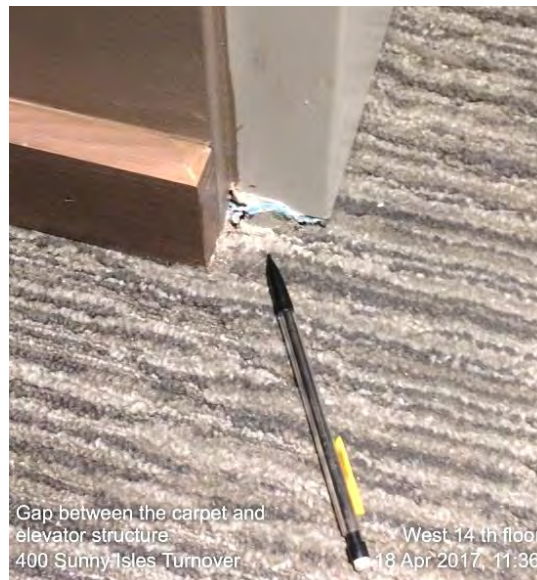
Figure 4

Another gap between the elevator door jamb and the carpet, here on the 14<sup>th</sup> floor. The pencil shows the significant size of the gap.

Areas of poor fit and finish should be corrected. The means and methods to be determined.

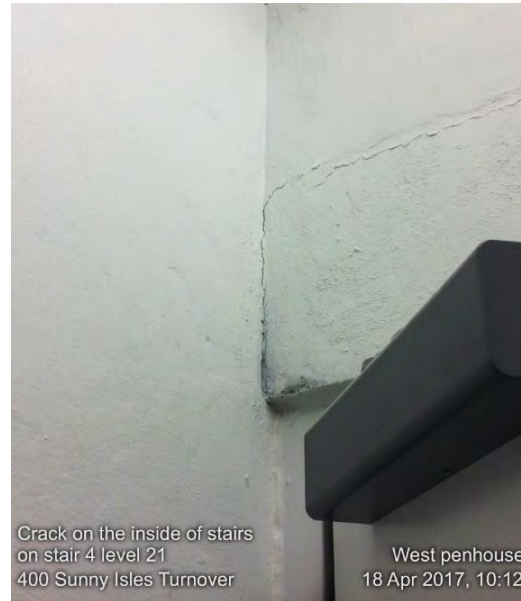
Figure 6

A crack has formed above the door on the inside of the stairwell 4, 21<sup>st</sup> floor. The crack seems to be following the perimeter of a bond beam in the wall.

A joint segregating the different finish materials should be provided and filled with an elastomeric sealant.

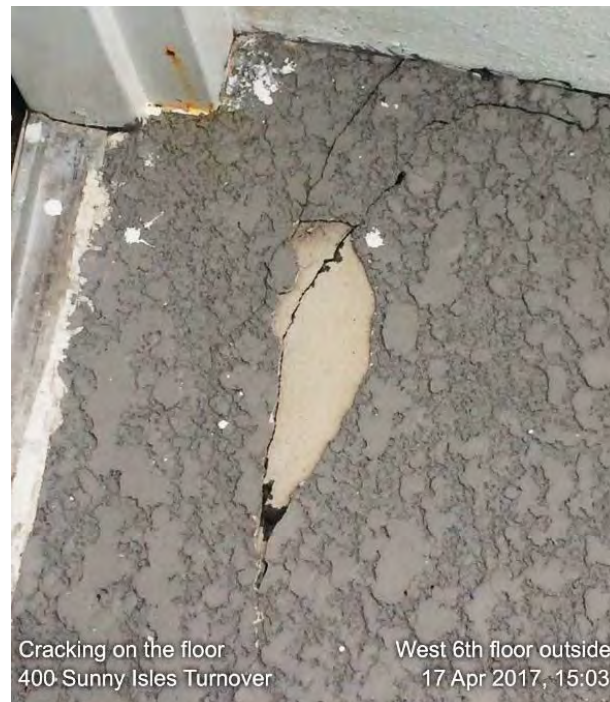
Figure 7

Cracks were noticed just outside the 6<sup>th</sup> floor, stairwell 12 door, as well as rusting on the door frame. This knock down textured coating appears to have been installed over another coating or waterproofing coating that was incompatible in terms of bond. The coatings would have to be investigated, and, if incompatible, the installations would have to be both removed and a new coating system properly applied.

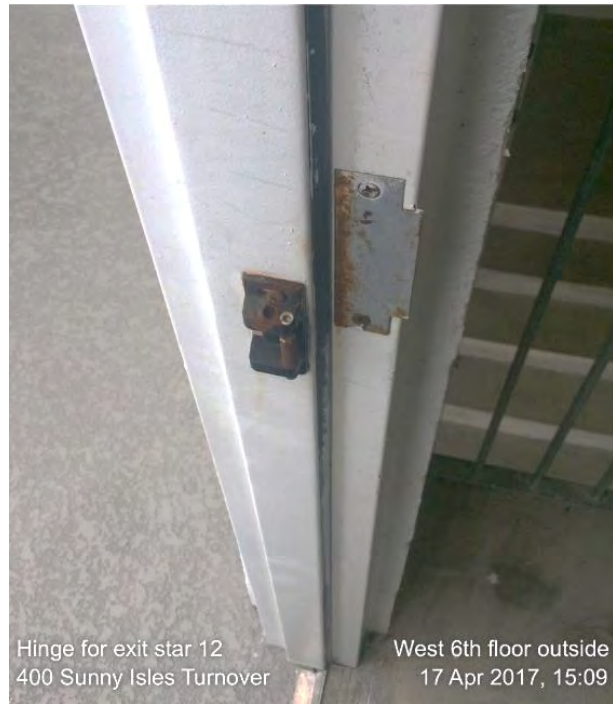
Figure 8

Severe rusting on the door catch for the 6<sup>th</sup> floor exit of stairwell 12. The door catch itself is entirely corroded while the metal plate screwed into the door frame is rusting especially on the edge that most rubs against the door when opening/closing. Exterior door hardware in marine environments should be stainless steel or other highly corrosion resistant material.

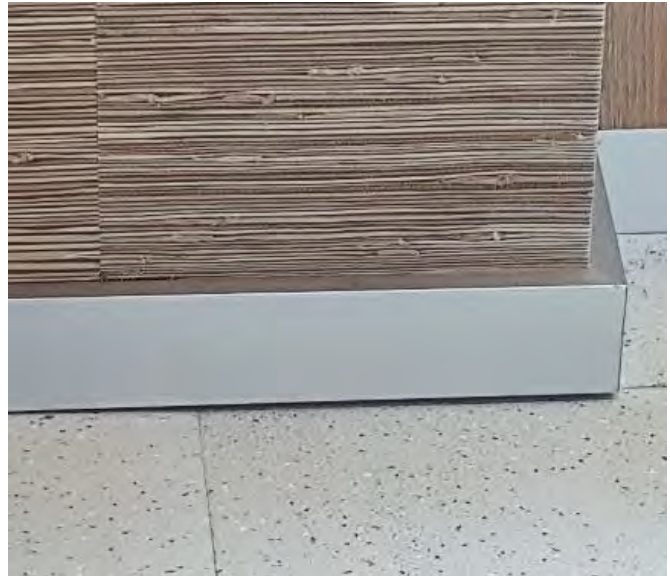
Figure 10

There is a gap between the vinyl baseboard and the floor. The floor is out of conformance with ACI flatness criteria of  $\frac{1}{4}$ " in 10 ft. horizontal distance.

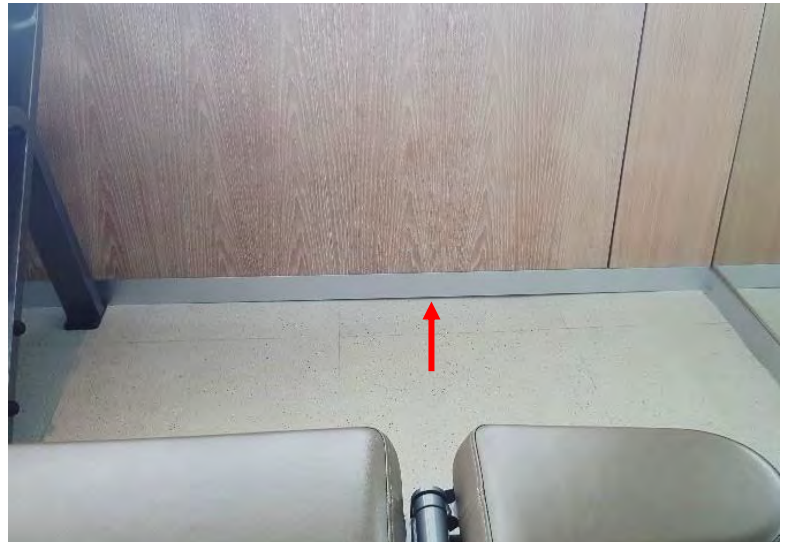
Figure 11

This is another instance of a gap between the baseboard and the floor, as was common along the perimeter of the fitness room.

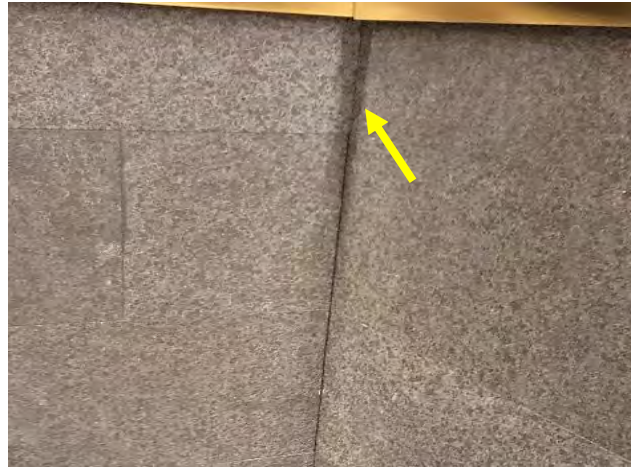
Figure 13

A significant gap is shown in the corner of the lobby walls. It appears that there is also a waxy stained area that appeared to have dripped from above. The material should be identified and remediated.

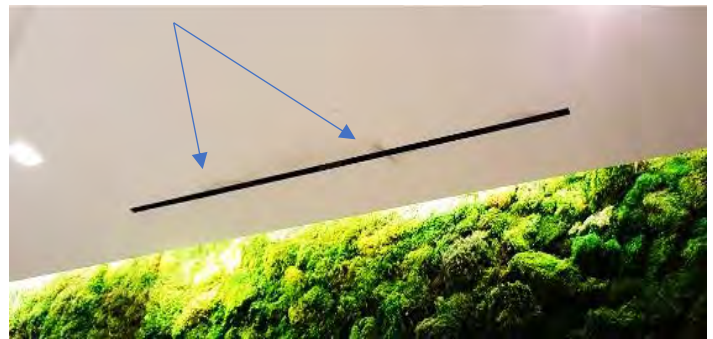
Figure 14

A dark stain is noted on the sheetrock at the top of the HVAC vent above the West Lobby reception desk. This appears to be moisture related and should be investigated.

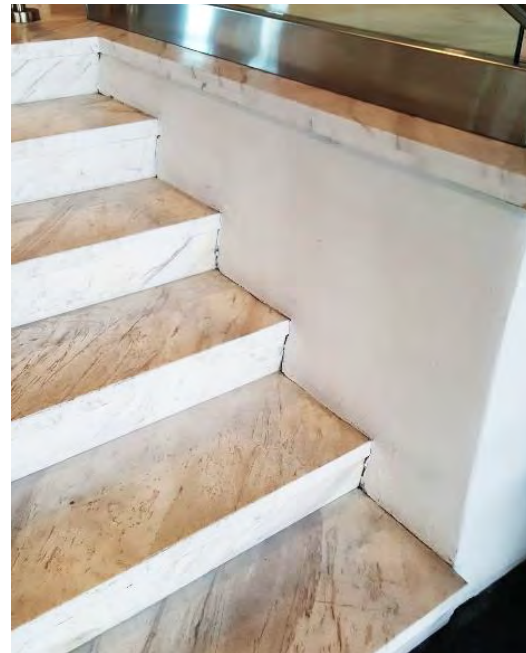
Figure 15

There are significant gaps between the stairs and the wall leading to the West Lobby. As these stairs are wet cleaned on a regular basis, the stucco at the end wall might be better finished with a white tile or other durable waterproof coating, that should be sealed with polyurethane sealant at the wall juncture with tread and risers.

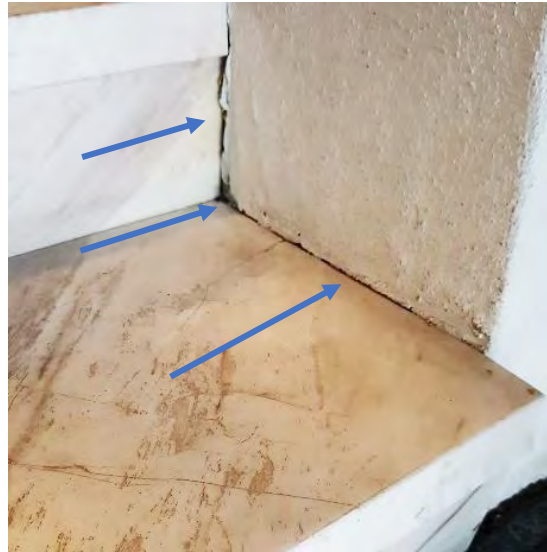
Figure 16

A close-up view of the gap between the stairs and the adjacent wall.

Water entry during regular cleaning of tile surfaces will allow water to enter and over time is expected to deteriorate the painted stucco.

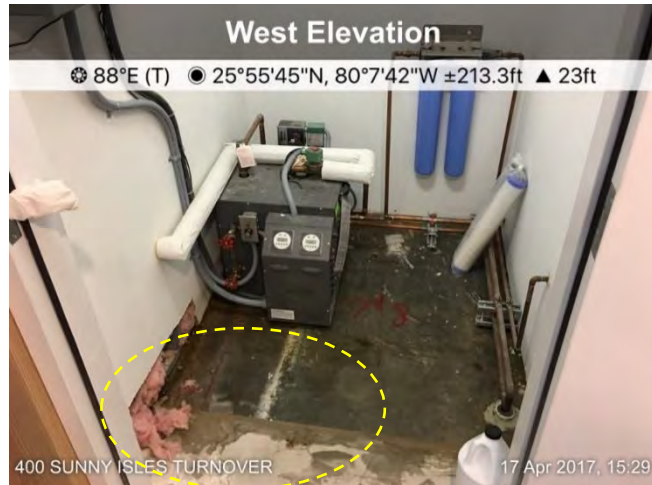
Figure 17

Water was found entering into the boiler room (shown), coming from the adjacent steam room, near the sauna. The water is ponding on the floor, as can be seen by the reflection of the boiler on the floor's surface.

The bottom left side of the left wall has also been opened, causing insulation to fall out. The walls in this room are therefore not sealed in several different places.

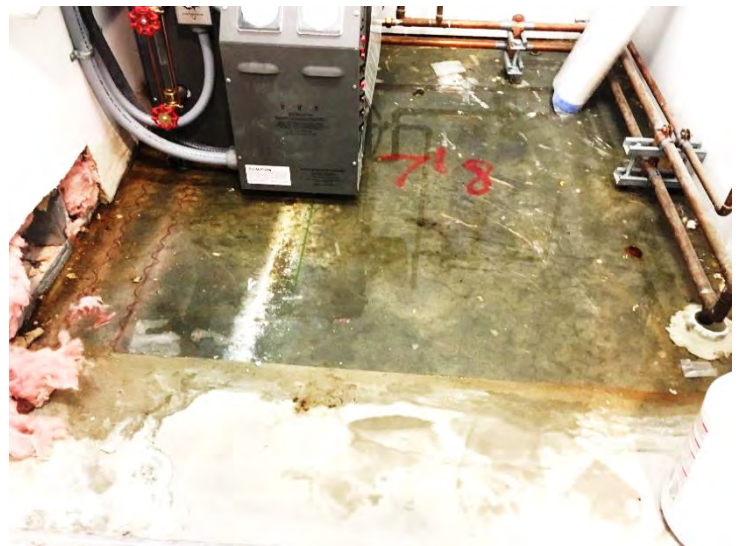
Figure 18

A close-up view of the water on the boiler room floor and the insulation on the left.

The property manager stated that planned repairs of this area were in process.

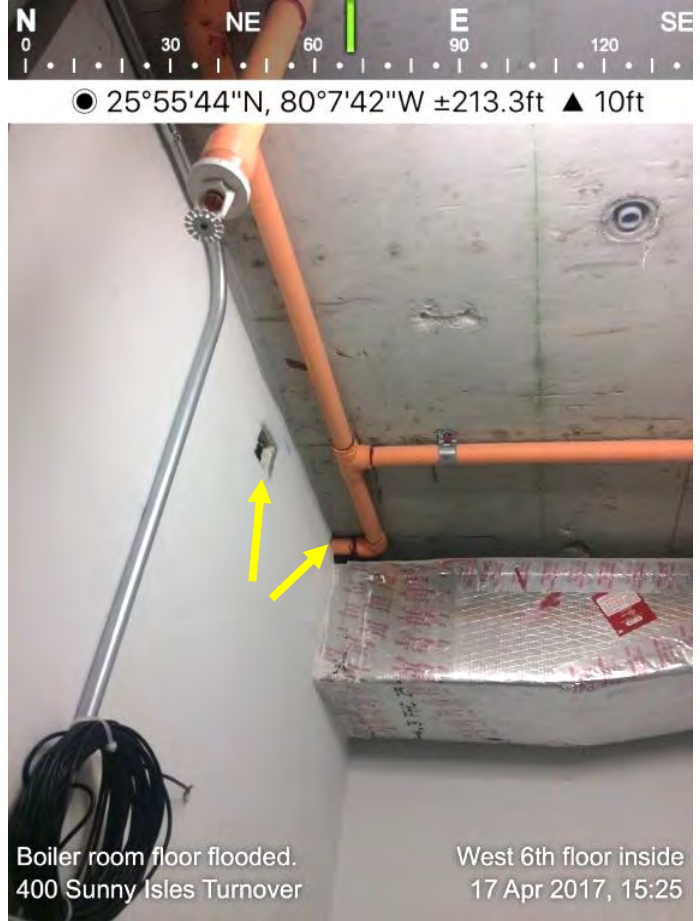
Figure 19

Boiler room ceiling has openings in concrete ceiling and sheetrock in several locations. The walls are not rated for fire, per A206, wall type

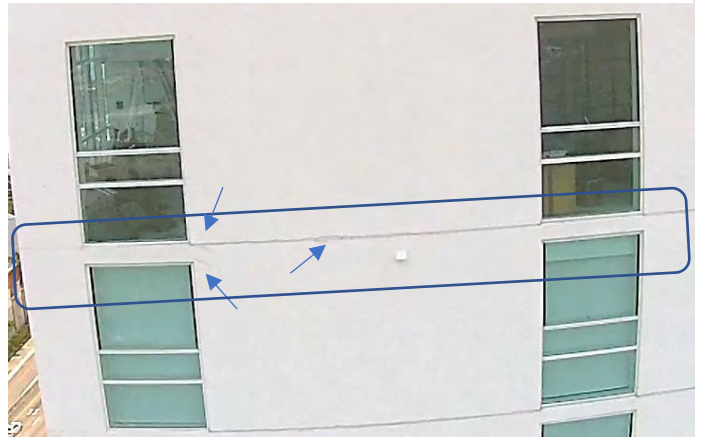
Figure 21

Stucco surface finish appears to be irregular at window openings where the slab meets block wall substrate. Also the entire joint appears to have been surfaced with sealant over a solid expansion control joint, which would not normally require sealant. This area should be sounded and repaired if subject to water intrusion or de-bonded stucco.

Scuppers at 6<sup>th</sup> floor terrace knee-wall (note there is no slab to joint juncture problem).

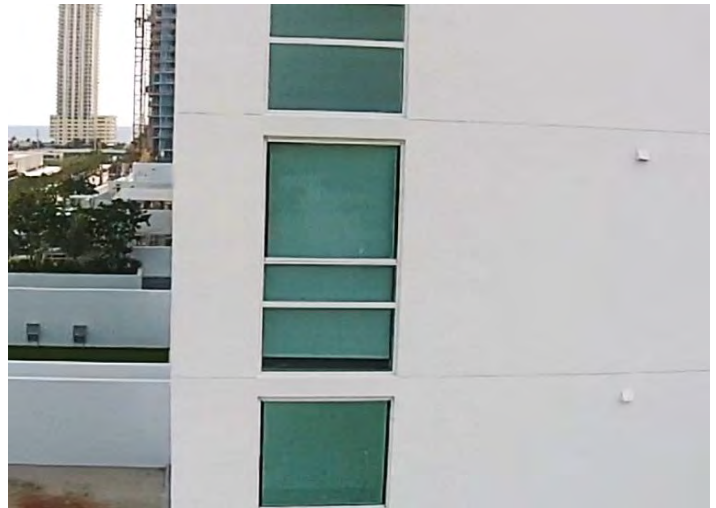
Figure 22

Window stacks on west wall up to the 17<sup>th</sup> floor are in good condition with no defects noted. Windows on floors 18, 19, and 20 are all questionable due to caulking of stucco joints, indicating there may have been cracking (see above photos and comments on the caulking).

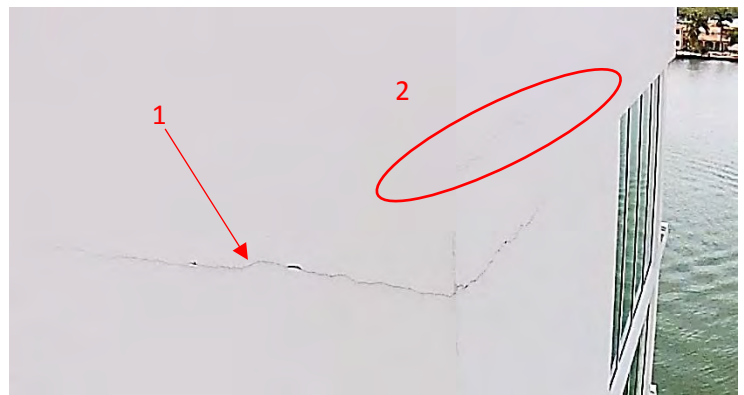
Figure 24

Cracking of stucco on west wall of tower below unit 601 W terrace.

Two cracks are present in this location. The most prominent at label 1. Another fainter crack is circled at label 2.

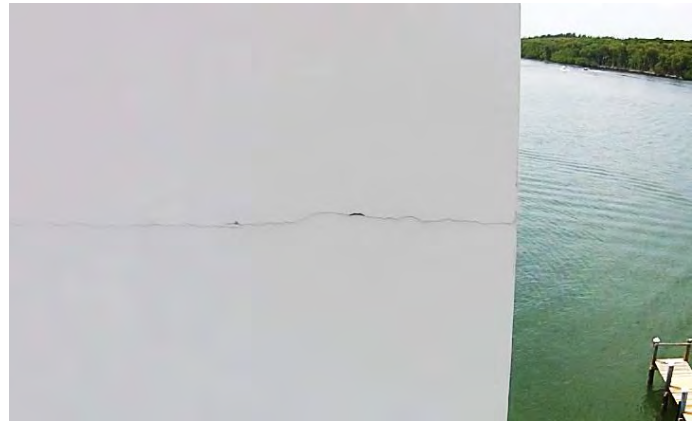
Figure 25

Another view of the more prominent crack shown above, below 601 W terrace west facade.

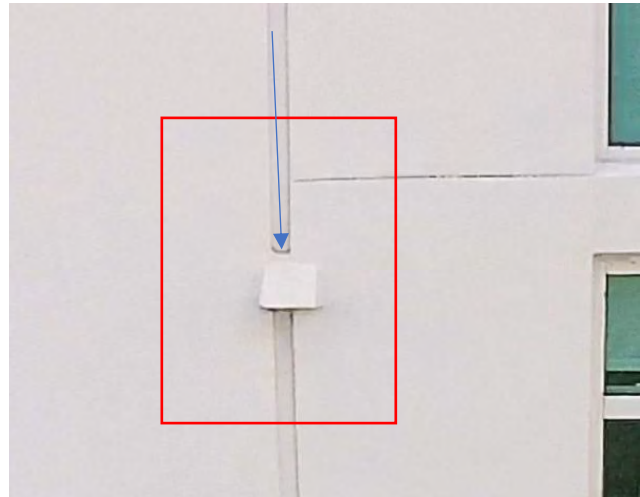
Figure 26

Location of exhaust vent hoods coinciding with architectural reveal joints is a waterproofing concern. The location of the sheet metal hoods penetrating the building envelope cladding at a PVC joint that experiences greater than normal movement with expansion and contraction, and even greater movement at the sheet metal is expected to experience stucco cracking and waterproofing challenges, or coating problems with differential materials and movement. Arrow is at black sediment above vent.

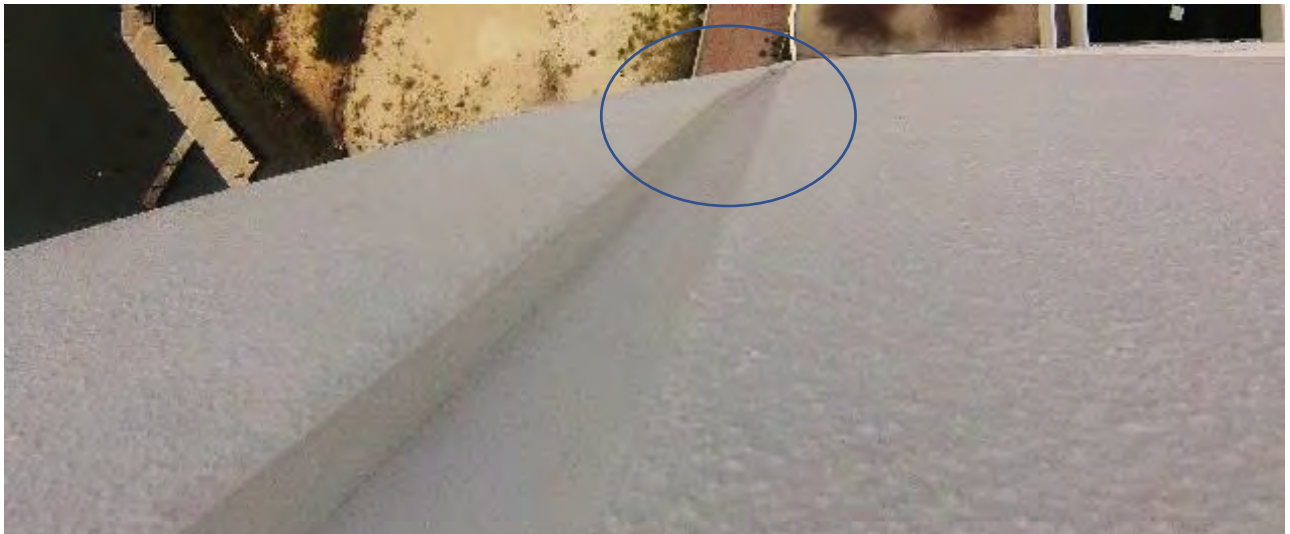
Figure 27

Looking down the architectural trim from the roof, the building corners and trim details appear to not be straight. This is a sign of poor workmanship and may suggest that the stucco thickness may vary along the exterior walls. The writer of this report has no recommendations for repairs, but the condition should be monitored for signs of cracking or delamination that might require investigation.

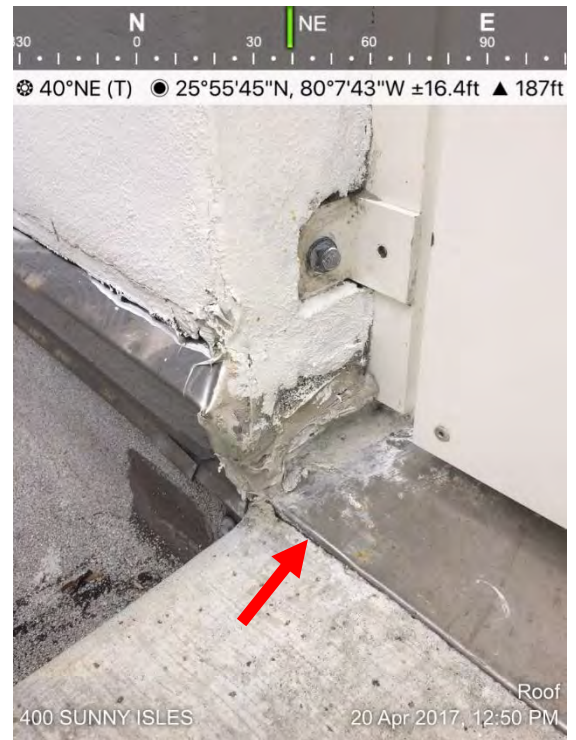
Figure 28

Flashing at corner of wall is capped by a caulk which is not considered long-term waterproofing. The stucco above the flashing at the corner is open and cracked with paint covering the added caulk. This flashing was not done according to architectural plans detailed on page A7.06.

Door bracket mounting door to wall has also caused a stucco penetration, which according to ASTM C926 should be protected via a flashing detail or sealant to provide watertight condition.

Note also that the water running down the door will enter the crack at the concrete landing/metal flashing juncture, (see red arrow) that will be a perpetually wet problem under the landing.

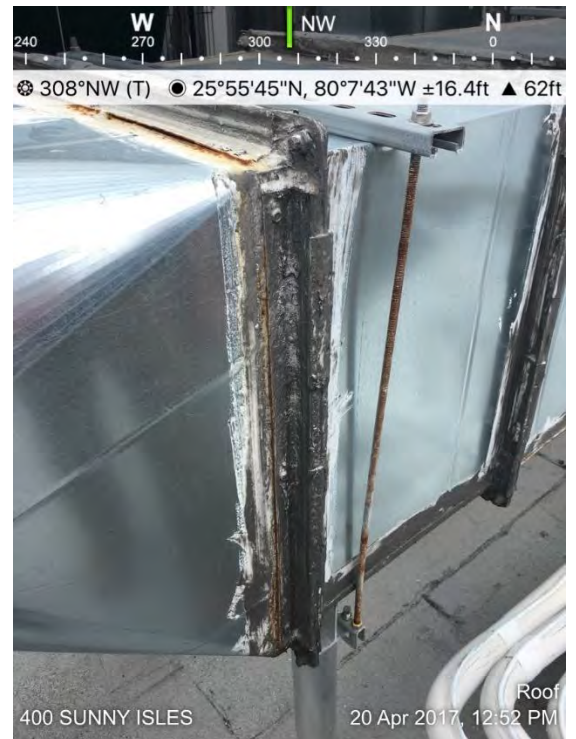
Figure 29

HVAC ducts are rusted at the closure metal flanges and at the threaded hanger rods. The duct flanges were coated in a black roofing sealant in an unsuccessful attempt to stop corrosion.

Both the hanger rod and the flange problem appear to be due to dissimilar metal use. The galvanized material should be utilized throughout the assembly.

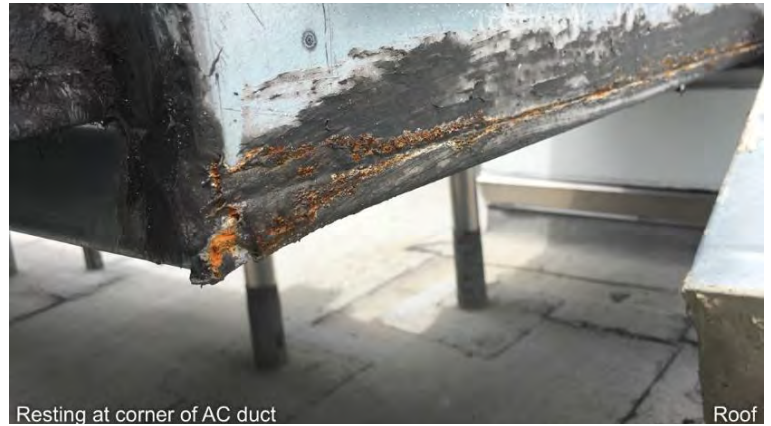
Resting at corner of AC duct  
Figure 30

Underside of HVAC ducts are also rusting underneath the black roof sealant.

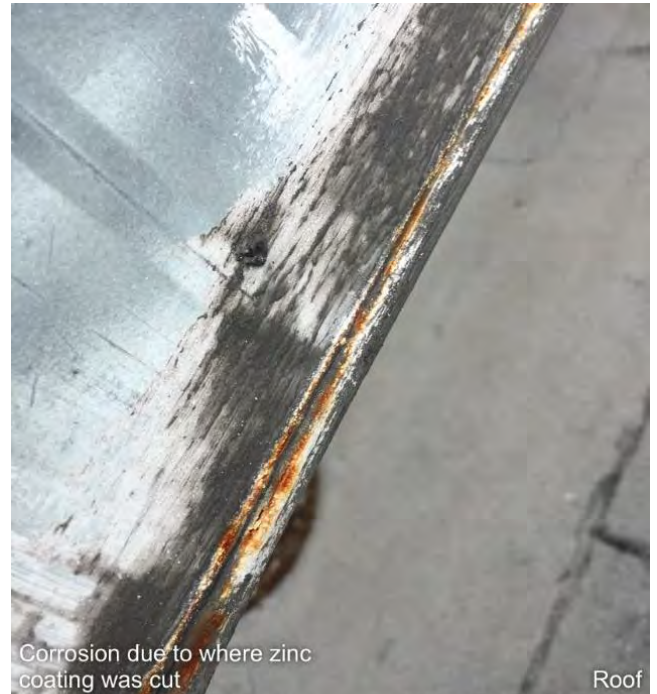
Figure 31

Another close-up example of where the zinc coating was most likely ground off and rust has begun forming as a result.

Corrosion due to where zinc coating was cut

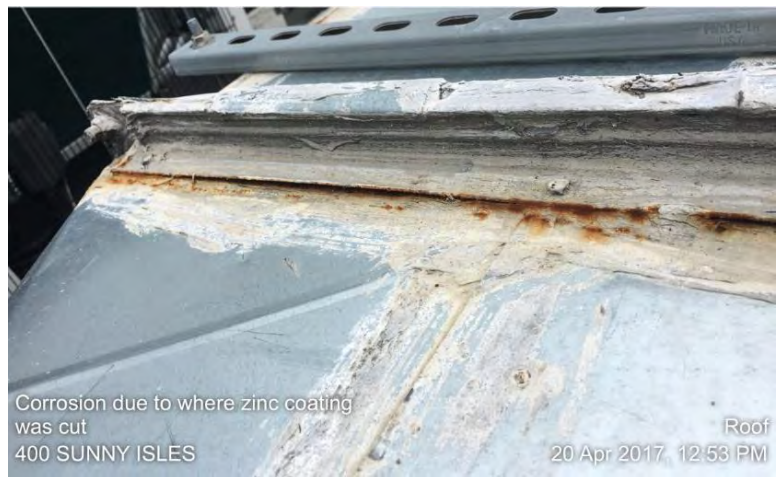
Figure 32

Closer example of corrosion on the duct sheet metal edges. The sealant applied to the duct work is a failed attempt to prevent corrosion.

Corrosion due to where zinc coating was cut  
400 SUNNY ISLES

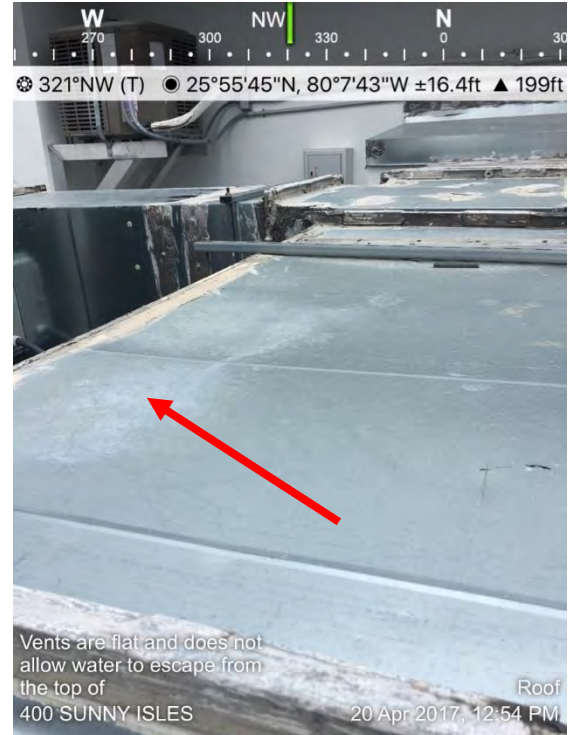
Figure 33

HVAC ducts are improperly sloped. The top surface should have a break in the sheet metal in an X-shaped sloped pattern that is sloped and directs water off the surface during rain events. The red arrow is a residue left from an evaporated puddle. Over time, this will cause rusting and a hole to form on the surface of the duct.

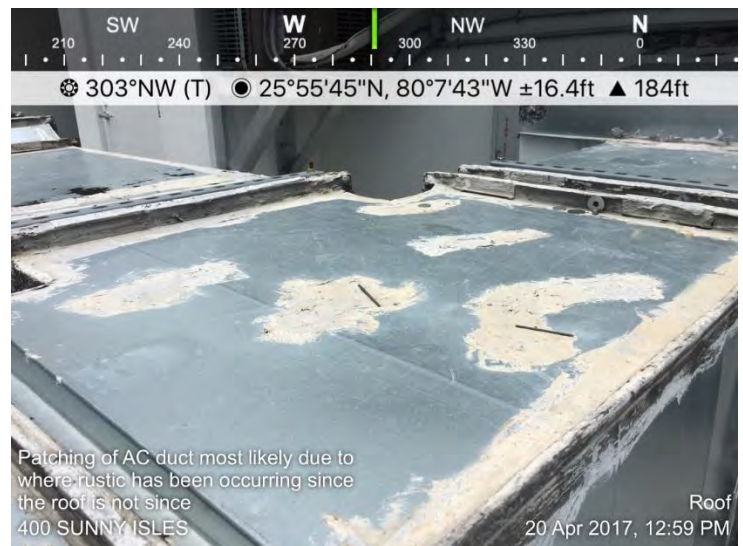
Figure 34

More examples of the sealant that was applied to the ducts. The sealant was applied in patches that appear to be located where more of these evaporated puddles have formed. The sealant was presumably added to reduce the spread of the corrosion at these points.

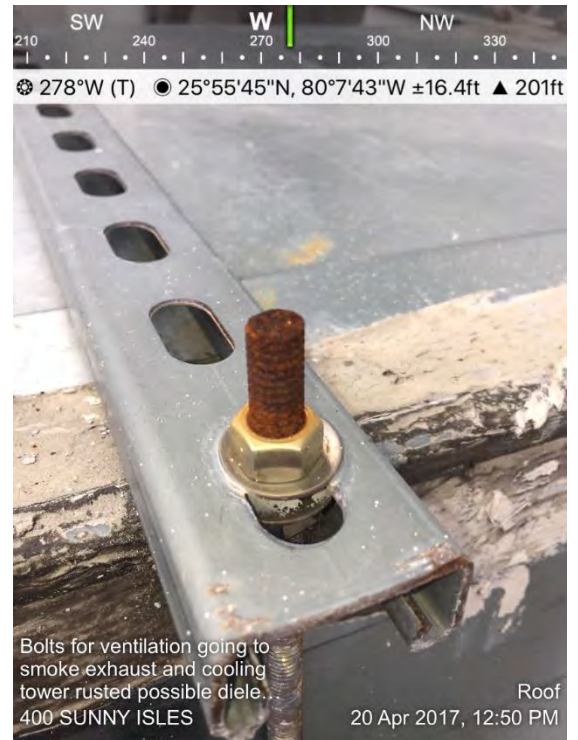
This figure shows that the threaded anchor rod is rusting above the bolt, but not below. This is due to galvanic corrosion from dissimilar metals between the rod and the bolt. All anchor hardware should be replaced with anti-corrosive hardware.

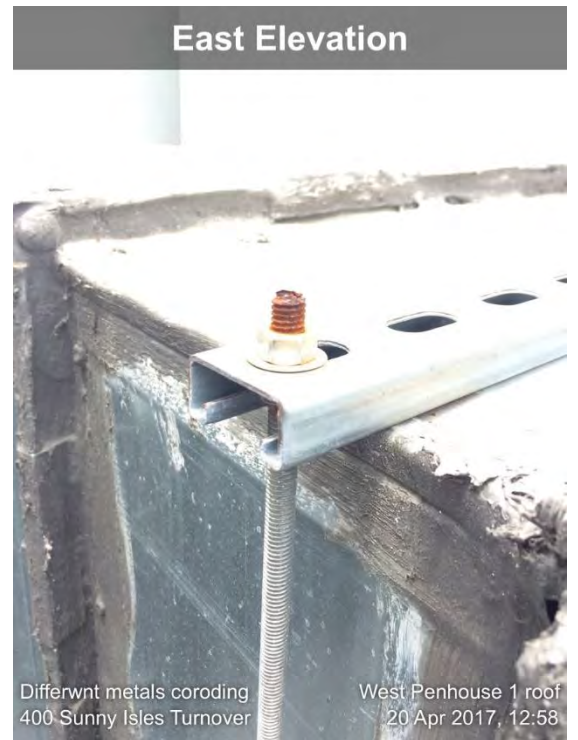
Figure 35

This is another anchor rod rusting above the bolt while the rest of the bolt is fine. Note that this image was taken in a different core roof than the figure above, which means that this is a typical, recurring issue and that all anchor hardware should be checked and replaced with anti-corrosive hardware.

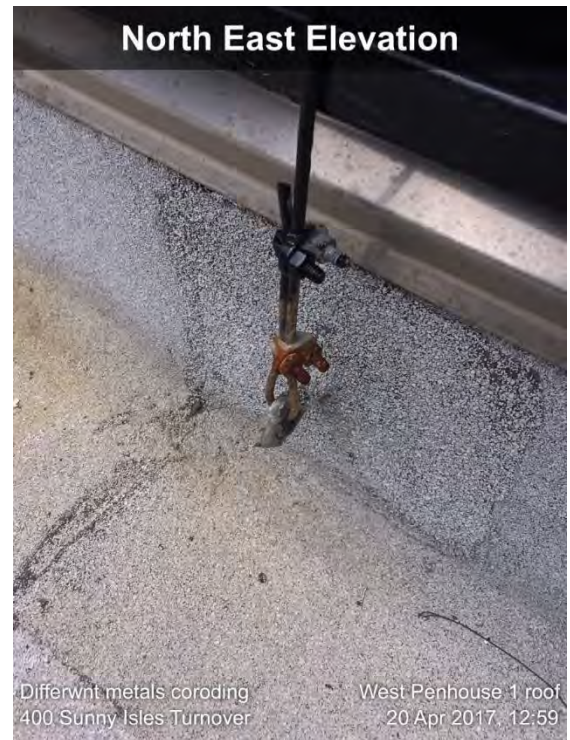
Figure 36

This rusted anchor if a tie-down anchoring cable is again the result of galvanic corrosion due to dissimilar metals. In the event of a hurricane, the reduced strength due to the rusting could cause the anchor to fail which would make the machinery held down by the anchor lift away from the building or become damaged.

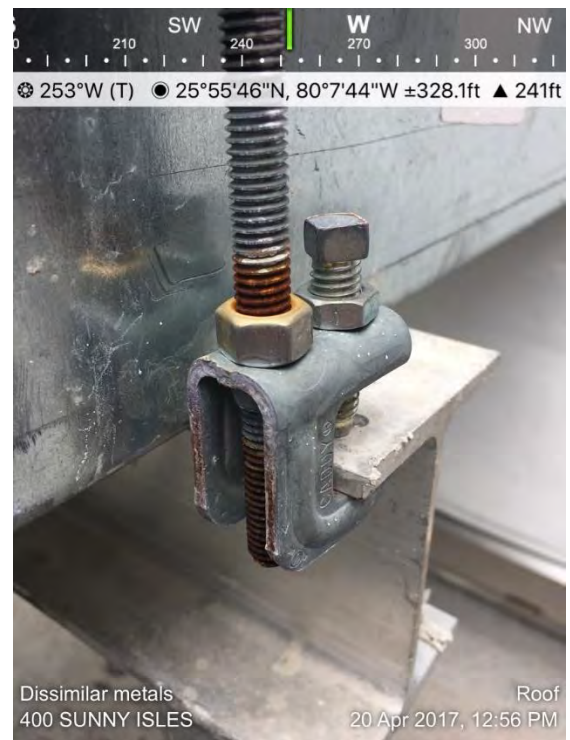
Figure 37

The anchor for HVAC duct base was rusted at the bolt. Again, this is due to galvanic corrosion between the anchor rod and the bolt. Over time, if this continues to corrode, it will significantly reduce the strength of the anchor which can cause failure during storm or high-wind events.
