CASE NO.: 2020-024374-CA-01

**NOTICE OF FILING**  
**EXHIBITS “A” THROUGH “E” OF COMPLAINT**

***Re: 400 Sunny Isles Condominium East Association, Inc.  
Section 558.04, Florida Statutes, Notice of Claim of Construction Defects***

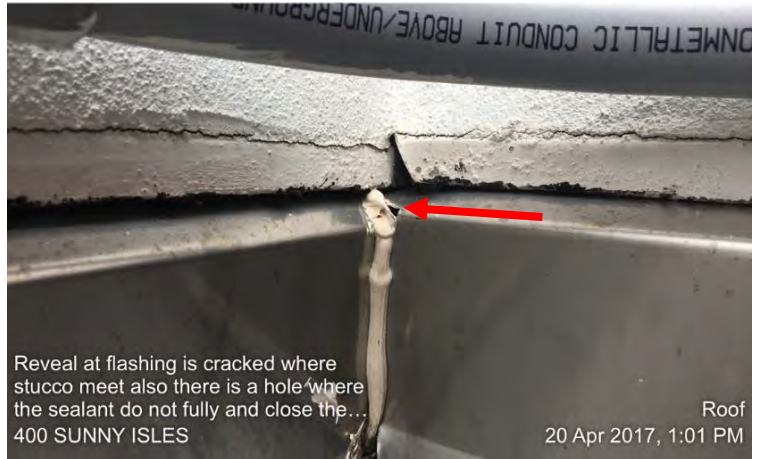
Figure 38

Caulk sealant was also applied at the corner of the flashing where the flashing was not completely sealed. Sealant should be applied at the lap of abutting sheets of flashing. It appears that this installation depends on the sealant to form the watertight condition in lieu of a sealed lap of flashing material. Note the open point and wide bead of visible sealant on the surface. This caulk is not considered a long-term waterproofing solution, and will allow water to intrude behind the flashing and cause roof damage over time.

Similar cases were noted at many of the other flashing corners.

This flashing was not done according to the architectural details on page A7.06.

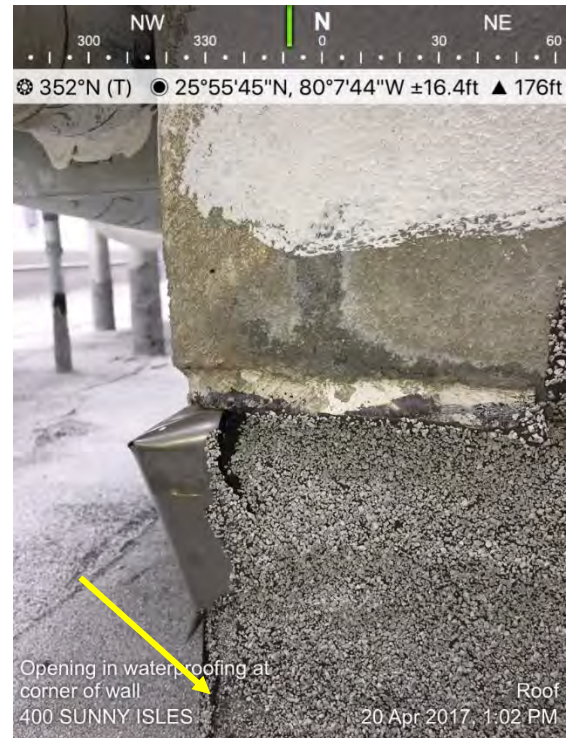
Figure 39

The corner of the wall under the HVAC condensate lines is open at the juncture between the stucco wall and the metal flashing. The metal flashing wraps around the corner but then stops. This is incorrect, as the entire wall should be flashed to prevent water from entering behind the roof granules.

This flashing was not done according to architectural details on page A7.06.

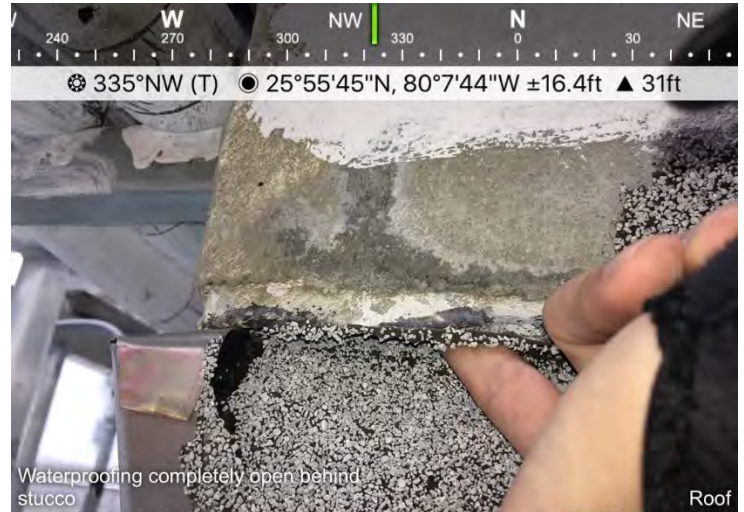
Figure 40

Another view of the opening shown above. The roof granules in asphalt do not provide a proper watertight condition of the building's structure. The gap at the base of the stucco was approximately ½ to 1 inch wide.

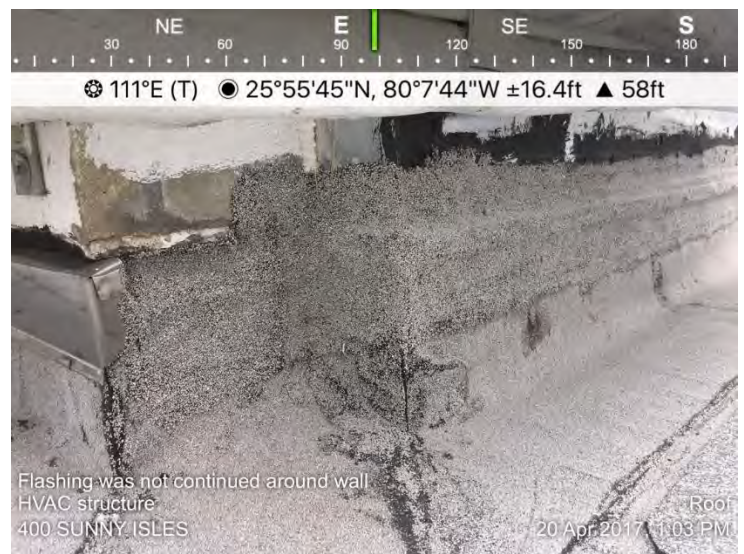
Figure 41

This entire section of wall should have metal flashing to prevent water from entering behind the roof granules. This is not considered to be waterproofed and should be corrected. There does not appear to be a cant strip provided at the roof to wall juncture (typical condition).

This flashing was not constructed according to the architectural details on page A7.06.

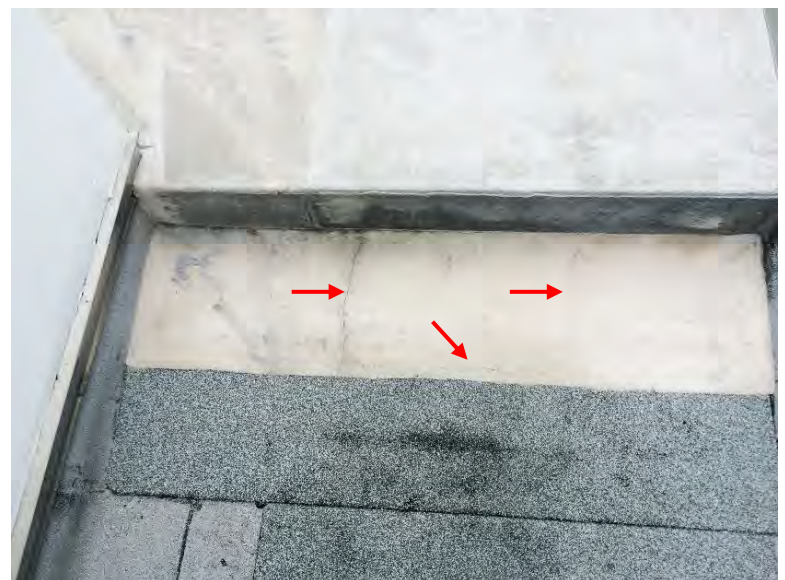
Figure 42

This concrete step should not be level with the roof membrane, as seen in **Error! Reference source not found..** Water will penetrate the porous concrete surface as a result. Visible cracking of concrete step has already begun to form, as indicated by the arrows.

This will produce a perpetually wet condition under the roof membrane.

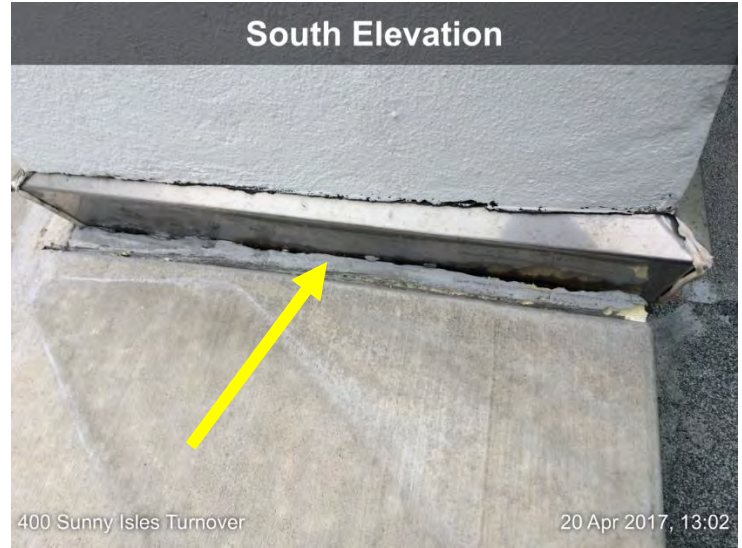
Figure 43

A foam board was found between the wall and the concrete step as highlighted by the arrow in Figure 44. This foam runs from the edge of the step to the turn of the stucco wall.

This will produce a perpetually wet condition under the roof membrane.

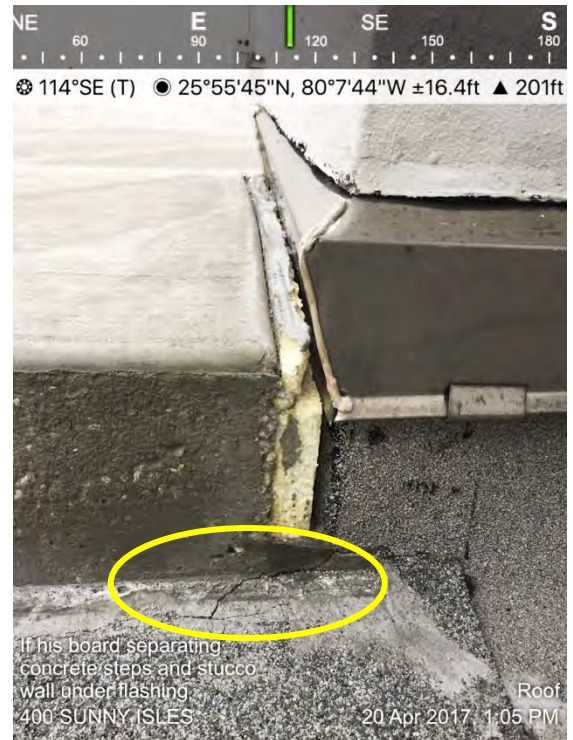
Figure 44

The foam board is in between the concrete step and the roofing membrane that has turned up the wall. This appears to be the result of adding the step after construction of the roof. The concrete is already cracking at the base of the concrete step where the concrete meets the granules (circled).

Since this board is made of foam it will also soak up and hold water, therefore restricting the water from evaporating, allowing the water to penetrate the roof membrane. Note that the roof membrane is not designed to be perpetually wet.

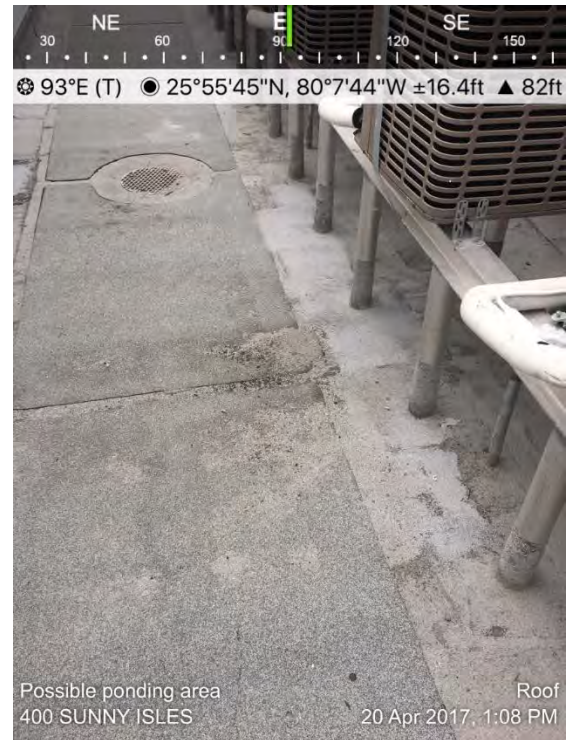
Figure 45

This is an area where the roofing membrane is not sloped properly towards the roof drain. This creates debris fields and damages the roof membrane. Over time, this can cause water intrusion or organic growth to occur.

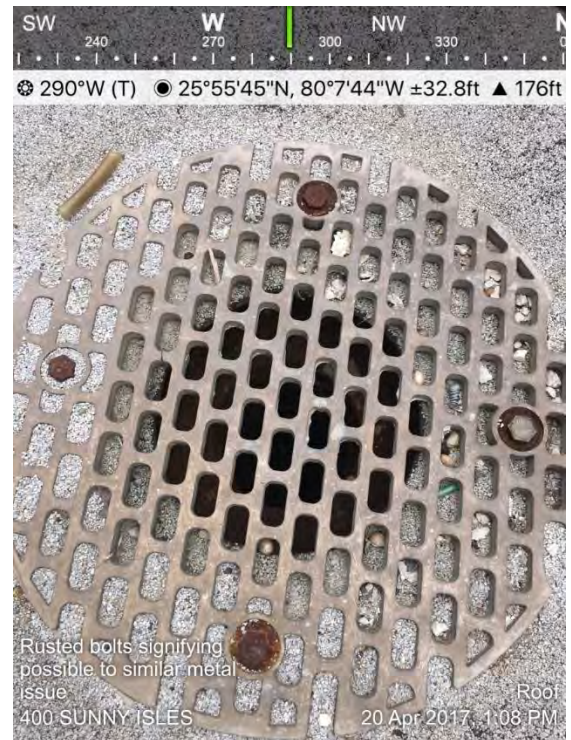
Figure 46

This style of roof drain was determined to be inadequate. The roofing granules have been clogging the holes for drainage as well. The bolts inside the drain are rusting due to galvanic corrosion from dissimilar metals. Roof drains in the mechanical area are not as specified in the architectural drawings as shown below.

Drains should be provided with a drain dome, such as the one scheduled as ZURN Z-121-E. A diagram for this drain is shown in Figure 49.

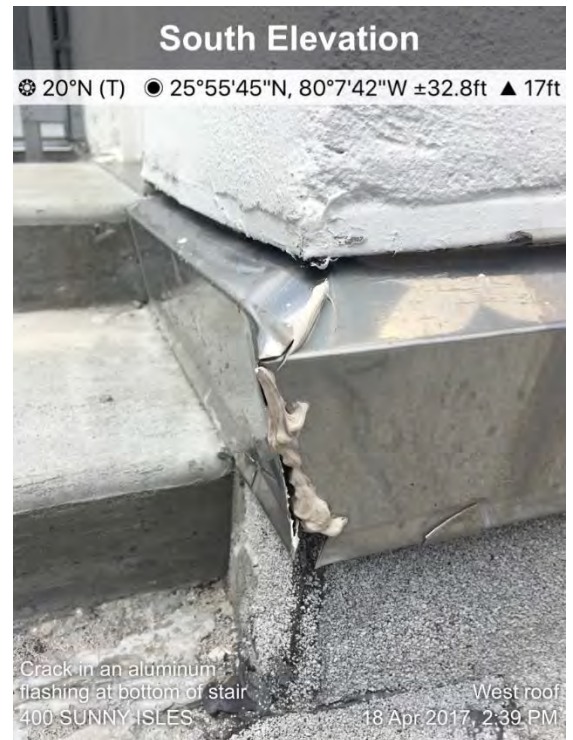
Figure 52

Flashing at the corner is both dented and open. The open flashing at the corner will allow water to intrude past the roofing membrane. Yellow caulk was added post-construction as an attempt at waterproofing. Caulk is not considered a long-term waterproofing solution nor was the opening completely closed. This flashing was not done according to architectural details on page A7.06.

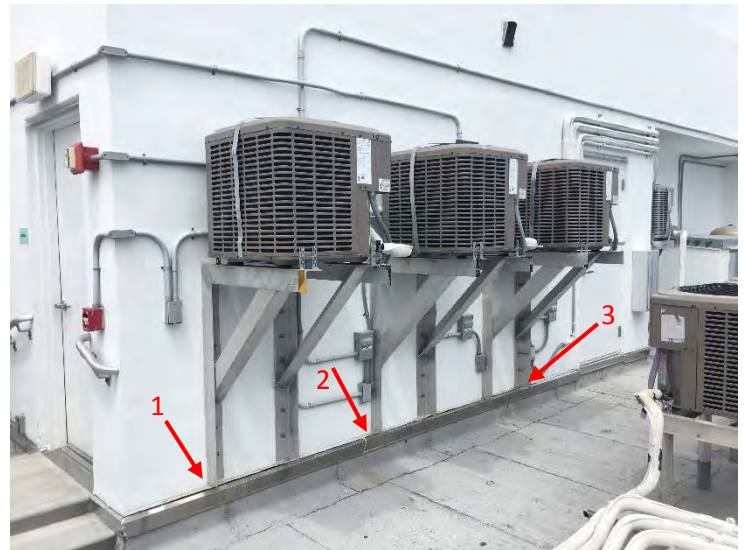
Figure 53

A situation was found where three separate wall-mounted HVAC compressor brackets were causing similar cracking at their bases. Figure 54 shows the locations of three that were documented, all of which were on the same wall. Figure 55 shows close-up views of these cracks at the bases of the brackets. Cracks in the stucco finish will allow water intrusion into the porous concrete which may result in damage over time. Cracking may be due to friction and force applied to stucco as the aluminum expands. A washer behind the angles might relieve this stress. Flashing in photo 2 does not have lap of metal flashing as required in design detail.

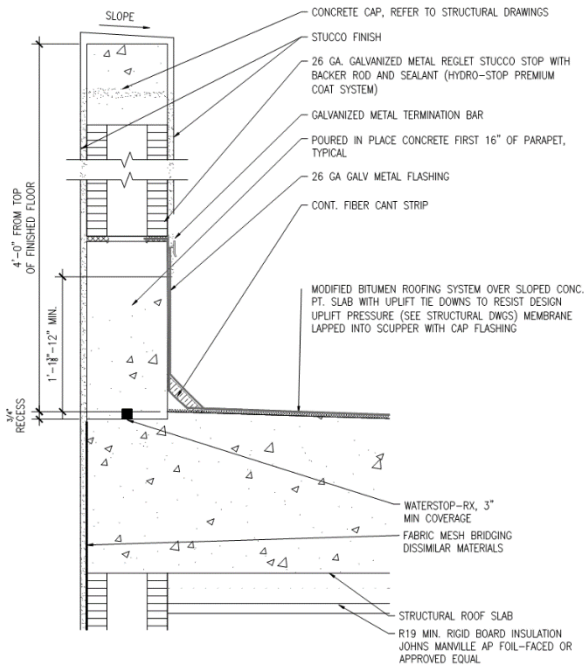
The wall was open at the juncture of the stucco base and the roof flashing. Normally, flashing turns up behind the stucco for several inches. It appears, as pointed out in (Figures 57 and 58) that the flashing turns up very little. Upon reviewing the architectural drawings, it was discovered that none of the parapets on the roof were done according to the architectural detail on page A7.06 (Figure 56).

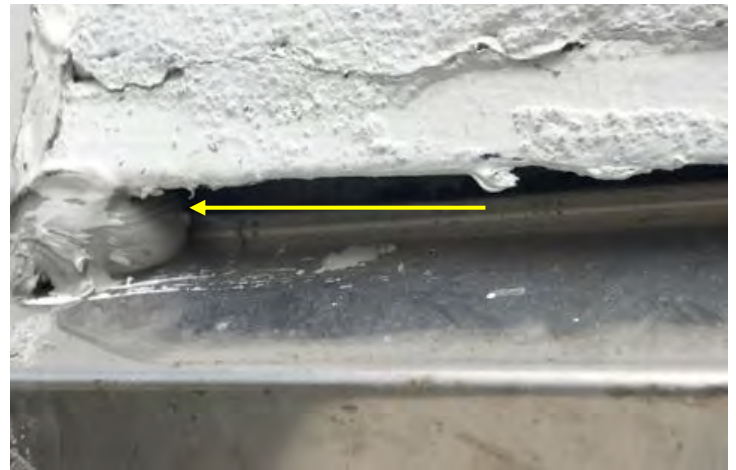
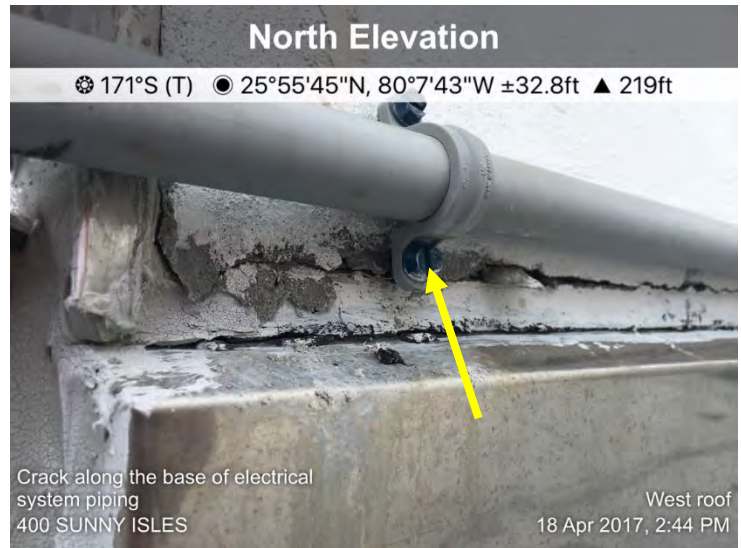
Significant cracking was found at the stucco base along this electrical conduit. The blue tap-con fastener in Figure 59 will corrode, expand and widen the crack and also provide reduced fastening strength as a result. These fasteners should also be sealed to ensure water cannot penetrate the stucco and underlying metal flashing that is thought to be turned up behind the stucco.

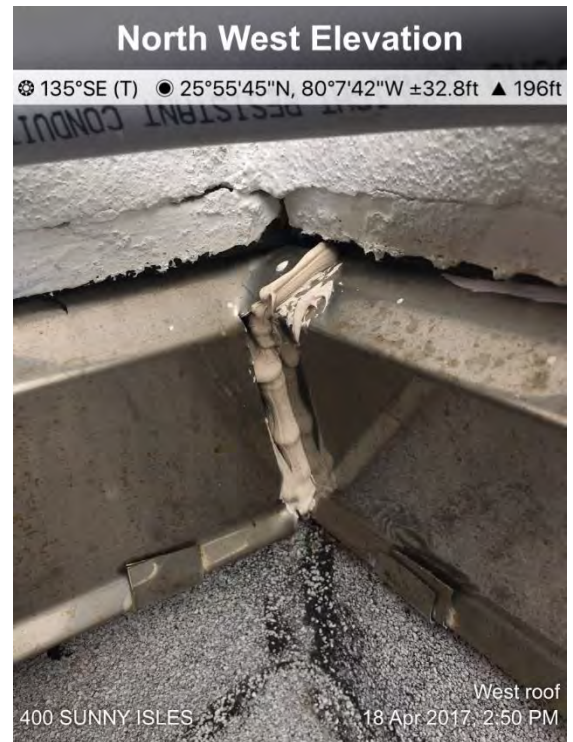
Figure 61

This is another example of the poor construction of the flashing and caulking shown above. In addition, the stucco at the base is also cracked in the corners in both Figure 63 and Figure 62. It is considered poor workmanship and might allow entry of wind driven rain. The flashing was not done according to the architectural details on page A7.06.

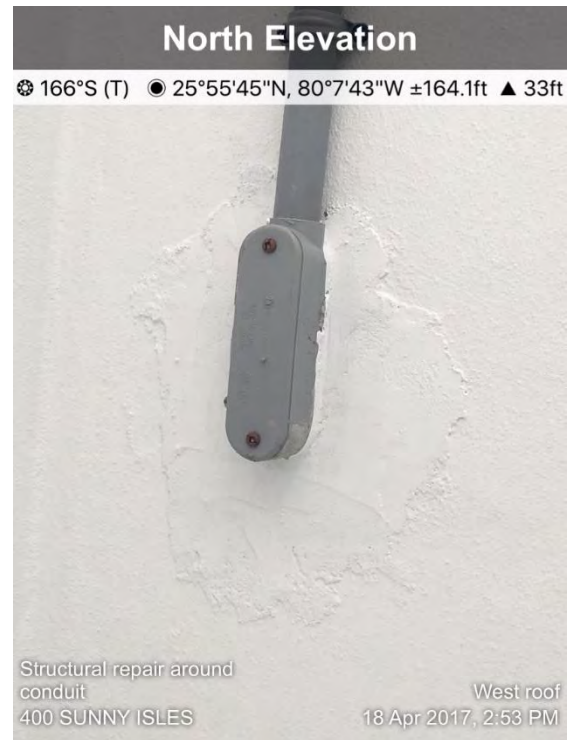
Figure 64

As with the previous image, the expansion and contraction of these two different materials will cause cracking. The area has already received prior repair attempts. The yellow caulk sealant should be installed with a V groove filled with sealant around the inset box (at left). The surface mounted box (at right) should be mounted a bit off the stucco surface and have top and sides sealed between the box and the stucco surface, and the bottom left open for drying. This box appears to have a missing knock-out and may be an inside work box which was not intended for exterior use. Repaired stucco suggests that this has already cracked multiple times around these two boxes. The yellow caulk trail leading to the top of the parapet also suggests that a crack is present at this location for potential water entry. Routing and sealant or other sealant band repair would be recommended at the top of the parapet.

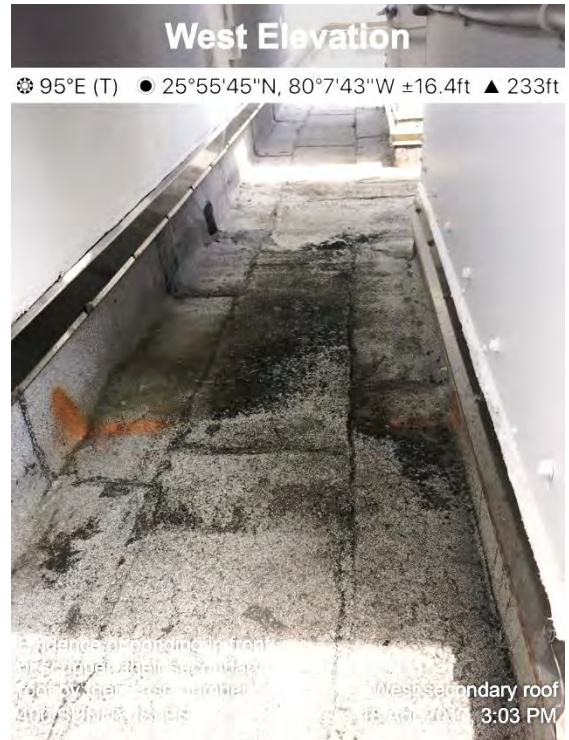
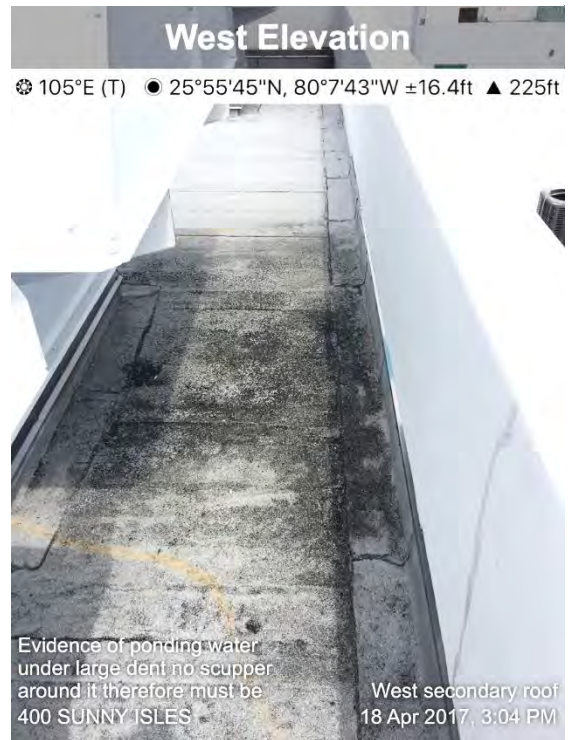
The roofing membrane is not intended to be perpetually wet, which can happen due to an improperly sloped roof or a clogged drain. This area of the roof, shown in Figure 69 and Figure 68, both have organic growth forming throughout. The roof is improperly sloped to the scupper on the west side of the cooling tower. Architectural drawings and plumbing plans call for overflow scuppers, yet they are not properly installed. This cant condition at wall flashing installation was not done according to architectural details on page A7.06.

The roof area shown in Figure 68 does not have a gutter on that side of the roof so the roofing membrane needs to be sloped around the cooling towers to the scupper on the opposite side. The architectural plans also confirm this. There is also an emergency overflow scupper specified in the plans that was not installed during construction. This flashing was not done according to architectural details on page A7.06.

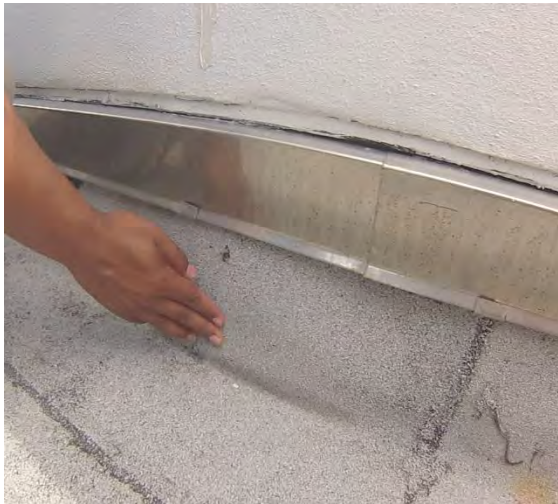
Directly next to the ponding area in Figure 70 is a large water bubble underneath the roofing membrane. The bubble is directly beneath a patched crack which may have been the cause of the bubble. This flashing was not done according to the architectural details on page A7.06.

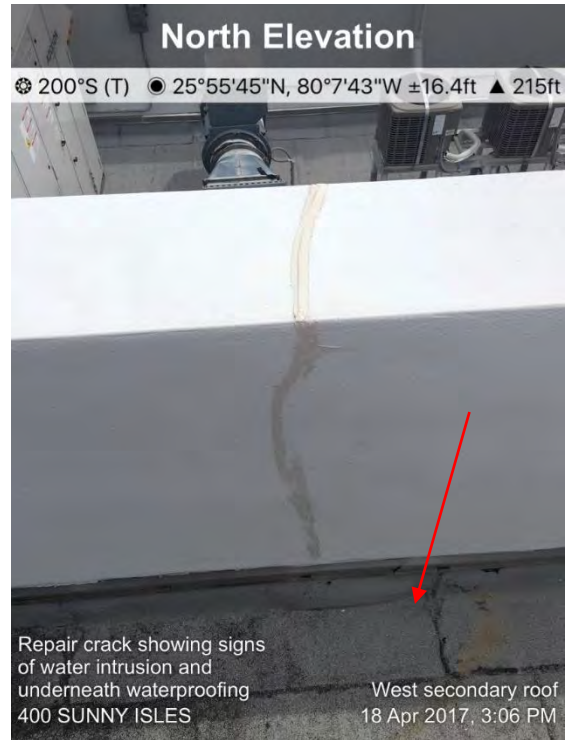
Figure 71

This yellow caulk was present in various patchwork locations around the roof, as indicated in previous images. Therefore, it can be said that it was applied post-construction. The duct to the smoke exhaust has had sealant applied to the surrounding area. This patch was used over the cracks that would have been caused by a failure to use a proper stucco penetration detail. A reglet and counterflashing might be considered for lapping over the turned up edge of this duct.

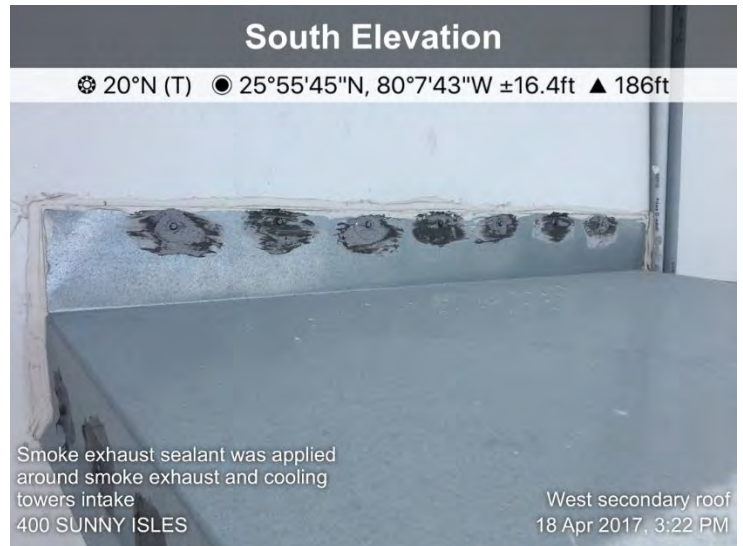
Figure 72

Rusting of the smoke exhaust system due to galvanic corrosion of the fasteners.

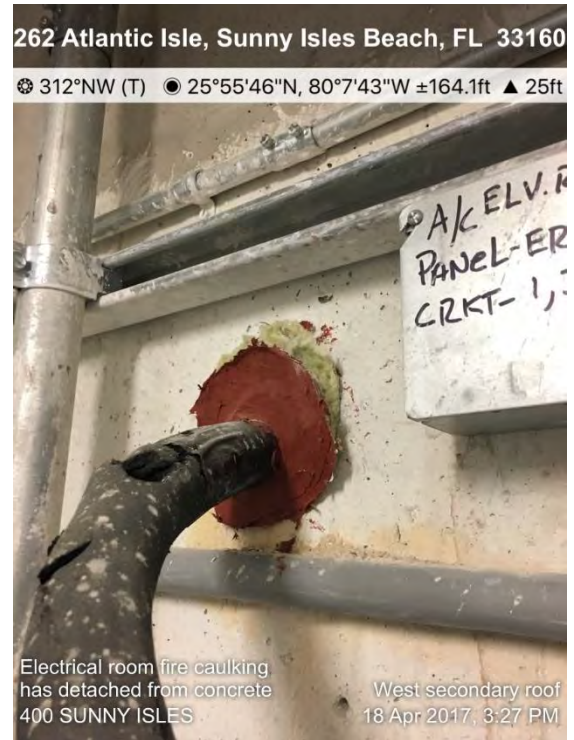
Figure 73

Fire caulking in the electrical room has fallen away from the wall. This needs to be repaired in order to remain compliant with fire safety protocols.

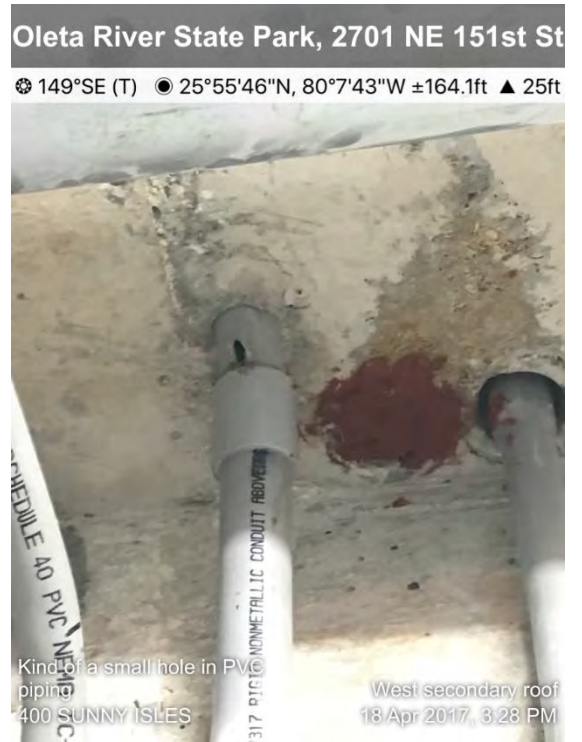
Figure 74

This drill hole was observed in an electrical conduit in the electrical room. Fire caulking should be reviewed and adjusted.

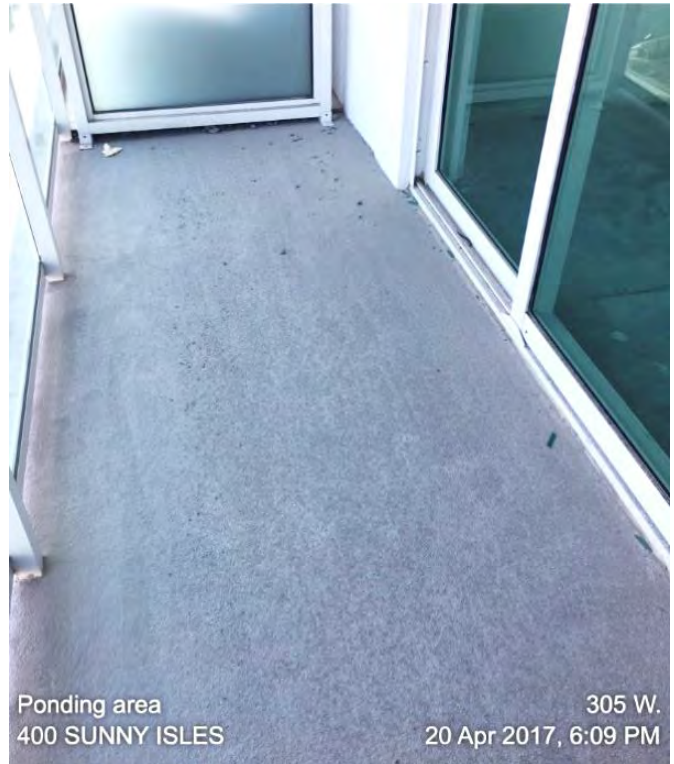
Figure 75

A ponding area on the balcony surface was noted as a the dark stain coloration. In addition, pieces of mortar from underneath the tiles in the neighboring patio appear to be washing/blowing onto this patio.

The fastener at the connection angles of the panel penetrate the waterproofing. The entire base connector should be coated on all sides with the waterproofing coating below the bottom of the panel frame.

(This applies at all panels throughout the project.)

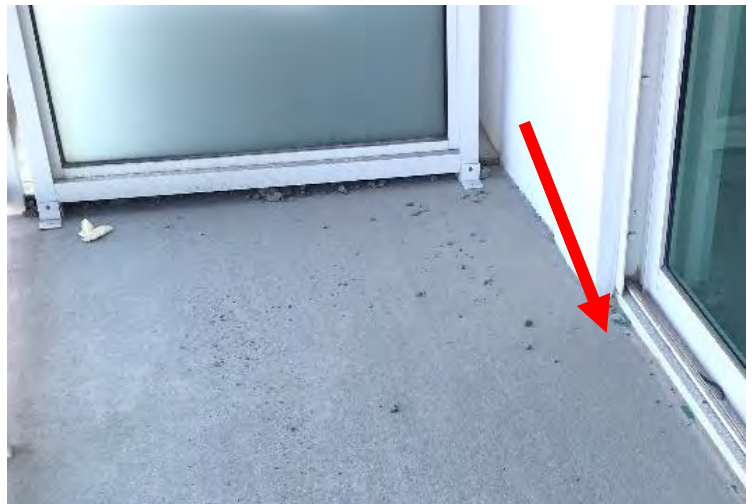
Figure 76

A close-up view of the particles from underneath the neighboring patio tiles.

The red arrow indicates a depressed area just in front of the sliding glass door track. This is not acceptable as water retained in this area can degrade the waterproofing coating and cause deterioration under the door area if water enters but is entrapped by coating on the surface.

Recommend that the slope be corrected and waterproofing is repaired afterward.

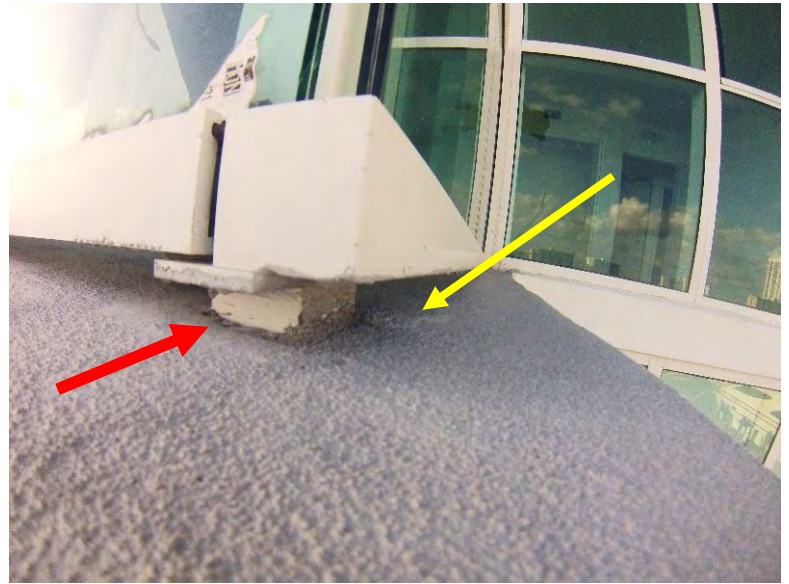
Figure 77

Thick poured patches of waterproofing material was noticed around the posts of the railing on the balcony as well as small gaps between the concrete and the post, allowing water to get inside.

The waterproofing coating should be turned up the vertical sides of the railing posts. Voids around the post are considered potential water intrusion sources.

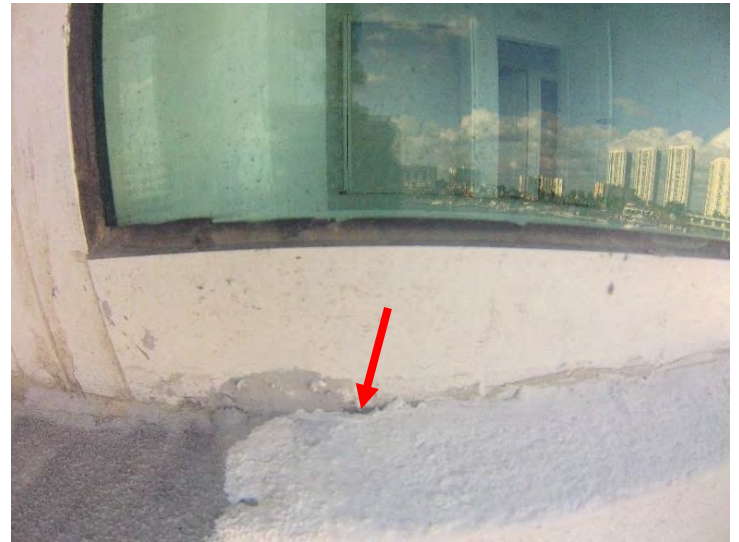
Figure 78

The exterior frame of this window appears to be splashed with cementitious material and/or waterproofing. The painted stucco is required to be provided with sealant at the juncture of the aluminum.

Gaps also appear to have formed between the stucco and the frame and the concrete and the frame.

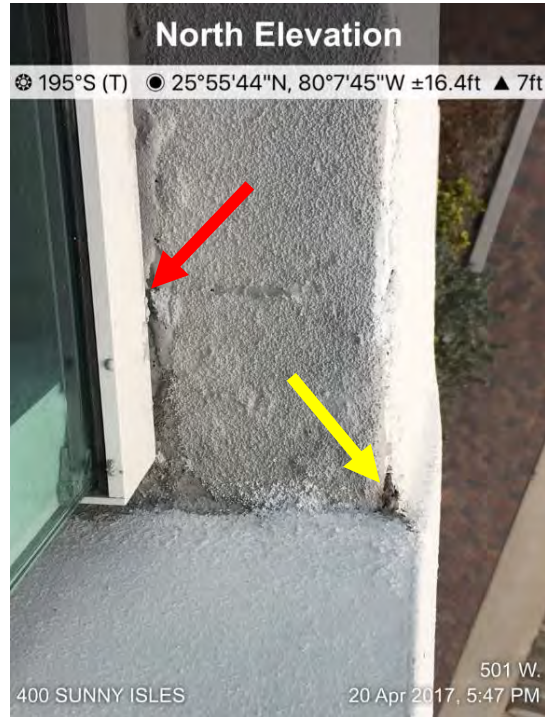
Figure 79

Cracks and holes in the stucco and waterproofing were prominent underneath the glass railing and on the edges of the balcony slab.

Added thicknesses of localized excess waterproofing was also found underneath the railing.

It is a concern that metals or other surface defects may have been covered by simply pouring additional waterproofing material over to cover the condition.

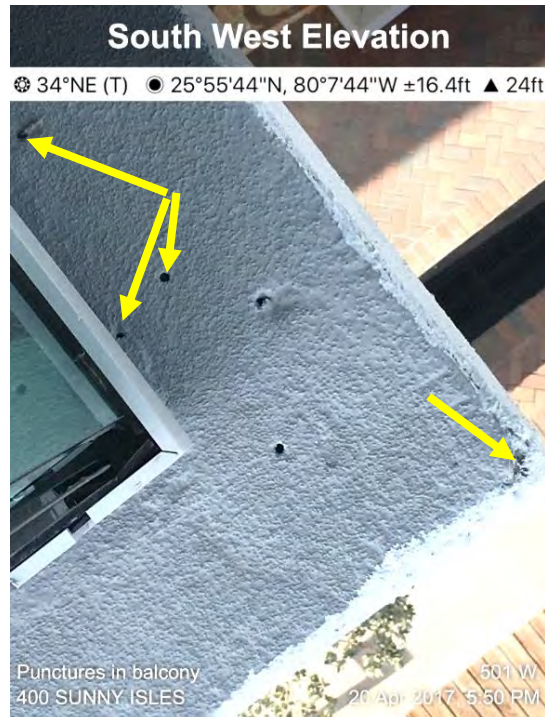
Figure 80

Holes/penetrations were noted in the balcony waterproofing, allowing for water to intrude into the concrete structure.

The corner of the balcony slab also appears to be damaged with possible cracks or holes.

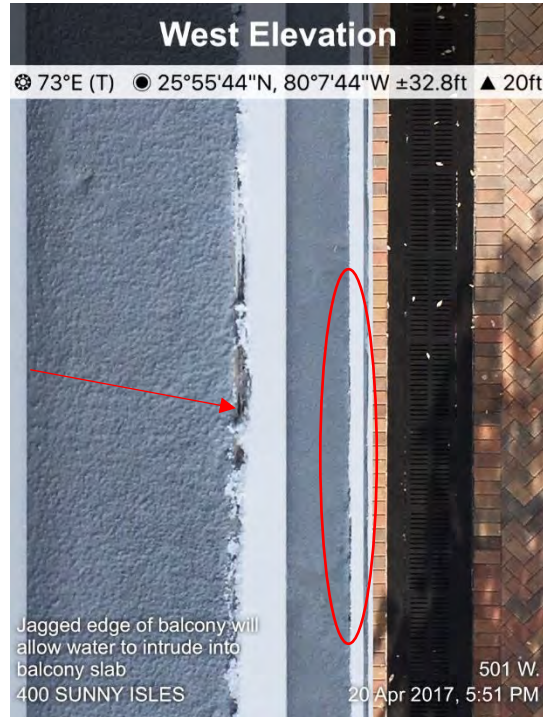
Figure 81

The edges of the balcony are jagged at the upper edge of the stucco application. voids and cracks of stucco perimeters will allowing moisture to seep into the concrete slab and stucco at the bonding surface. Note that these edges can be seen on the balcony below as well (circled in red).

This condition is considered to be a workmanship problem and also fails conformance with ASTM C926. That requires stucco to be of uniform thickness and watertight at perimeter conditions.

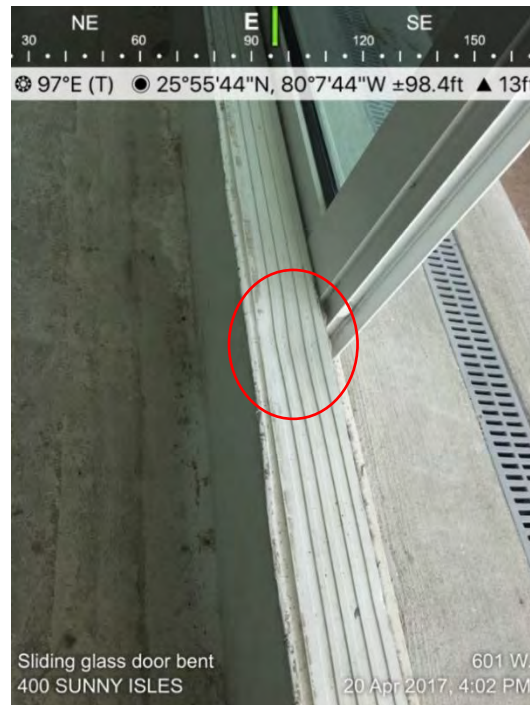
Figure 82

Sliding glass door to patio is bent (dented on upper surface) on the inside.

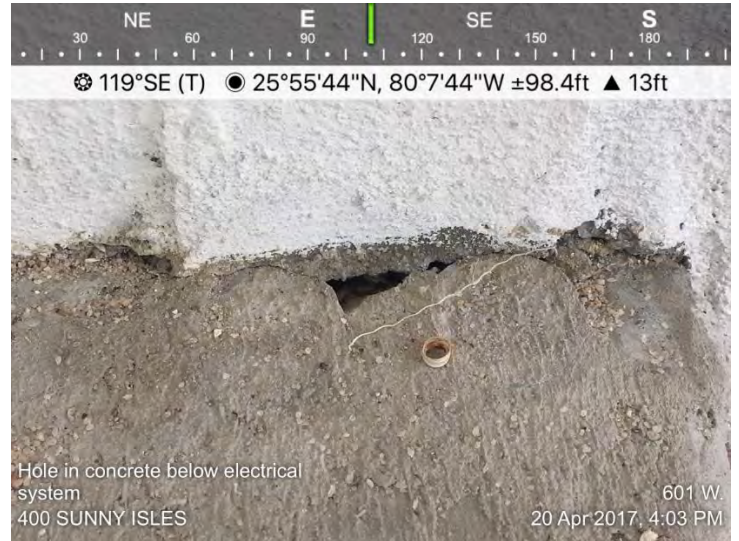
Figure 83

A significant void and crack was found at the juncture of the wall and terrace surface. This area would allow water intrusion into the concrete below. Electrical work was located on the wall between the floor and the wall.

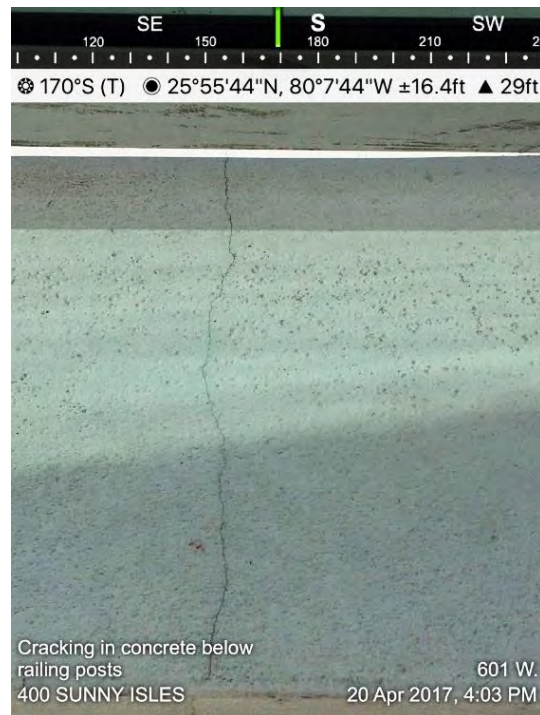
Figure 84

The concrete below the knee walls below the railings on the balcony were cracking in several locations.

These cracks should be repaired and slope on the top surface of the parapet should be verified such that water does not stand. Cracks on horizontal surfaces are subject to moisture intrusion to a much greater degree than vertical surfaces. ASTM C926 requires that horizontal surfaces be sloped to prevent standing water.

This should be performed at all flat surfaces throughout the project.

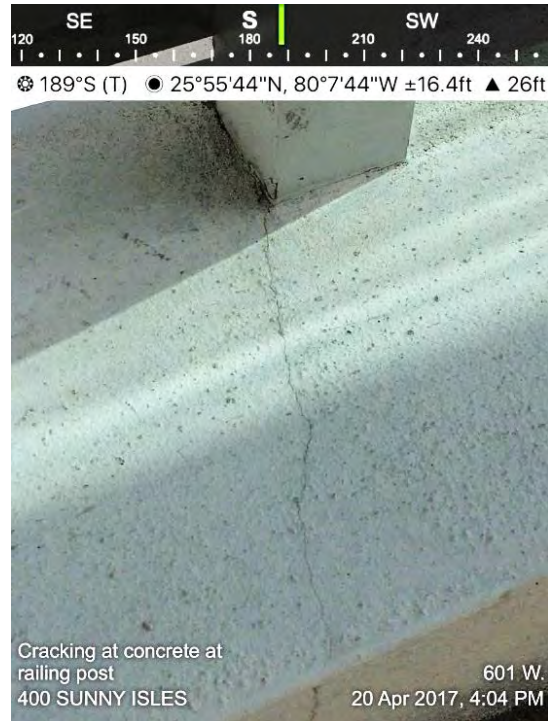
Figure 85

Another crack in the concrete below the railing posts. This crack appears to be originating at the corner of the post itself.

Cracks on horizontal surfaces are subject to moisture intrusion to a much greater degree than vertical surfaces. ASTM C926 requires that horizontal surfaces be sloped to prevent standing water.

This should be performed at all flat surfaces throughout the project.

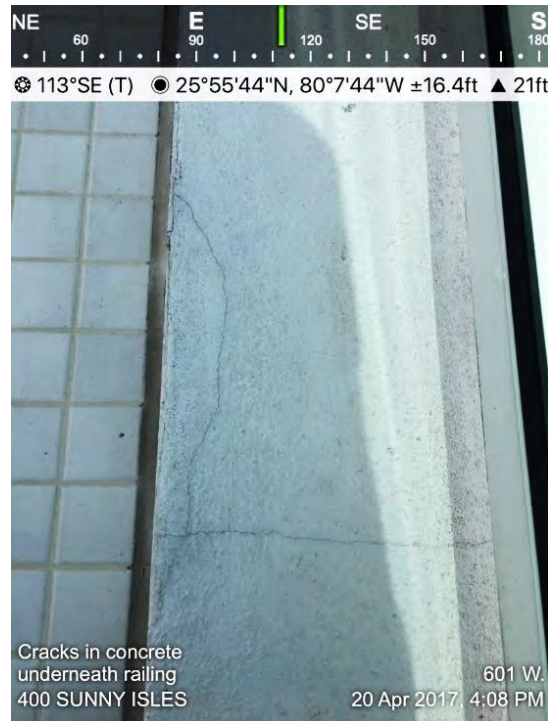
Figure 86

Cracking in the stucco below the railing next to the pool.

Cracks on horizontal surfaces are subject to moisture intrusion to a much greater degree than vertical surfaces. ASTM C926 requires that horizontal surfaces be sloped to prevent standing water.

This should be performed at all flat surfaces throughout the project.

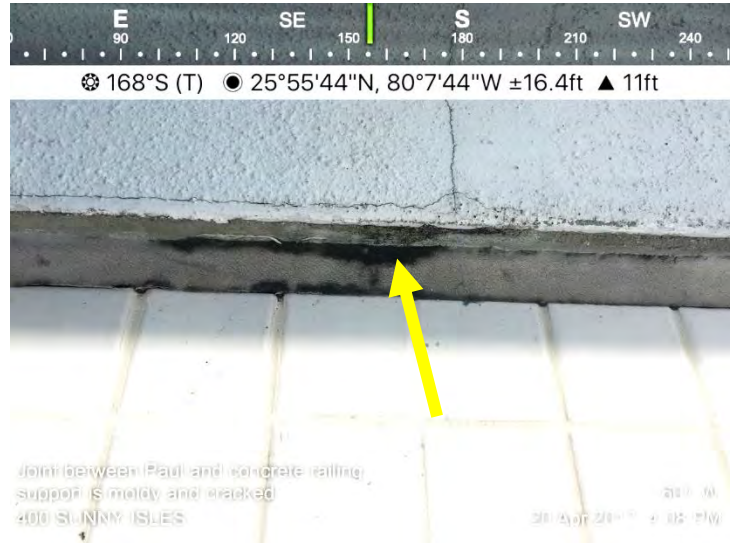
Figure 87

The joint between the pool tiling and the concrete/stucco wall underneath the railing is supporting organic growth. Cracks are forming along the edge of the concrete and at the locations of the organic growth (yellow arrow).

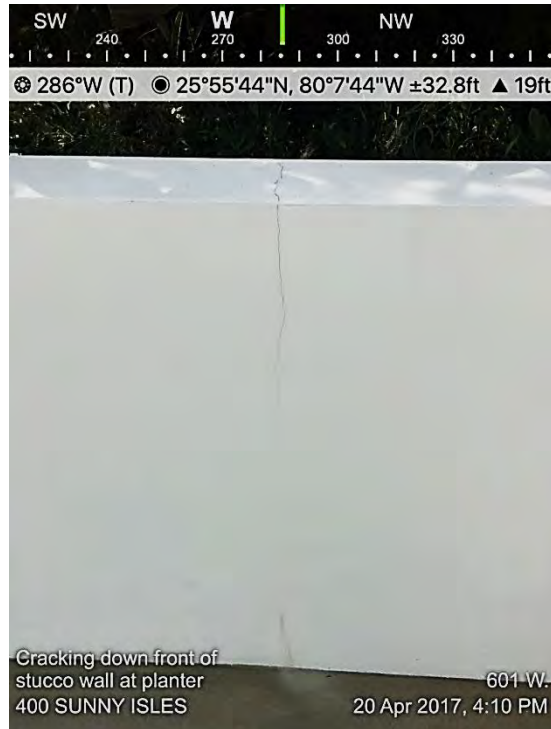
Figure 89

A crack has formed across the top of the planter wall and down the entire face of the wall of the planter.

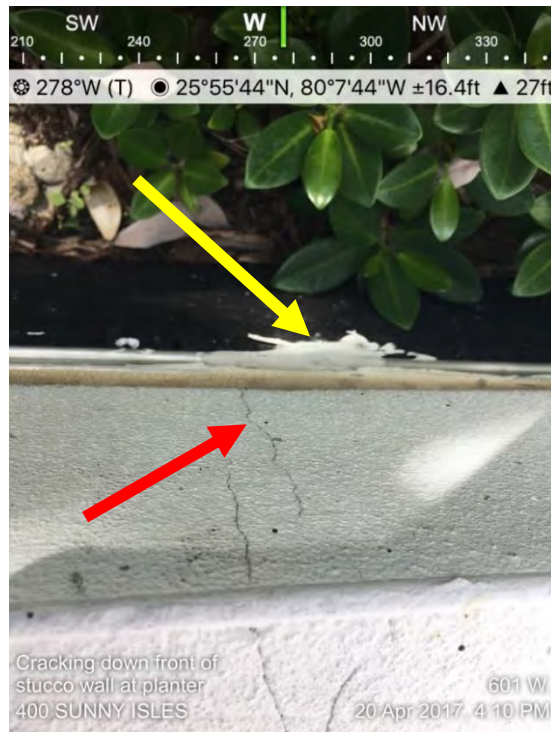
Figure 90

This is a downward view of the cracks on the planter wall on the inside. (see blue arrow) Cracks can be seen in multiple locations propagating down the stucco wall.

At the bottom of the photo the top flat surface of the wall is seen to be cracked perpendicular to the stucco corner bead.

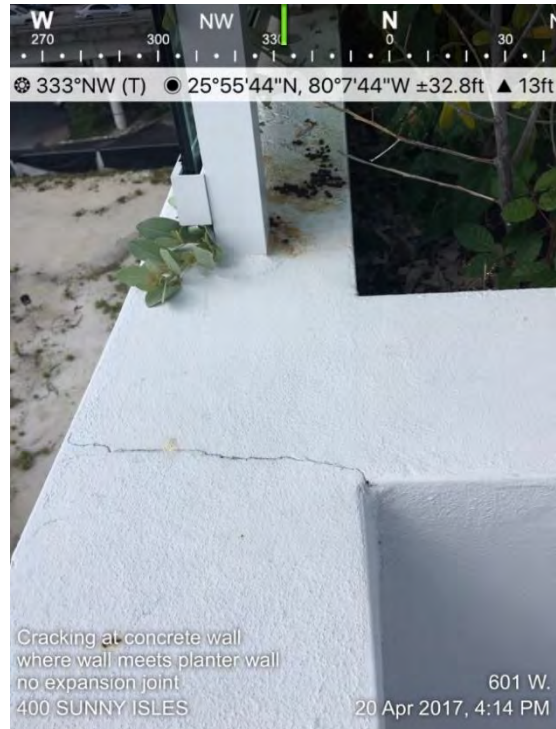
Figure 91

The exterior balcony walls also have cracking in the stucco where the planter wall joins the exterior wall, due to a lack of expansion joints in the concrete. This particular crack extends from both the inside wall to the outside wall. An expansion joint should be placed at the juncture of the planter wall and knee wall continuation due to thermal and moisture differential conditions.

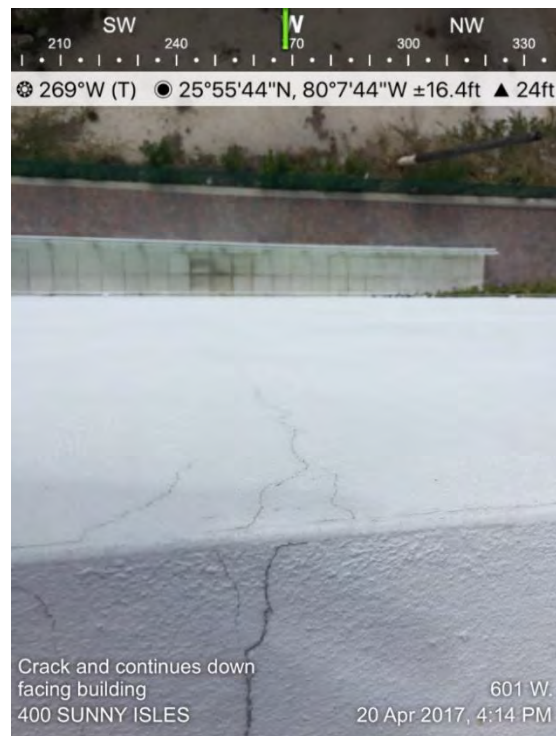
Figure 92

This is another view of the crack shown above, as it continues down the exterior face of the wall. The top of the knee wall is at the bottom of the photo. Note that cracking stucco that would eventually be expected to de-bond at the exterior of the wall would fall to walkway and ramp far below.

Cracks on horizontal surfaces are subject to moisture intrusion to a much greater degree than vertical surfaces. ASTM C926 requires that horizontal surfaces be sloped to prevent standing water. This should be performed at all flat surfaces throughout the project.

This area should be corrected with addition of an expansion joint and stucco repair.

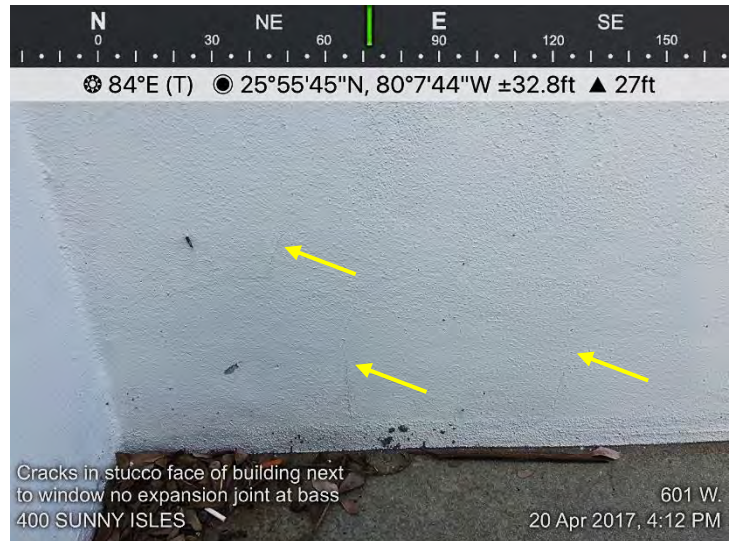
Figure 93

Cracks appear to be propagating from the base of the outside wall on the patio due to the lack of an expansion joint.

An expansion joint should be added as the stress will allow moisture to enter cracks and debonding of stucco will eventually develop at the interior and exterior surfaces of the wall.

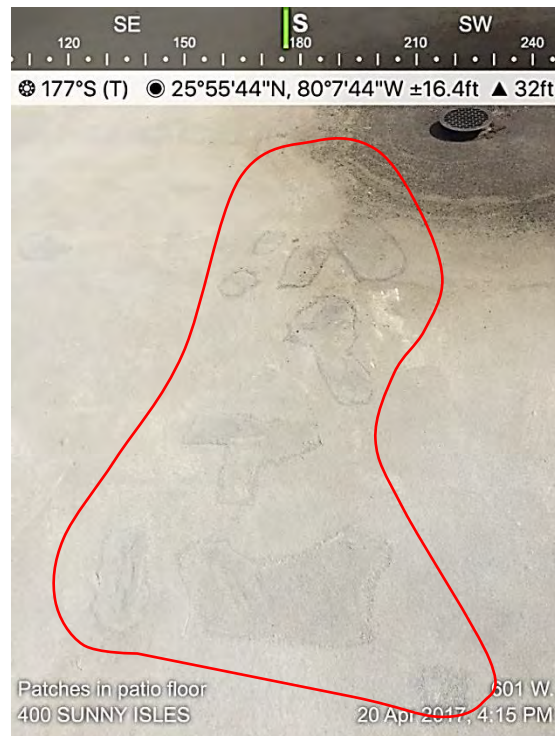
Figure 94

Patches of the surface in the concrete of the patio slab were considered significant. Additional investigation is warranted to determine the cause of the waterproofing membrane.

In addition, dark areas around the drains is deposits of waterborne sediments that show that the terraces typically do not properly drain. The bi-level drains used in this condition should be promenade drains with extensive drainage capacity at the lower slab elevation. The drains installed have minimal drainage area in the lower segment of the bi-level design, and consistently performed inadequately throughout the project. them, indicating that water was ponding around them instead of draining properly.

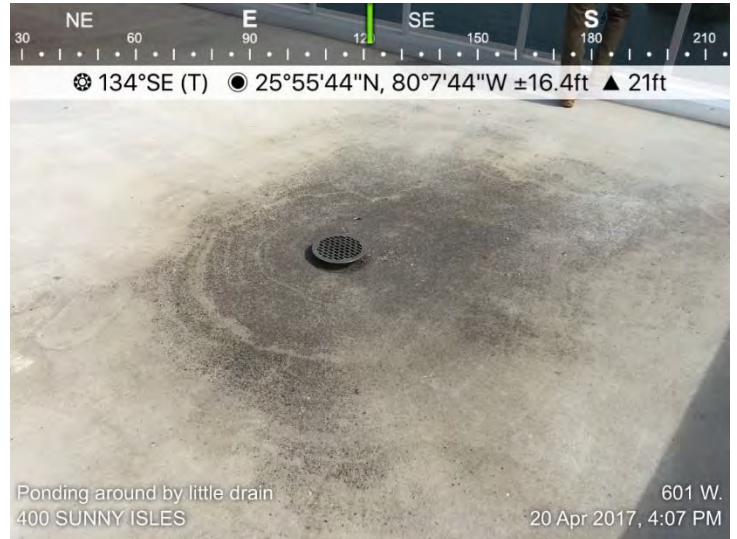
Figure 95

Another view of the significant ponding around the drain above.

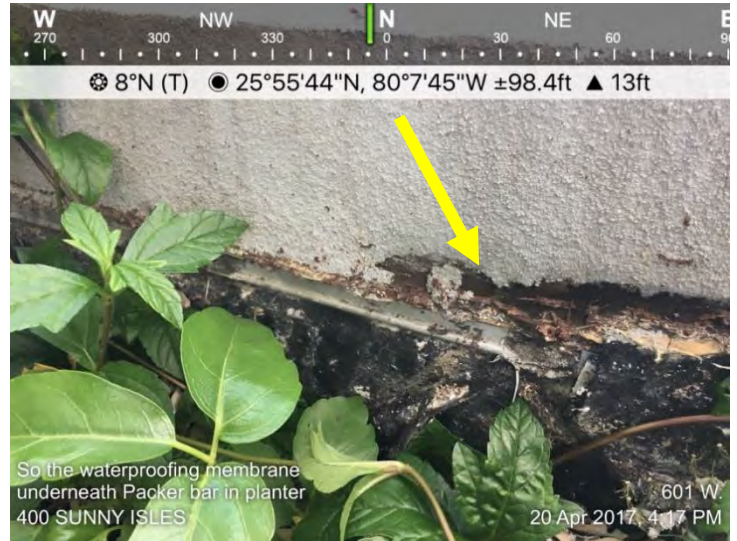
Figure 97

The waterproofing membrane underneath the backer bar in the planter is coming apart and no longer protecting the cement from the moisture and soil.

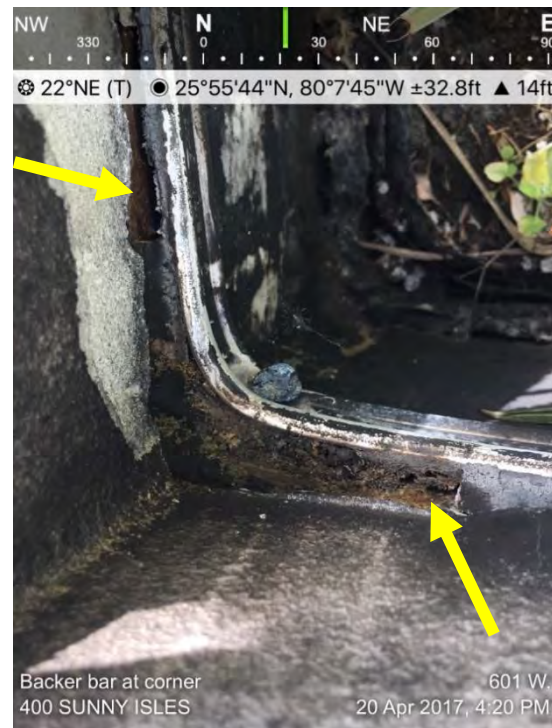
Figure 98

A downward view of the corner section of the backer bar in the planter. Holes in the waterproofing membrane can be seen along the entire corner section.
