CASE NO.: 2020-024374-CA-01

**NOTICE OF FILING**  
**EXHIBITS “A” THROUGH “E” OF COMPLAINT**

***Re: 400 Sunny Isles Condominium East Association, Inc.  
Section 558.04, Florida Statutes, Notice of Claim of Construction Defects***

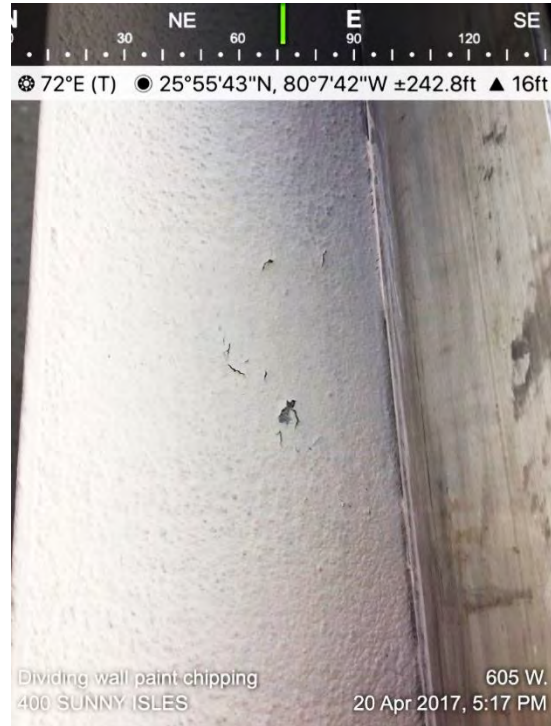
Figure 99

Paint on the dividing wall is chipping. This condition is considered to be caused by water entry at the top of the wall and moisture being entrapped under the paint coating resulting in adhesion failure.

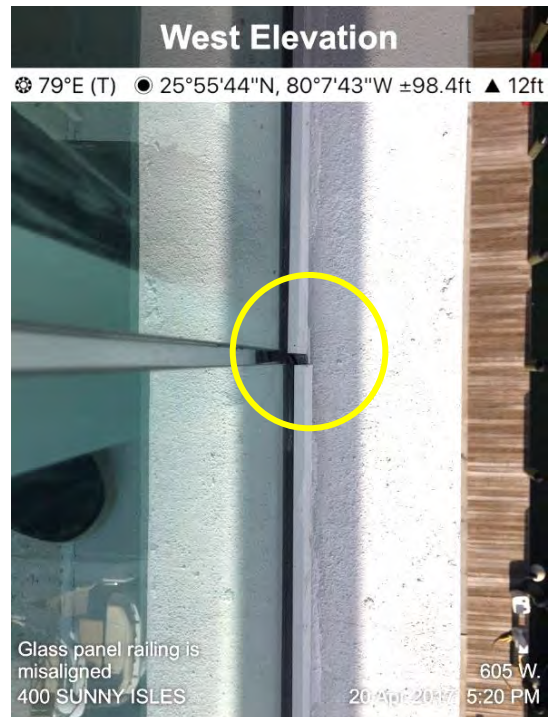
Figure 100

Glass panels are misaligned at the railing. This downward view shows the attachment point is skewed and out of conformance with the railing tolerances.

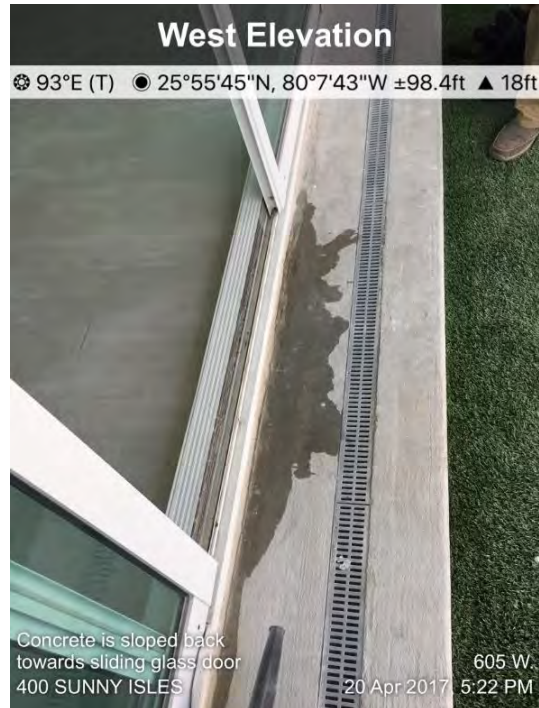
Figure 101

Concrete is incorrectly sloped towards the sliding glass door instead of the drain and the patio, causing water to pond at the base of the door instead of properly running to the drain. This will lead to development of organic growth on the surface, and concrete deterioration at the sliding glass door.

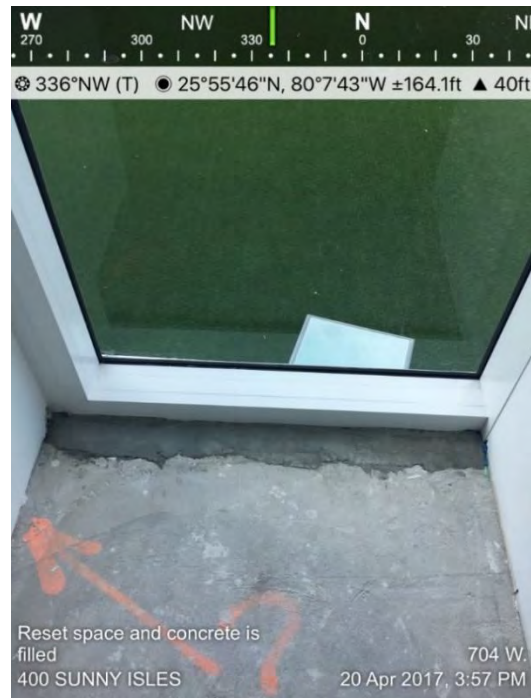
Figure 102

A recessed area below the window seems to have been filled with cementitious material. The material appears to be a grout and dissimilar from the normal slab concrete. The infill material boundary in this case is extremely irregular and is a concern because of the cold joint resulting at the juncture. Shrinkage of some installations and cracking could negate the intention of the depressed slab under the exterior wall and allow water to channel to the interior. Also, the aluminum window should not be subjected to contact with uncured concrete/cement as this negatively affects the aluminum finish as often occurs with concrete repairs of slabs that damage the finish of aluminum balcony rails.

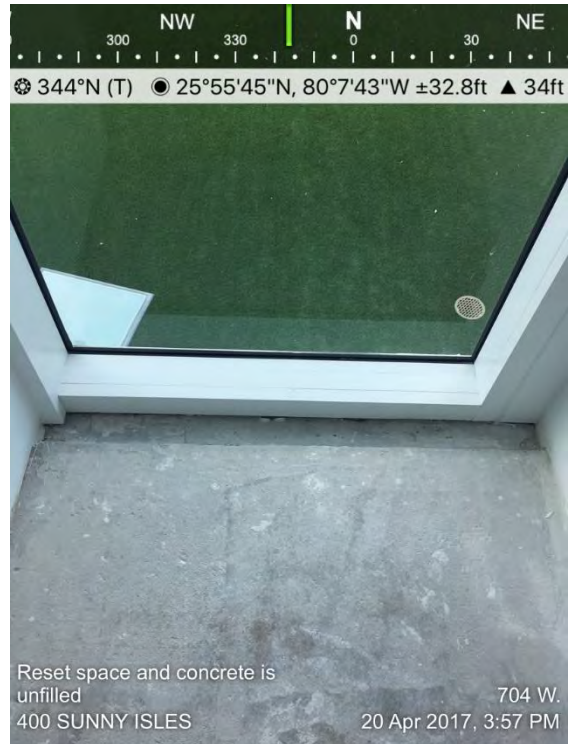
Figure 103

A similar recessed area as above but concrete is not filled. If the void space under the window is not filled, the exterior moisture would be expected to be absorbed by the interior infill material

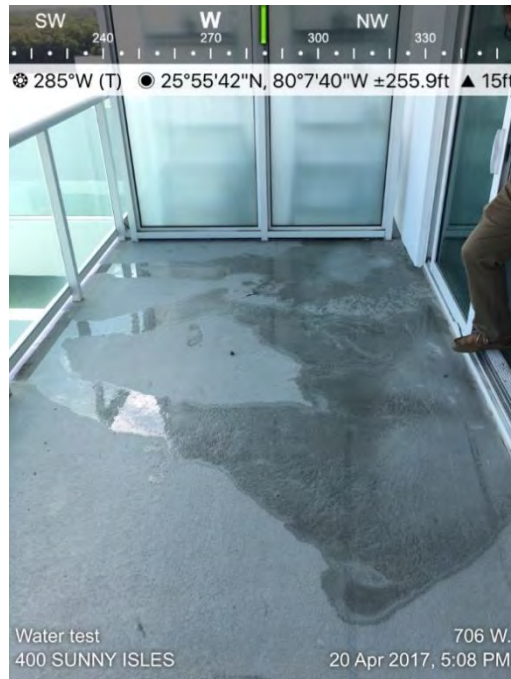
Figure 104

A water test was performed on the balcony of the unit. Water was poured onto the balcony near the doorway to see if it would drain properly. While some of the water was shown to drain off the edge of the balcony, the majority of the water remained ponded near the sliding glass door. The patio does not have a uniform or adequate slope indicated on the design drawings.

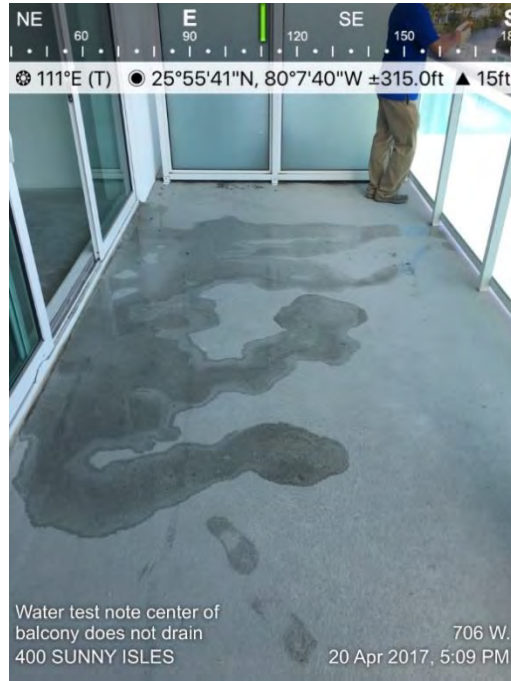
Figure 105

Another photo of water testing on the unit balcony. This particular image shows the water unable to drain properly from the center. The majority of the water ponded in front of the door.

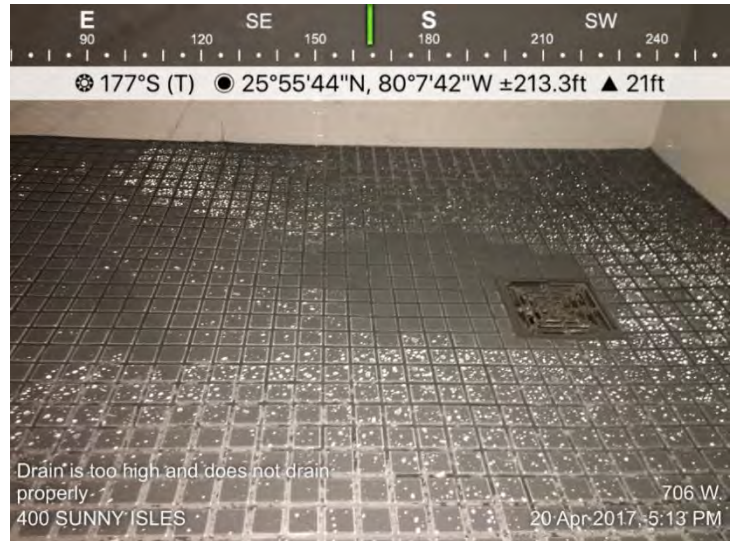
Figure 106

The drain in the shower does not appear to be draining properly, as it is set too high.

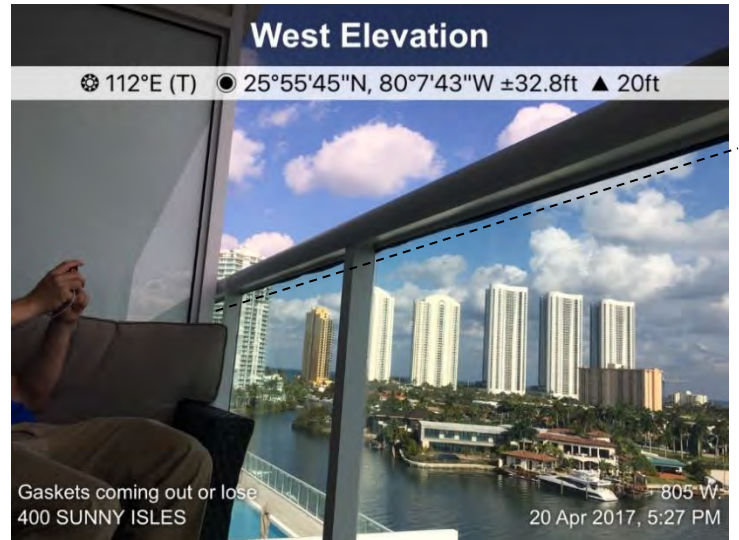
Figure 107

Gaskets were either coming out or loose along the windows.

Many locations were observed where the gaskets were loose or hanging down.

All the rubber gaskets for the entire project should be carefully inspected by the glass railing fabricator and installer, along with the owner's engineering representative.

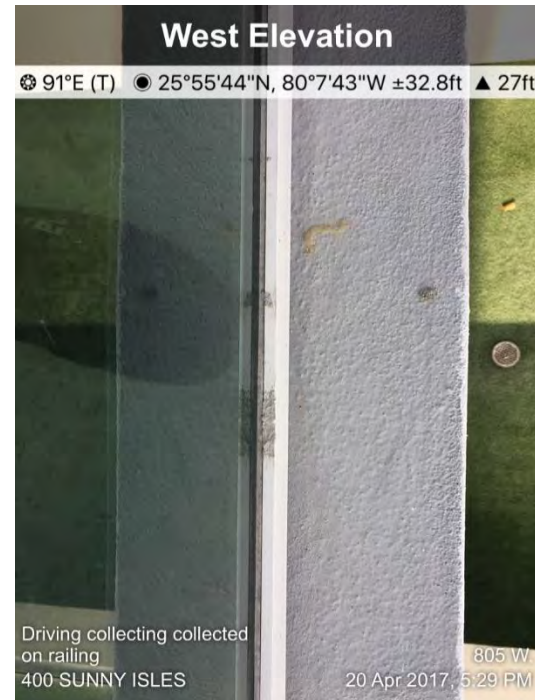
Figure 108

Mortar or balcony surfacing material has collected on the railing. Cementitious material is highly alkaline, and will damage aluminum railing finishes (eventually accelerating corrosion of the aluminum surfaces).

Railings must always be protected during construction to prevent contact with cementitious material.

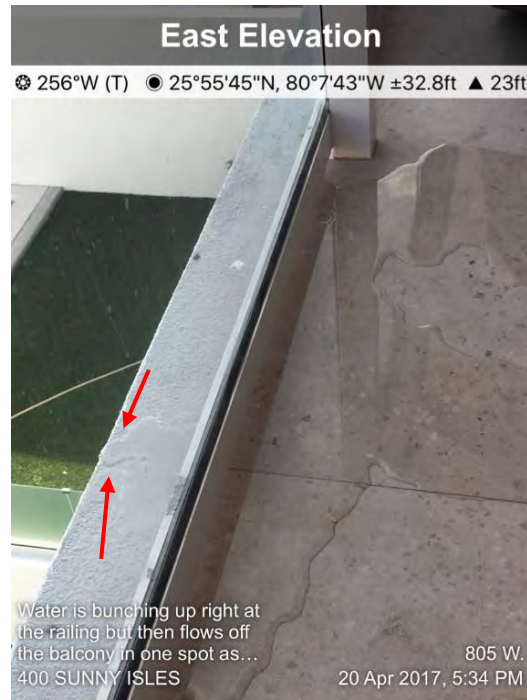
Figure 109

A water test was performed on the balcony. While the water flowed to the railing, it began to pond before flowing off (drainage was observed only in one small spot, indicated between the two red arrows). This area is much too small for significant amounts of water to properly drain uniformly from the balcony. Many balconies were observed where a thicker application of waterproofing had been applied (usually appeared to have been poured) along the edge of the slab.

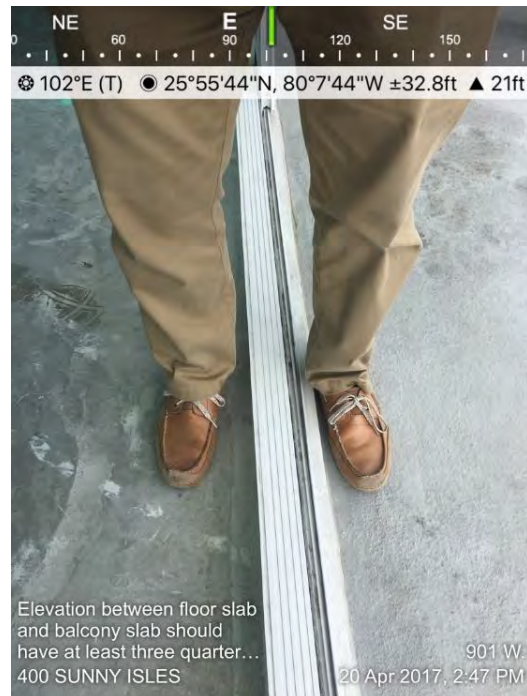
Figure 110

The interior floor slab should be at least  $\frac{3}{4}$ " higher than the balcony slab to deter water from entering inside. It was immediately discernable that there was not a difference in elevation between interior and exterior elevation. In less than a foot of horizontal distance, as it was senseably indistinguishable from a flat floor. In this photo, you can see that the inspector's feet are at the same height, as there is little or no height difference between the two slabs. If tile is installed as is typical, the moisture would migrate downward and to the unit interior after rain events.

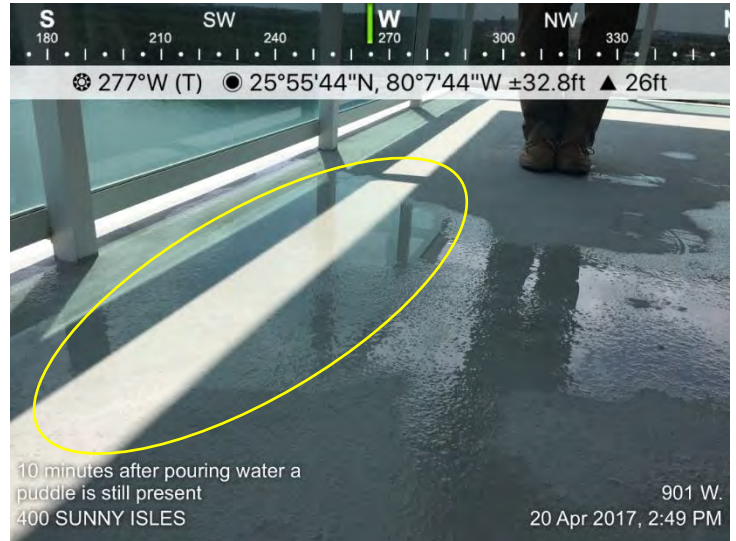
Figure 111

A water test was performed on the balcony of the unit. After 10 minutes, the water had ponded in the middle of the balcony and therefore did not drain properly, indicating that the balcony is not sloped correctly to allow for proper drainage.

It was noted that many of the balcony slab edges appeared to have been built up to a slightly higher elevation, often by the heavy (thicker) placement of waterproof coating.

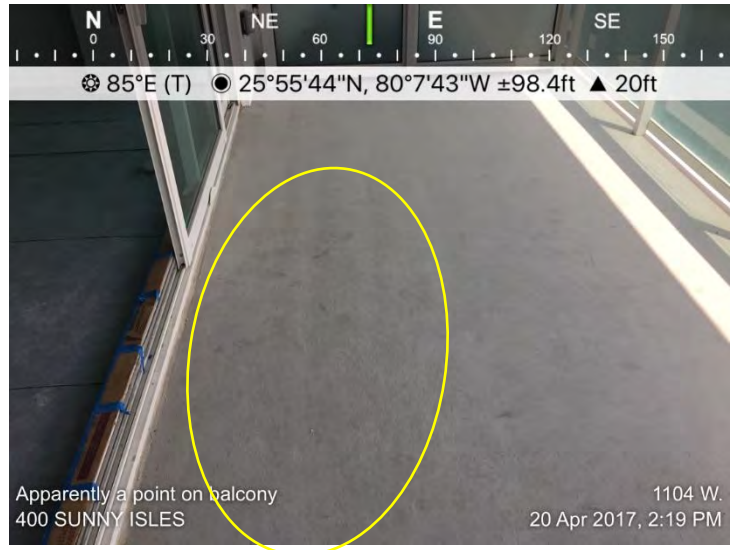
Figure 112

Dark area near the sliding glass door on the balcony shows apparent ponding area.

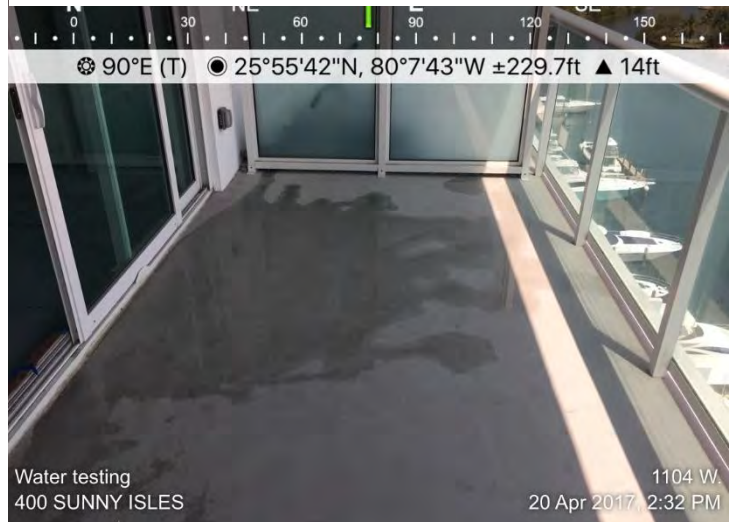
Figure 113

A water test was performed, showing that the water ponds in front of the door and in the center of the balcony instead of draining over the edge. This indicates that the balcony is not be sloped properly to allow for proper drainage.

This unit drains some of the water under the neighbors tile and setting bed under the demising panel.

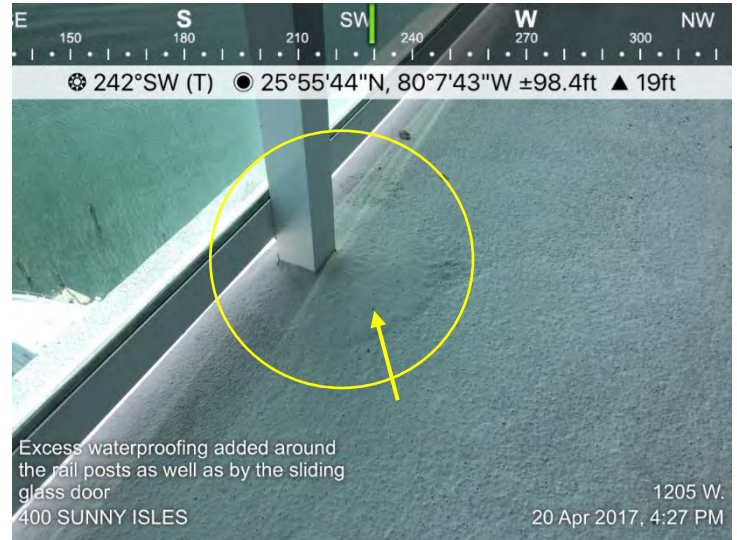
Figure 114

Excess waterproofing was applied around the rail posts and near the sliding glass door, as indicated by the smoother circular area.

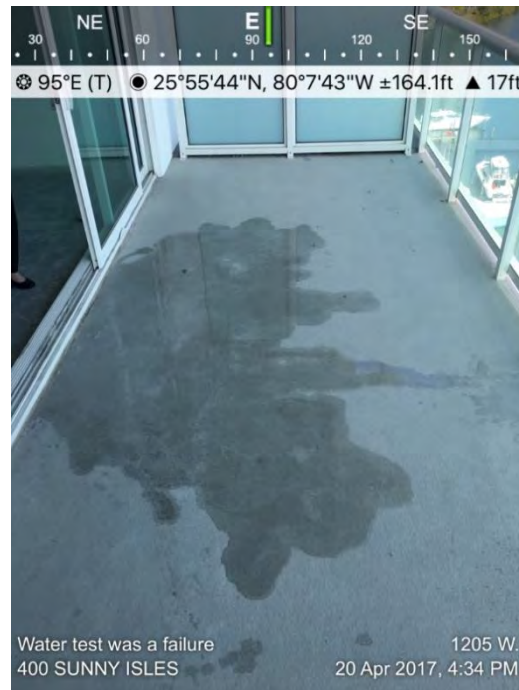
Figure 115

A water test was performed on the balcony. Only a small amount of water was able to drain over the edge while most of the water ponded in the center of the balcony. This indicates that the balcony is not sloped correctly to allow for proper drainage.

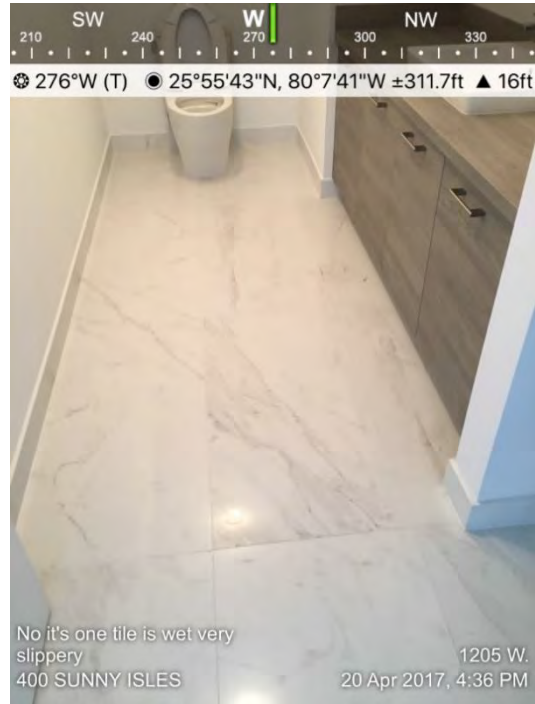
Figure 116

An area of tiles in the bathroom was wet and very slippery, suggesting water may be leaking up through the tile or dripping from the ceiling. This area should be re-checked after rain events and periodically to determine if this moisture problem is repetitive. If the facility staff verifies a recurring problem, further investigation will be required.

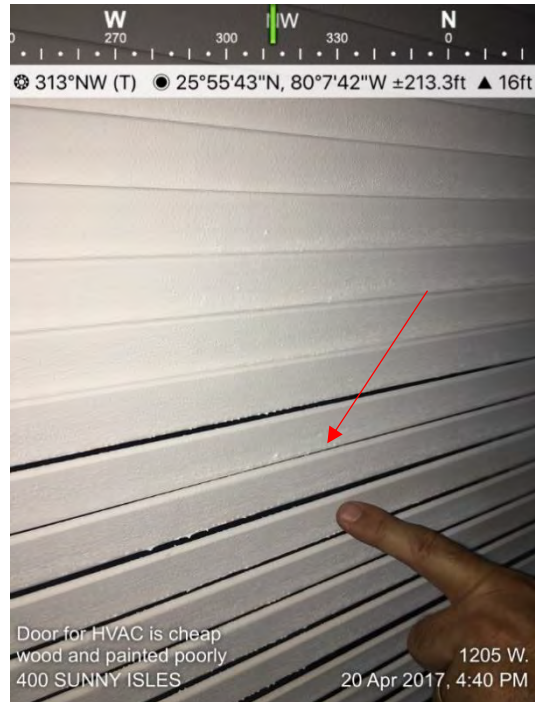
Figure 117

The wood door to the HVAC closet was painting was poorly performed. Beads of paint collected at the bottom of most of the slats. As slats were almost touching, the amount of air through this louver may be considered inadequate, and could hinder proper system air flow and operation.

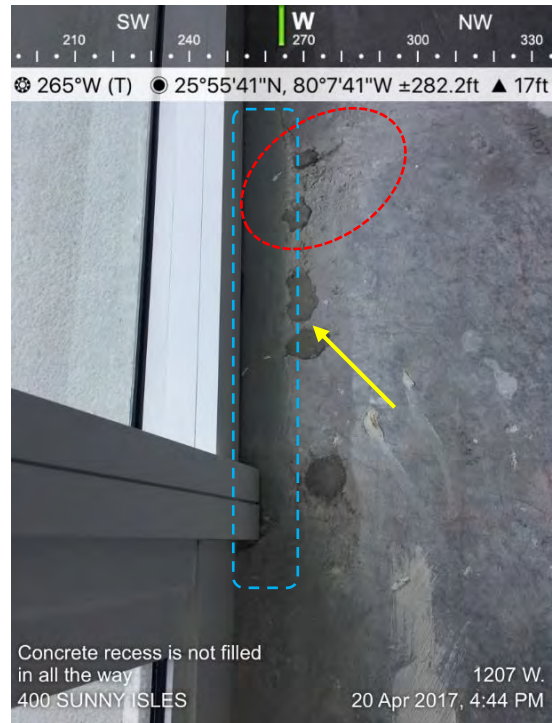
Figure 118

A recessed area of concrete was not filled in all the way, leaving a gap between the window frame and the floor slab.

The concern is that the rough, irregular juncture is prone to cracking at the cold joint between the new fill and the older slab placement. Secondary cracking could cause moisture to enter this area and this would be expected to cause spalling or other concrete damage over time. It was not possible to discern if or how the space under the window frame was placed, how it was terminated. It is a concern in how the added concrete placement could be sealed against moisture entry at cracks or cold joints.

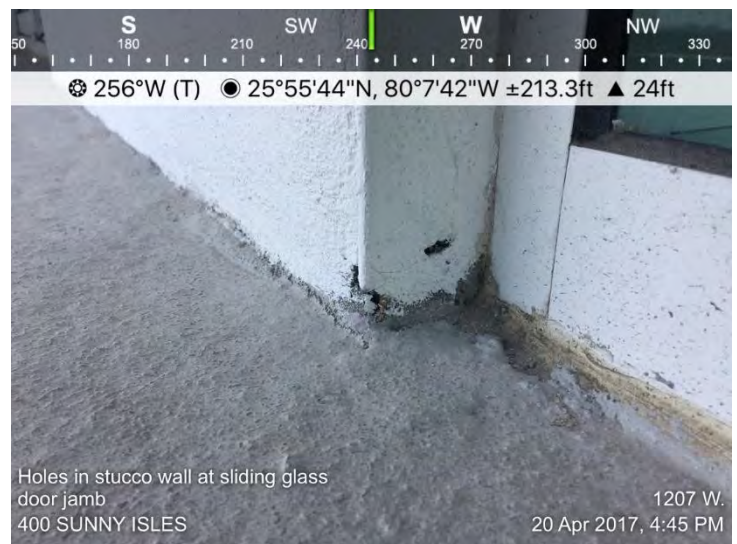
Figure 119

The stucco wall adjacent to the sliding glass door jamb was cracked and contained holes, allowing water intrusion into the concrete.

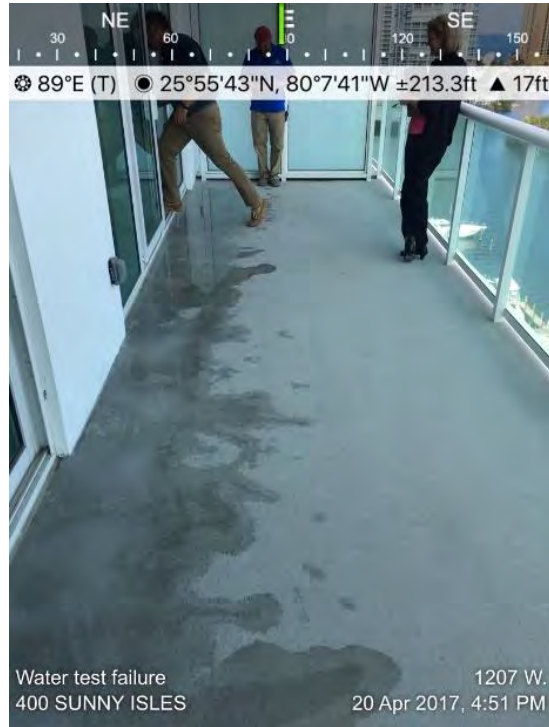
Figure 120

A water test was performed on the balcony. None of the water flowed off the edge, instead ponding along the exterior wall. This indicates that the balcony was not be sloped to allow for proper drainage. Water frequently traveled under demising wall panels onto other adjoining balconies, and often under adjoining tile installations.

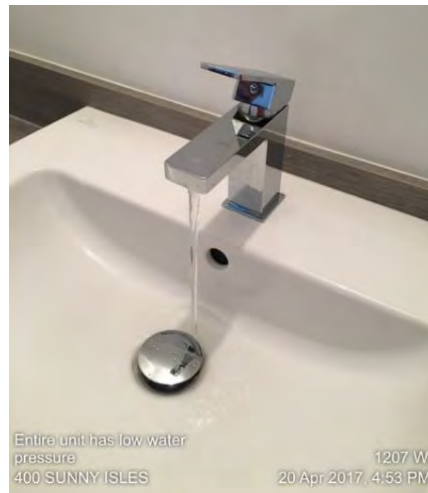
Figure 121

Low water pressure was found throughout the entire unit.

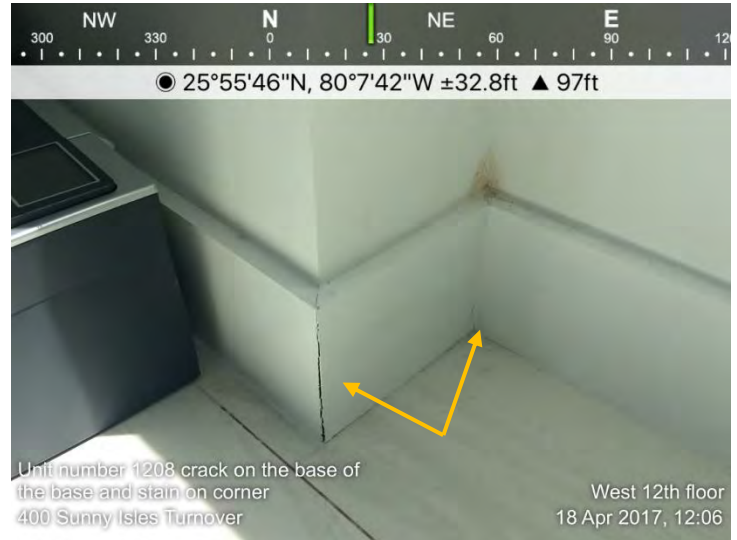
Figure 122

A crack was found in the corners of the baseboard (arrows). Gaps were also occasionally noticed between the baseboard and the floor.

Additionally, a dark reddish stain was noticed in the corner where the wall meets the baseboard, considered due to moisture and rust.

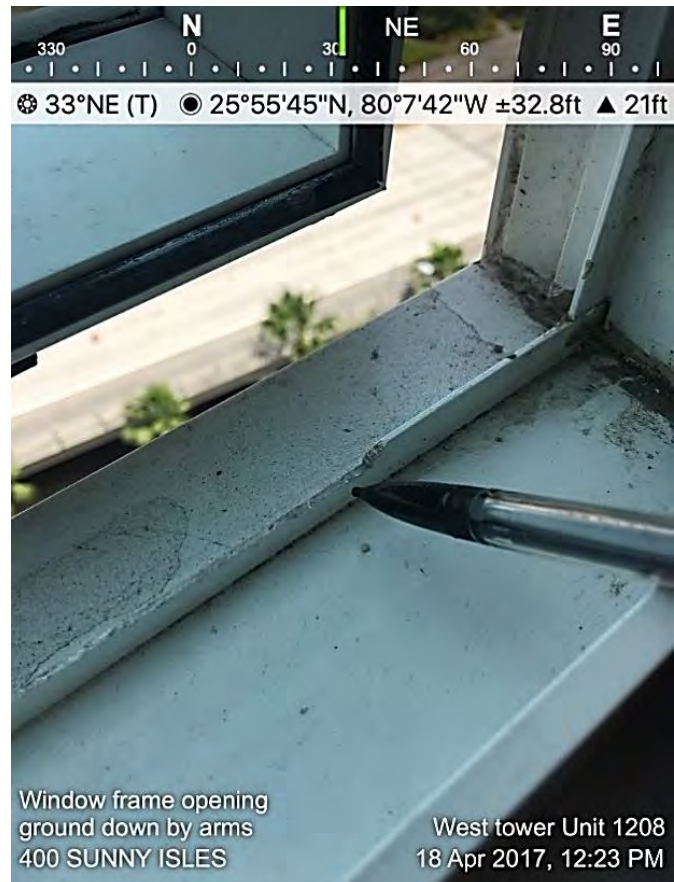
Figure 123

It appears that the window frame opening was ground down by the window arms. This was a field modification which would alter the back dam provided at the back side of the window. This would logically change the effectiveness of the window design in terms of inhibiting water intrusion. Additionally, the Miami Dade NOA may have been invalidated.

A water test could be conducted to see if window waterrightness was compromised.

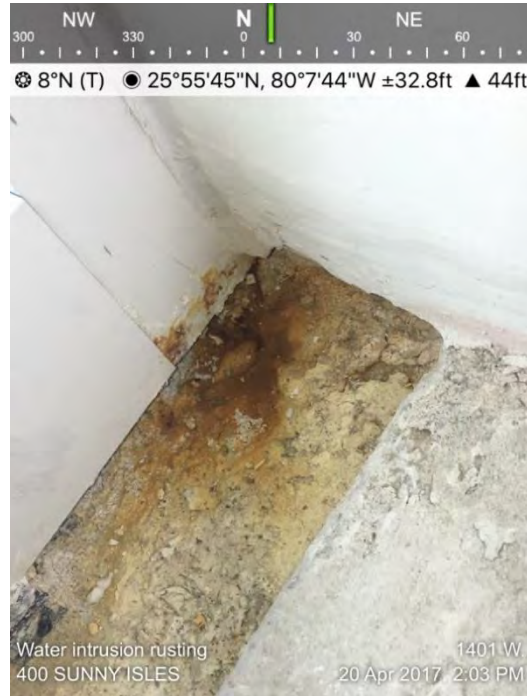
Figure 126

Water intrusion has caused rusting to occur in a cement recess beneath this window. Cement has not been completely filled in this area, as also indicated by the gap between the cement and the wall.

Further investigation and water testing is recommended.

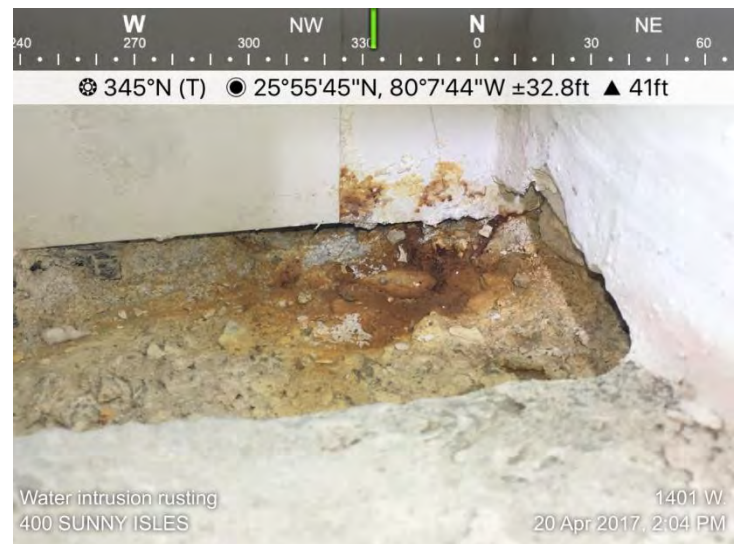
Figure 127

Another view of the water intrusion area. The gap between the wall and cement is much more noticeable from this angle and the extent of the rusting is significant.

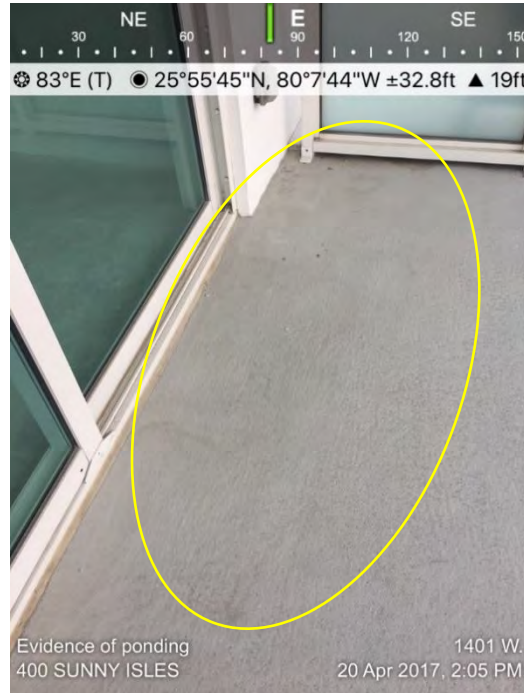
Figure 128

Dark areas on the balcony indicate ponding near the sliding glass doors and in the center of the balcony.

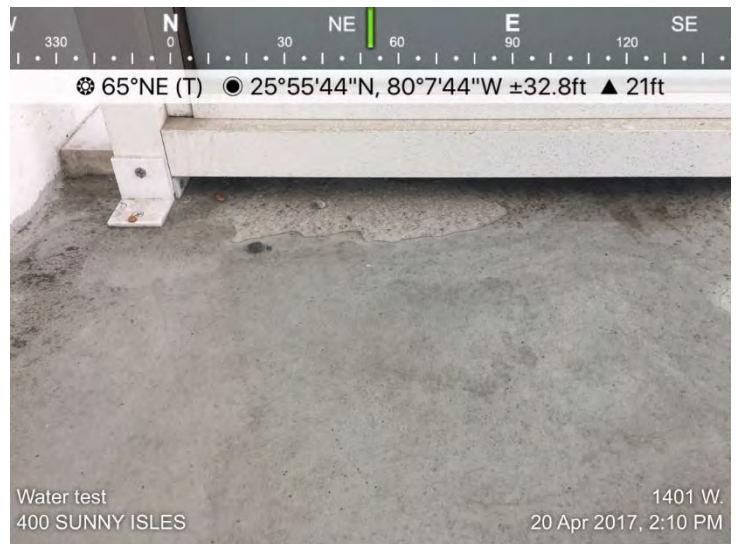
Figure 129

A water test was performed on the balcony after noticing evidence of ponding. Water did indeed pond in the center of the balcony and even flowed into the neighboring balcony instead of draining properly over the edge, as indicated in this photo. Balcony is not be sloped properly to allow for drainage.

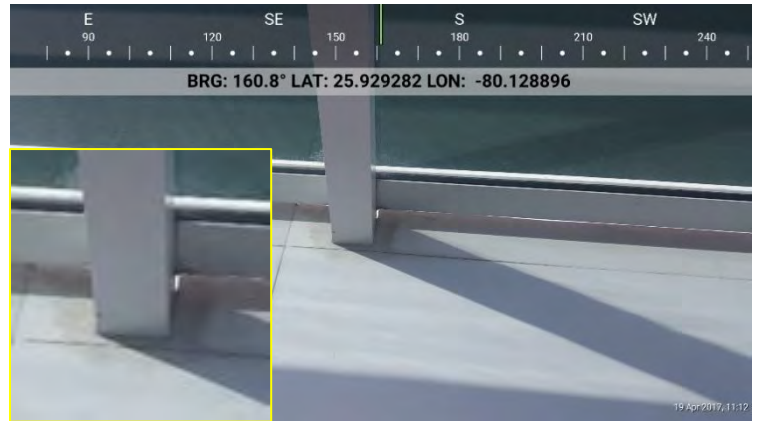
Figure 130

Discoloration around the railing posts on the balcony indicate possible water damage to the floor tiles or patching during tile installation.

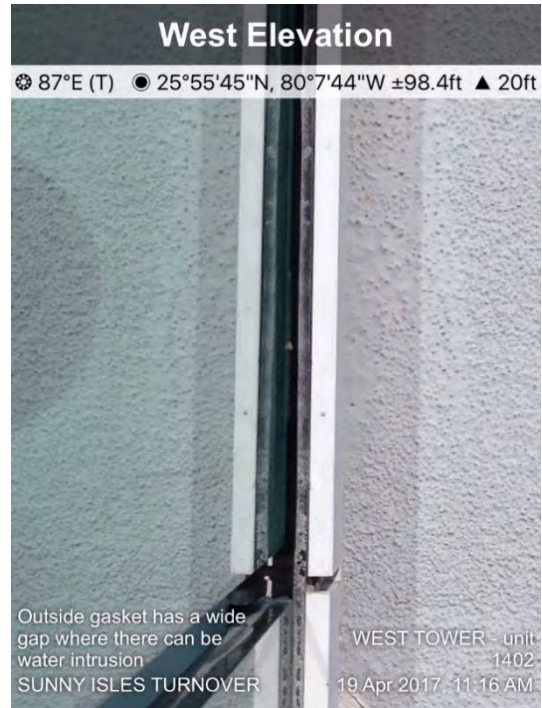
Figure 132

This is a close-up view of a rubber gasket at the base of one of the glass panels on the railing, showing there is a significant gap between the glass and the gasket. This may be allowing water intrusion into the structure.

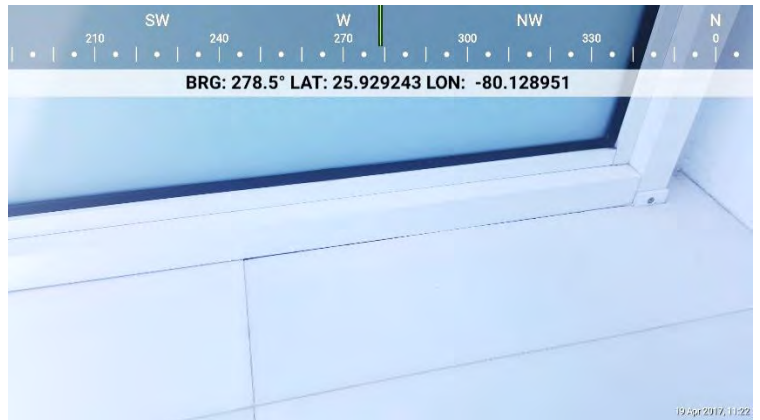
Figure 133

Gaps were noticed between the dividing wall on the balcony and the tile flooring, allowing for water intrusion underneath the divider.

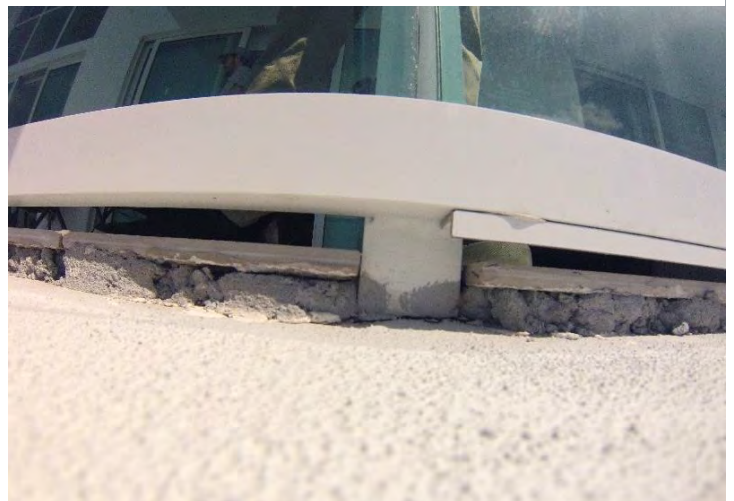
Figure 134

Mortar underneath tiling on balcony is loose and not sealed properly, allowing water to intrude underneath the tile and between the concrete. Cracks were also found at the base of the railing posts, also allowing for water intrusion.

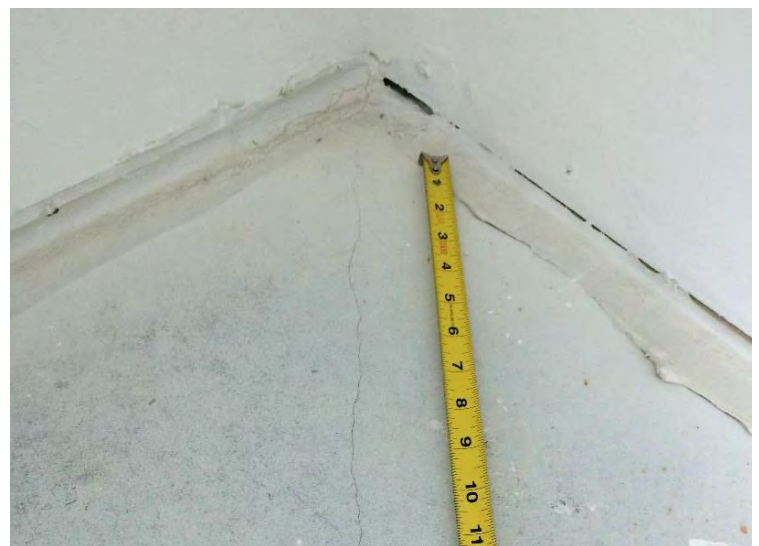
Figure 136

A close-up view of the above crack. The gaps between the wall and the concrete slab are clearly seen. Small diagonal cracks are not uncommon in post tensioned slabs. This crack should be noted in location and inspected in the ceiling of the unit below for additional problems. Initially, the crack in ceiling should be filled and monitored.

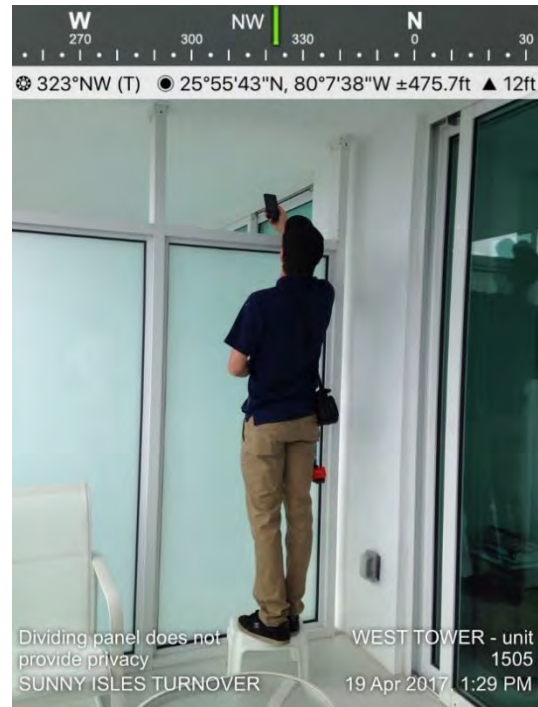
Figure 137

The dividing walls between units, shown here in unit 1505, do not provide enough privacy. A person can easily stand on a stepping stool, as the person in this picture is showing, and look over to the neighboring unit's balcony. Persons on the adjoining balcony have also climbed over the wall on one past occasion. The Original design of the balcony demising wall has been changed since the original design drawings were distributed during project development. The recommendation is to provide a secondary upper glassed panel above the existing panel location.

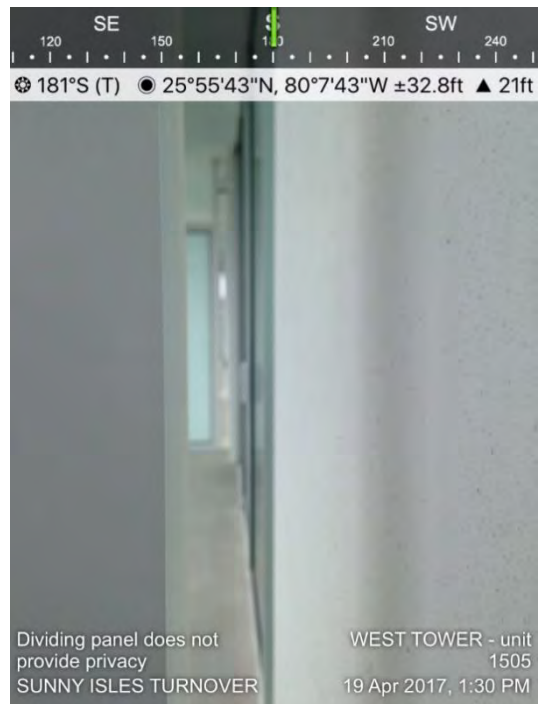
Figure 138

In addition to the dividing panels not being tall enough, there is also a significant gap between them as indicated here. One can clearly look through the gap between the wall and the divider and see down several units.

This amount of gap is also found between the divider and the balcony railing.

This is considered a privacy concern, and is not a code issue but may be a design problem for unit owners.

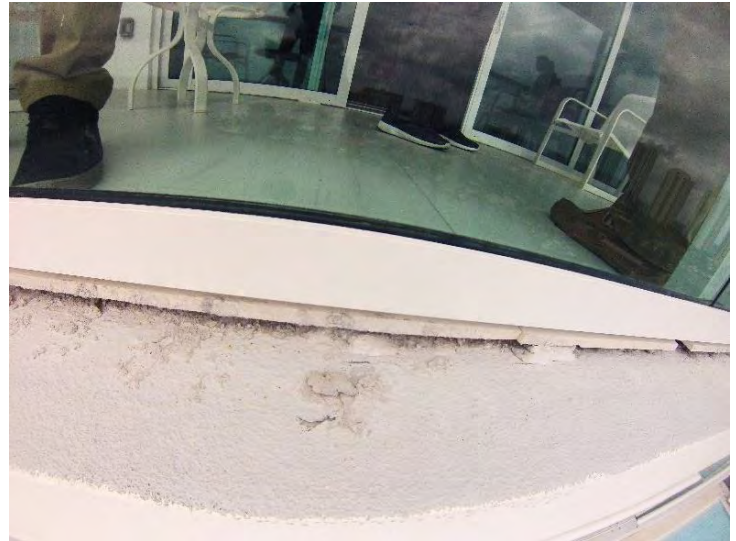
Figure 139

Mortar from underneath the tiling on the balcony is loose, allowing water to get between the tiles and the concrete. Tile Council of North America Requirements are that exterior installations of tile must be fully bedded in mortar bed. Failure to do so creates volumes of space where moisture can accumulate and where moisture damage to concrete slabs can commence.

It is unclear whether the tile work for various units can be identified as having been done by the developer or by independent contractors hired by the unit owners.

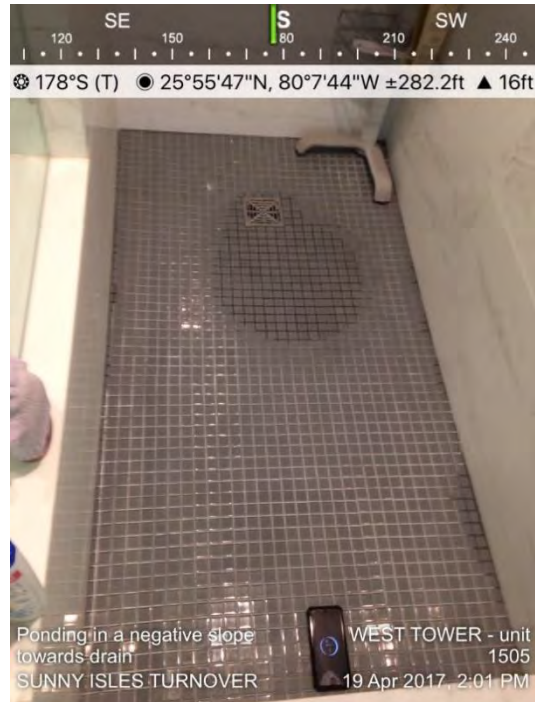
Figure 140

The shower does not appear to be correctly sloped to allow for proper drainage, as indicated by the dark area where water seems to be ponding.

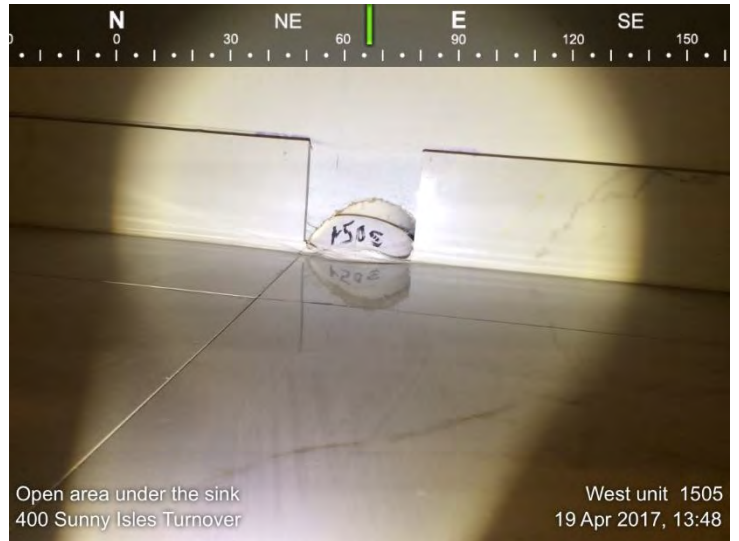
Figure 141

An open area in the wall under the sink was noticed in the bathroom.

This area can be closed with plaster and peiced with base mold.

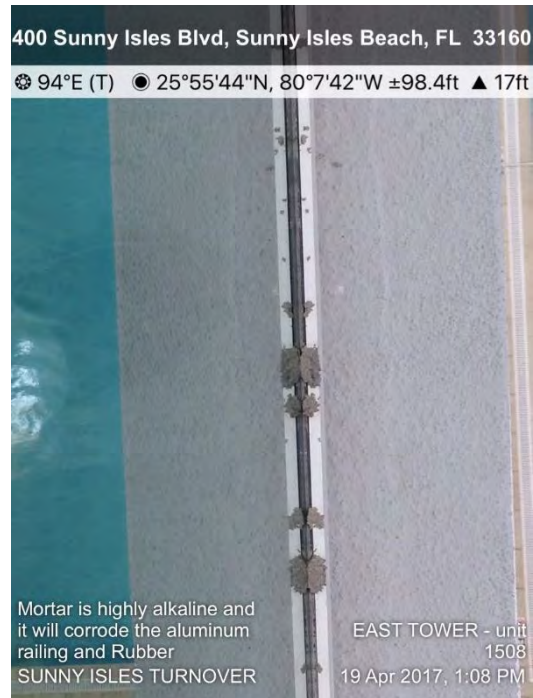
Figure 142

Mortar was found along the bottom edge of the glass panels on the railing. The mortar is highly alkaline and will damage aluminum coatings and begin to corrode both the aluminum railing material..

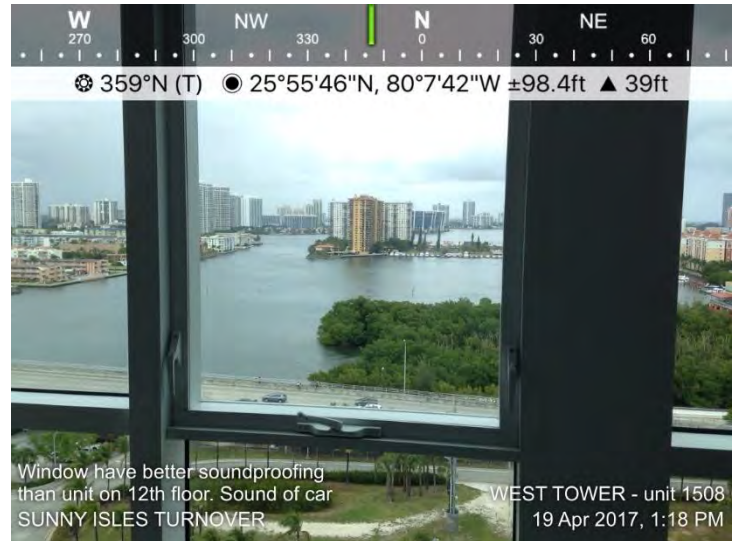
Figure 143

Windows in this unit were found to have much better soundproofing than the unit investigated on the 12<sup>th</sup> floor.

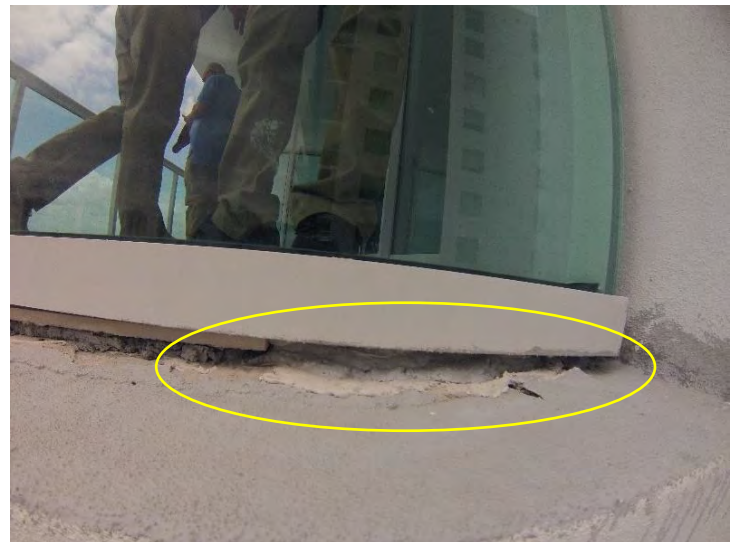
Figure 144

The mortar under the tiling on the balcony is loose, allowing water and moisture in. The concrete finish underneath the railing is cracked and curled up, allowing water intrusion and possibly promoting future corroding of the rebars.

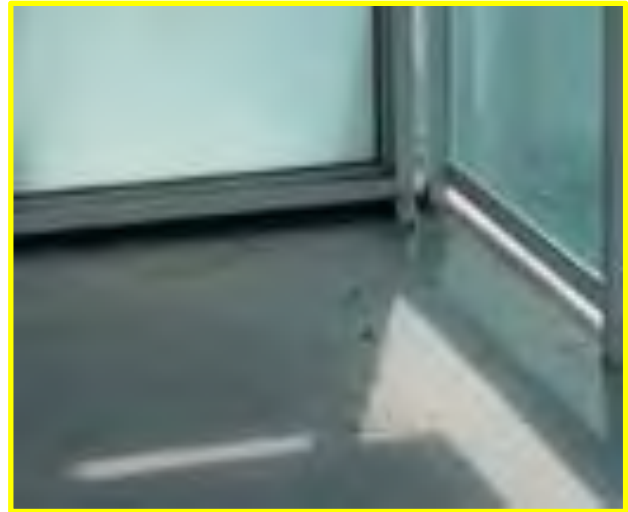
Figure 145

Pieces of dried mortar are shown washing and/or blowing into this unit's balcony from the neighboring balcony. (see yellow inset enlarged below).

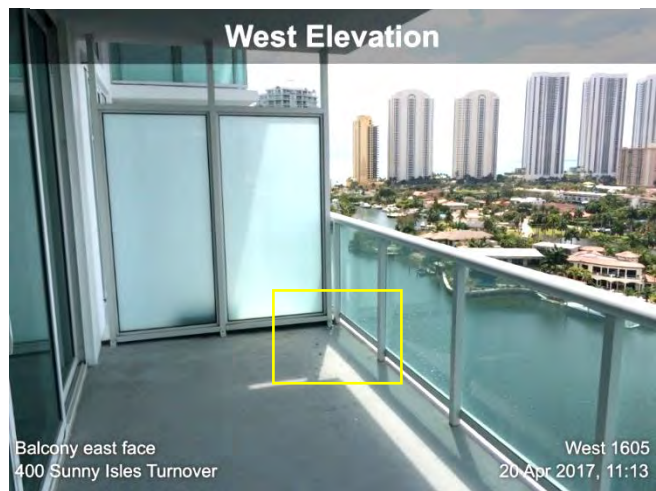
Figure 146

There is a problem with the demising panel design. As can be seen, when tile is installed on one balcony, a dammed condition is created under the panel. When (future) tile is added at the second side of the demising panel, an area under the panel is left which is a depressed area relative to the adjoining tile surfaces. The depressed area will collect water (and likely fill) from the relatively higher tile surfaces. The balconies also have a common problem where many of the balconies drain water toward the demising panel and not to the exterior edge balcony of the balcony.

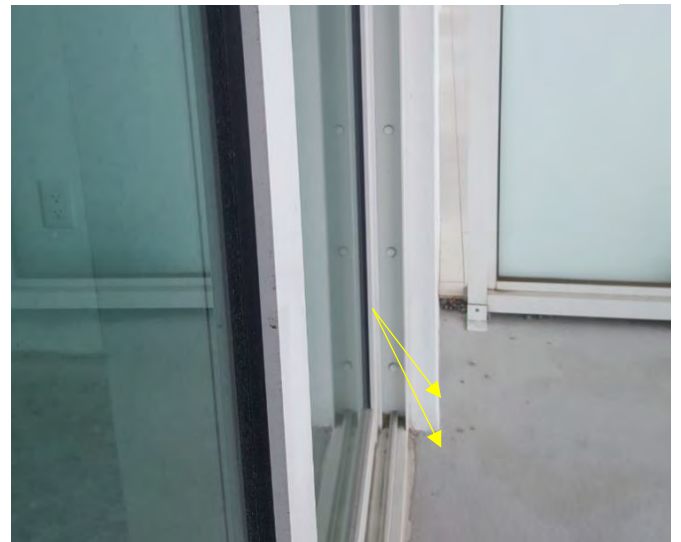
Figure 148

An enlarged view of the dividing wall support connections shows the fasteners and hardware that will be in this highly moist environment. The aluminum panels will expand and contract more than the concrete and the fasteners and angled feet of the panel will be moving relative to the concrete, which will open up the waterproofing in these locations. At right the photo shows the pieces of mortar trickling into this unit's balcony, (yellow arrows) carried by moisture flow, originating from under the tile of the neighboring balcony. The concern is the area under the demising panel will be perpetually wet, have openings in the waterproofing, and be inaccessible for observation, inspection, maintenance and repair.

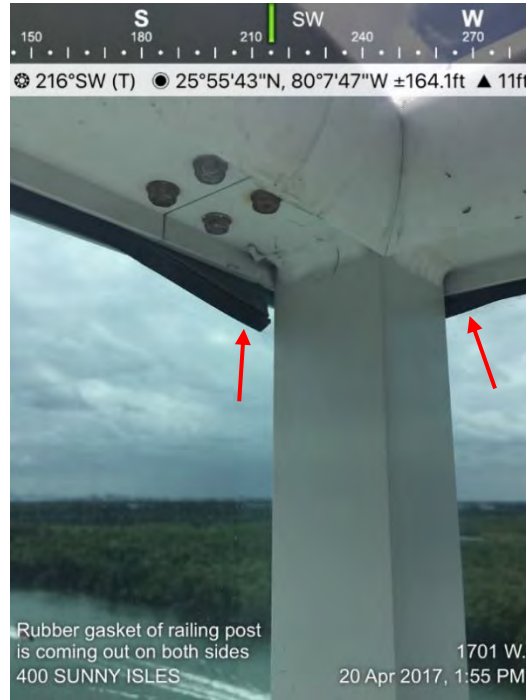
Figure 147

Rubber gaskets on the railing posts on the unit balcony are coming out.

Glass gaskets throughout project should be inspected and repaired.

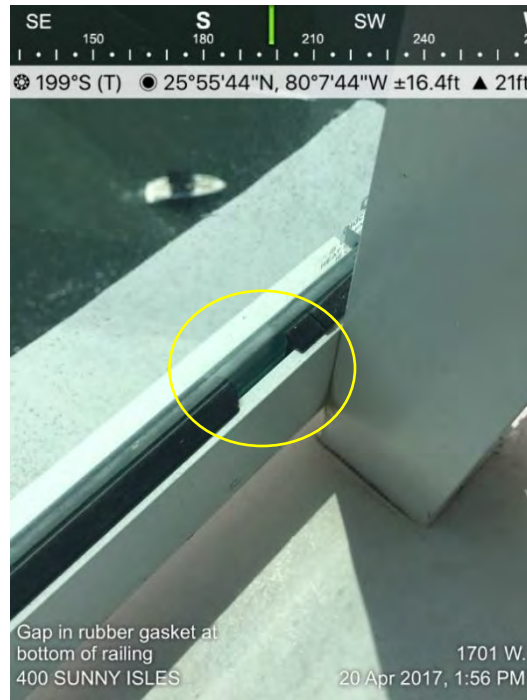
Figure 149

Gaps were noticed in the rubber gaskets, as in the case shown here. These gaps allow water and particulates to get in between the glass and the aluminum, possibly leading to corrosion of the metal.

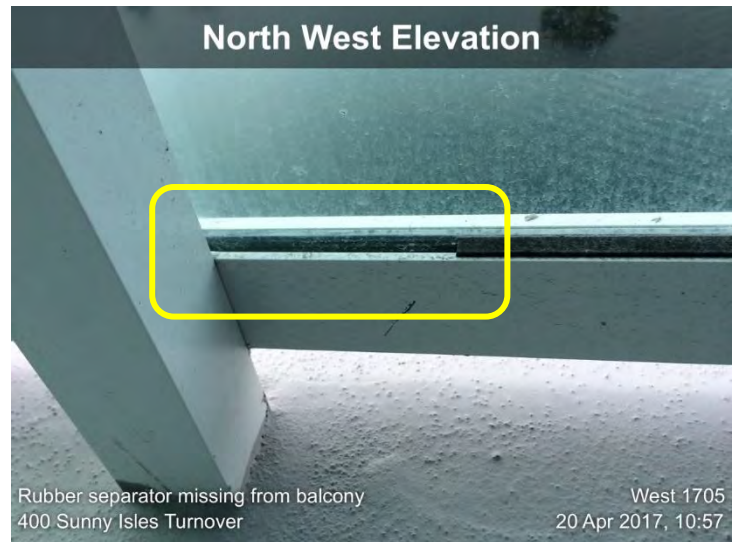
A rubber gasket was broken/missing pieces in the glass railing on the balcony, allowing water intrusion between the glass and the aluminum frame.

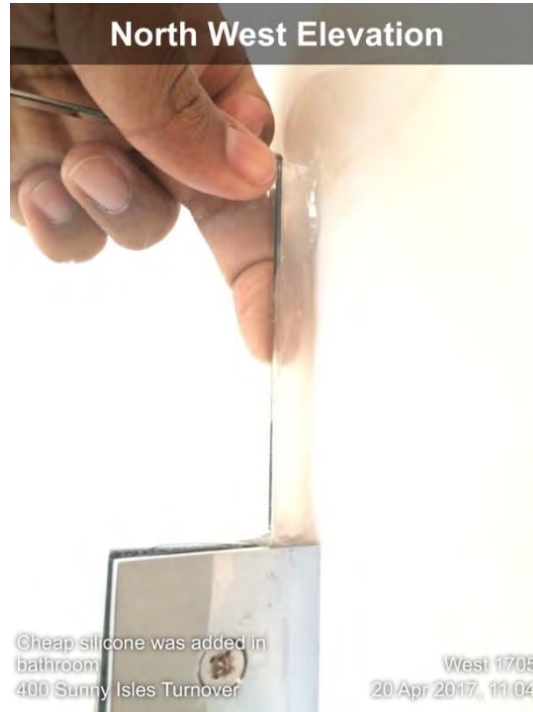
Figure 152

Failing silicone was used between the glass and the walls in the bathroom. This may have been used in other units and could possibly fail in the future. This is considered possibly a interior upfit contractor problem (hired by a unit owner) or work that was performed by the developer's contractor, as yet to be determined.
