CASE NO.: 2020-024374-CA-01

**NOTICE OF FILING**  
**EXHIBITS “A” THROUGH “E” OF COMPLAINT**

***Re: 400 Sunny Isles Condominium East Association, Inc.  
Section 558.04, Florida Statutes, Notice of Claim of Construction Defects***

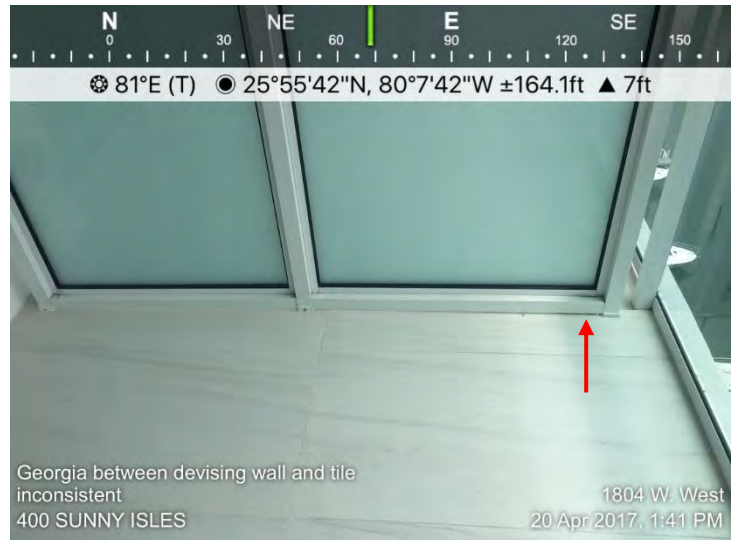
Figure 153

There was a significant and inconsistent gap between the dividing wall and the tile floor of the unit's balcony.

Water will enter these conditions, but how will it exit? How will the waterproofing below be monitored? How will waterproofing maintenance be performed at damp support and fastener locations prior to possible concrete spall development?

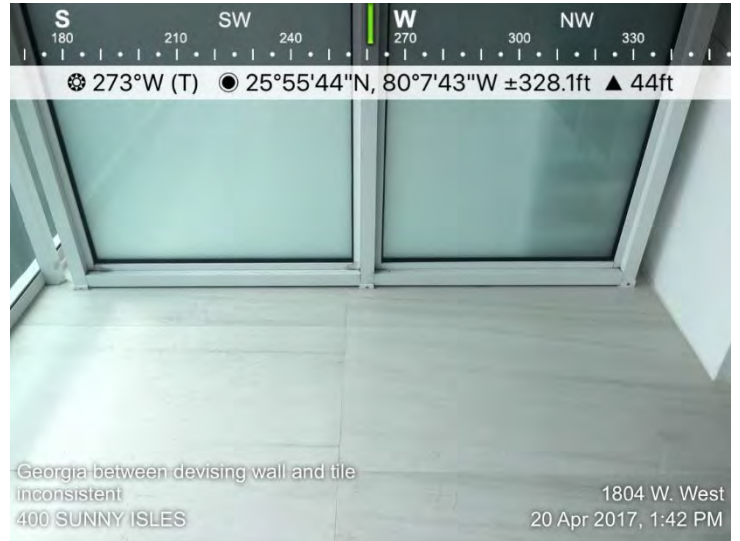
Figure 154

The dividing wall on the other end of the balcony had a uniform gap for the entire length of the divider. The slab and tile cannot be sloping correctly. How will the support posts that penetrate the tile and setting bed be waterproofed to prevent rainwater from draining down around the support posts? Since many or most of the balcony surfaces do not drain well, what damage due to the water infiltration without secondary drainage of the slab surface will result?

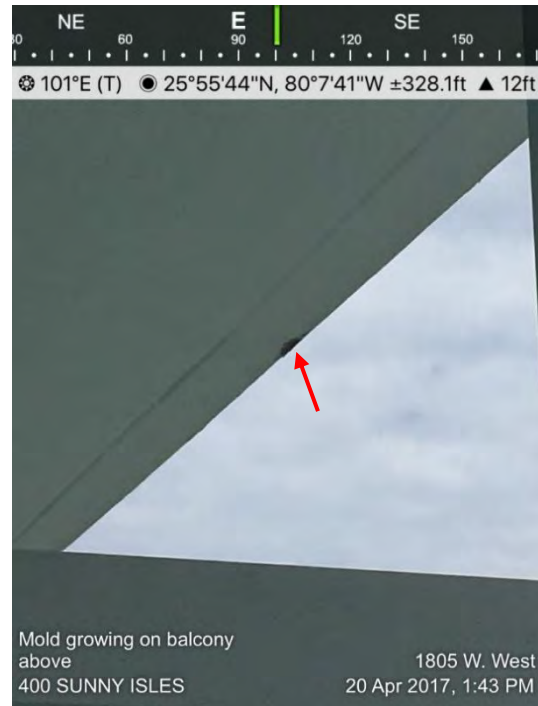
Figure 155

Mold was found growing on the roof of the balcony/floor of the balcony above.

Due to non-uniform provision of correct and uniform slope to the balcony edge, small areas must drain large areas of poorly sloped balcony surface over long time periods. The result is development of organic growth where edges remain moist for long periods.

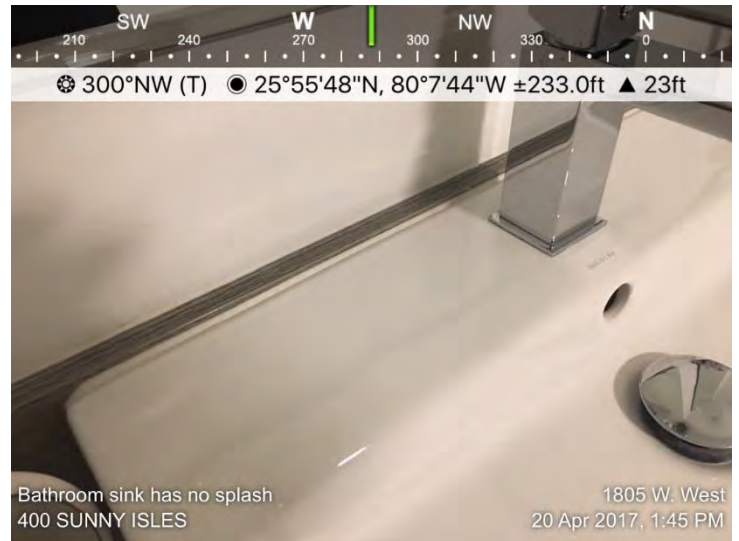
Figure 156

Bathroom sink had no backsplash to protect the wall from water intrusion.

This is a design error.

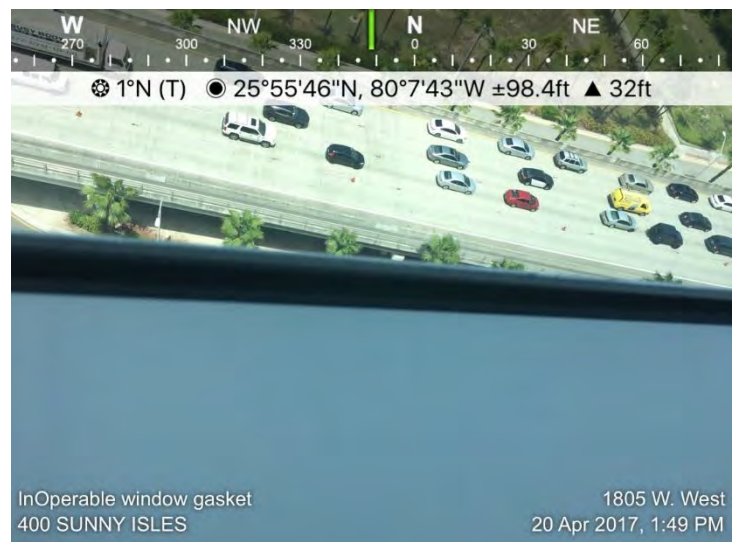
Figure 157

One of the window openings was inoperable.

The window installer should correct this condition.

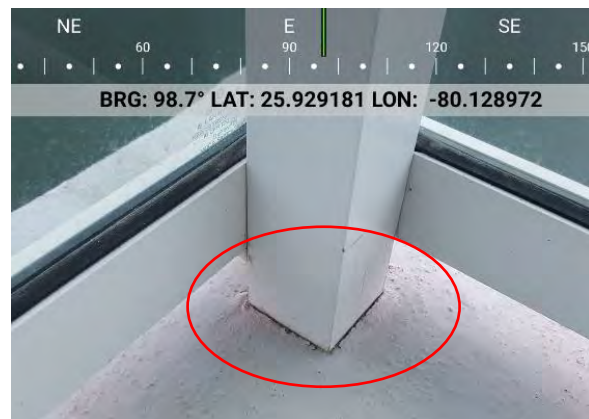
Figure 159

A gap between one of the railing posts and the balcony floor is allowing water to intrude and corrode the concrete rebar and the aluminum post support.

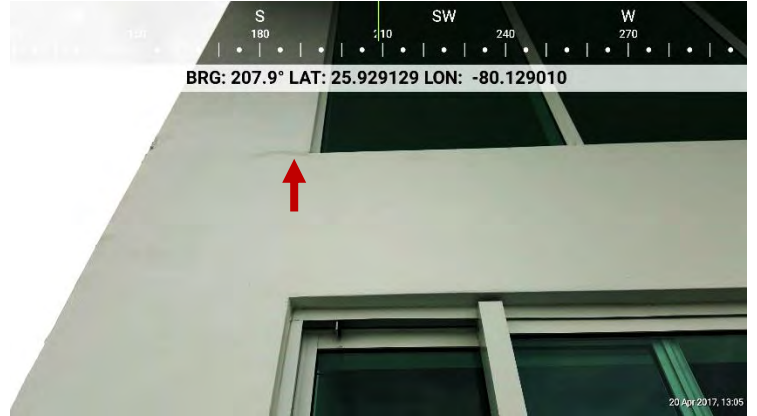
Figure 160

Exterior expansion joint near the window of the unit appears to have been patched.

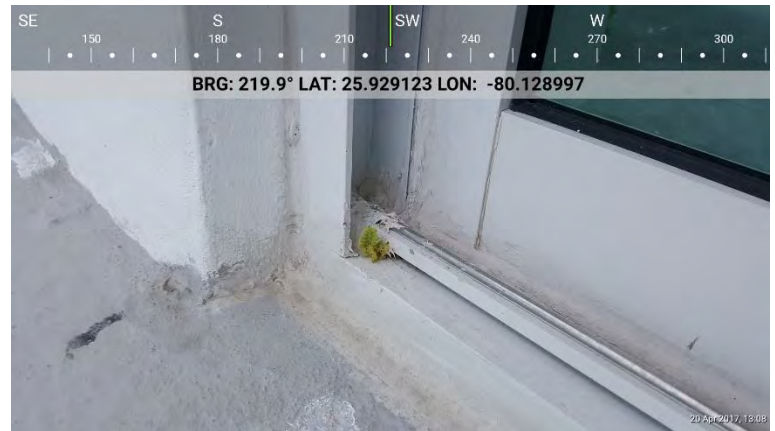
Figure 161

Water and organic material is able to intrude under the sliding glass door track, as evidence by this plant growing from underneath it.

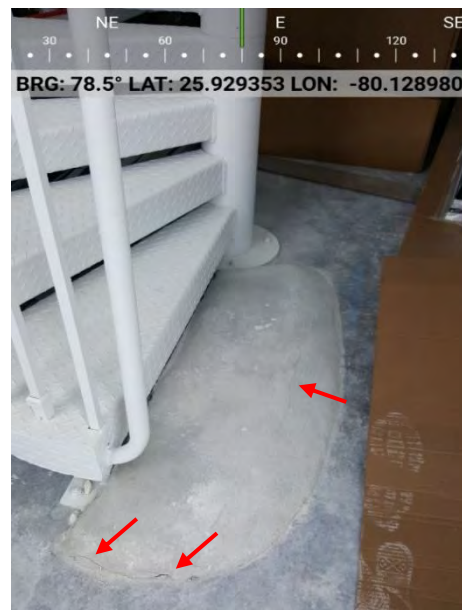
Figure 162

Large cracks were noticed in this temporary concrete step at the base of the spiral staircase. This is not considered a turnover issue as this was part of an ongoing interior upfit.

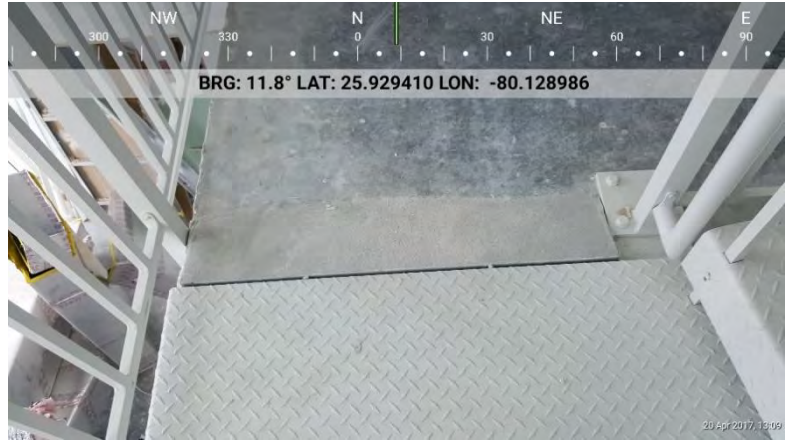
Figure 163

A significant gap was found between the concrete slab of the loft and the aluminum staircase landing. Verify this temporary condition has been corrected. Not considered a turnover issue.

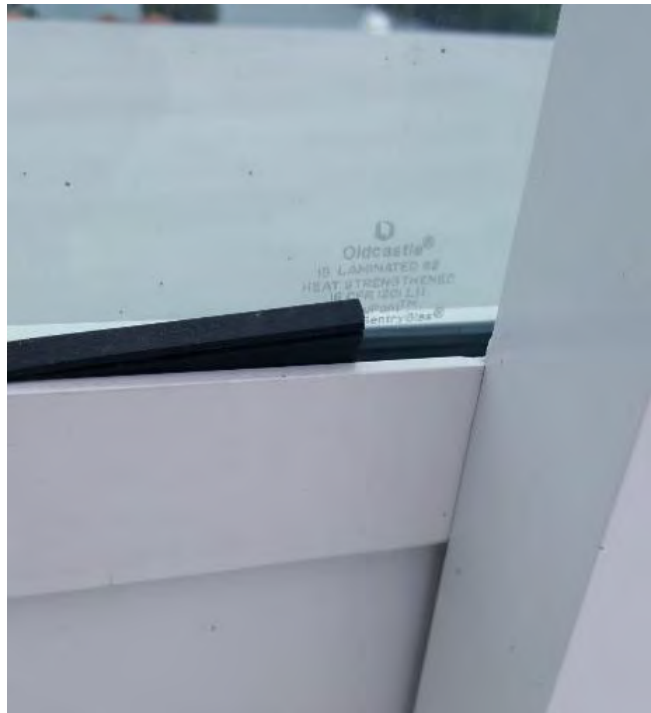
Figure 164

Rubber gaskets in the glass railing did not cover entire length, allowing for water intrusion and possible corrosion of the aluminum frame.

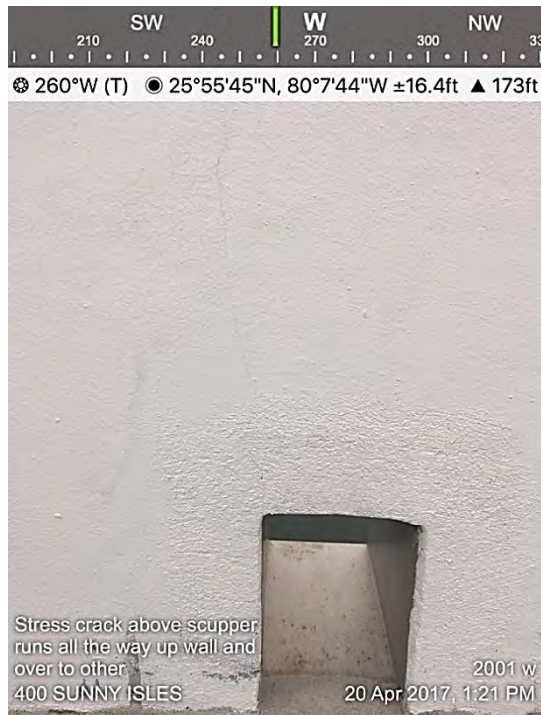
Figure 166

Stress cracks in the concrete walls of the roof patio were found. This crack runs all the way up the wall and over to the other side, originating from the scupper.

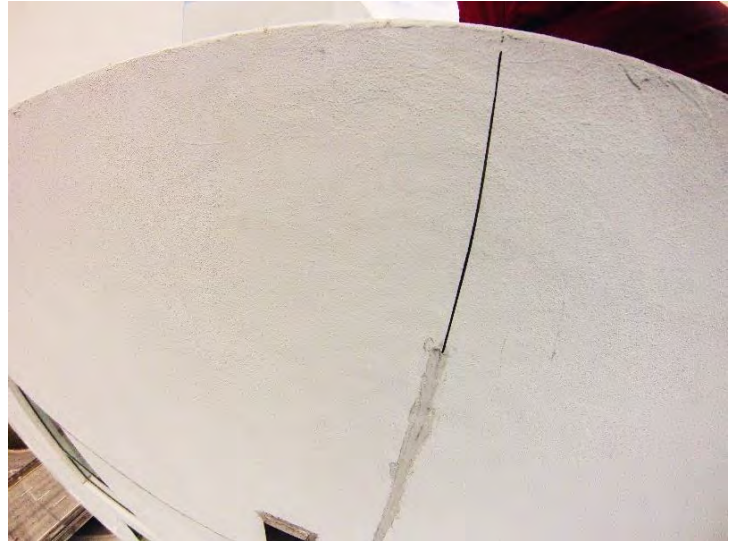
Figure 167

Gap between the two slabs of concrete forming the exterior wall on the roof was only partially patched.

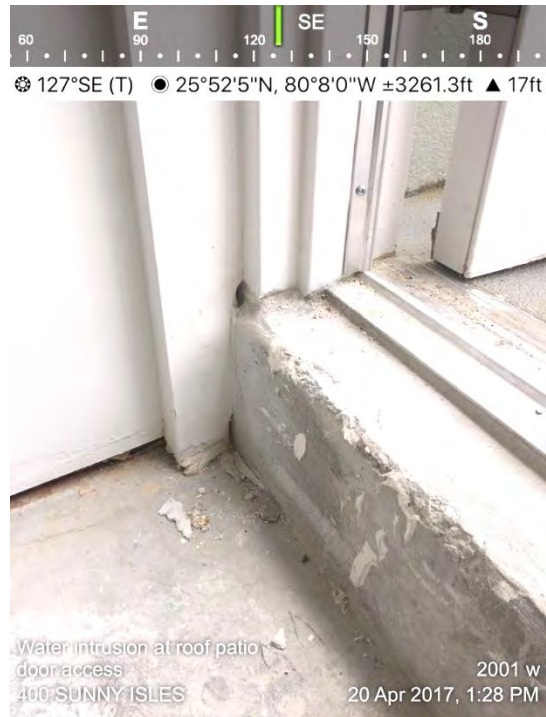
Figure 168

Water intrusion source was found in the doorway of the roof patio access door. Note the gaps between the walls/doorframe and the concrete. Rust was observed coming out of these areas.

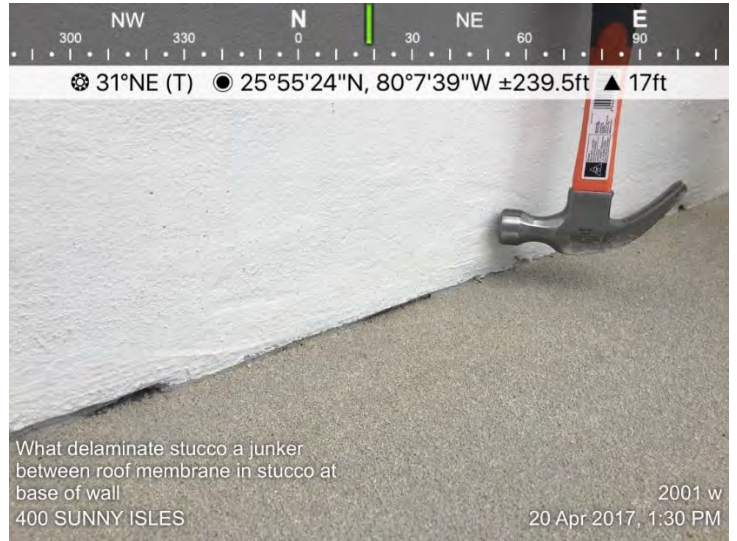
Figure 169

Gaps were observed and unbonded stucco was identified by sounding at the juncture of the stucco wall and the roof membrane.

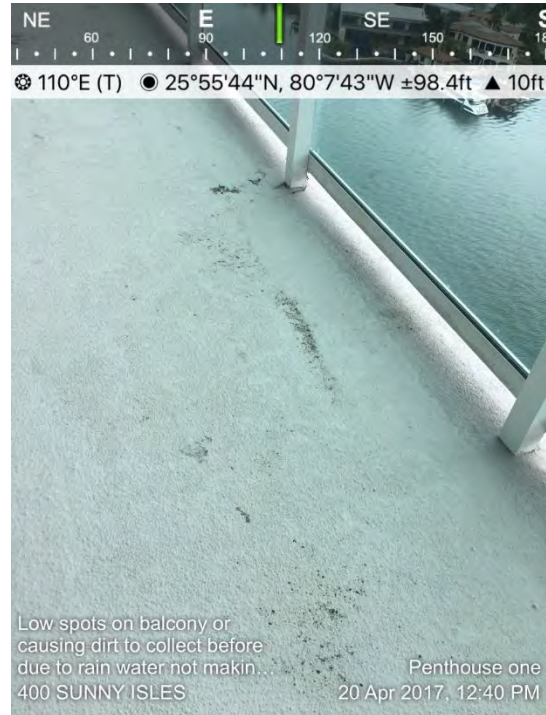
Figure 171

Dirt collecting on the balcony indicates rain water is not draining properly over the balcony edge. Darker areas also show evidence of ponding.

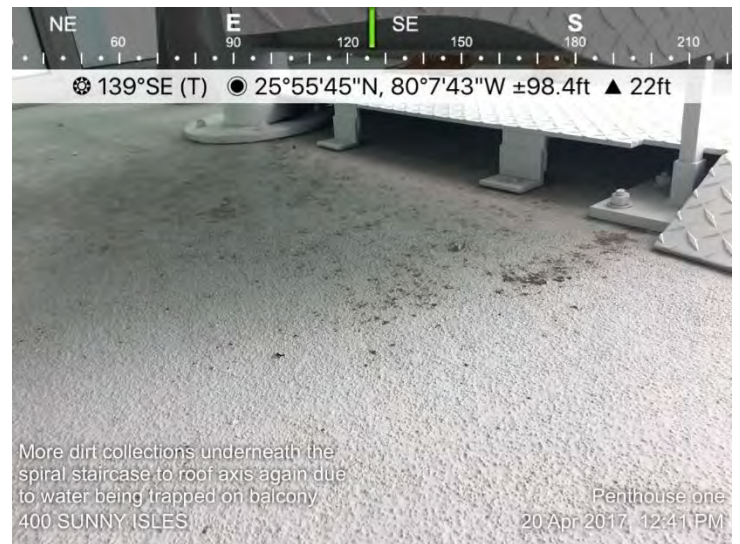
Figure 172

Another instance of dirt collection and water ponding, shown here at the base of the spiral staircase leading to the roof. Water is trapped in these areas and unable to drain. Bolted penetrations of the waterproofing membrane are a concern.

These areas should have bolts bedded in sealant and/or have a secondary waterproofing applied over the metal components.

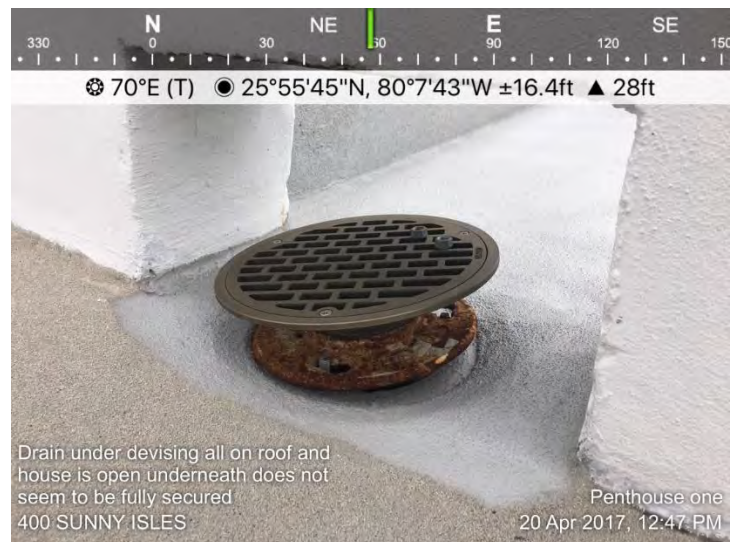
Figure 174

The drain under the dividing wall on the roof is not secured and easily removed. The drain itself is also rusting, most likely due to a dielectric union issue.

In addition, the Coordination Set plans do not reflect the drains being underneath the dividing walls. Instead, they are shown in the center of the terrace.

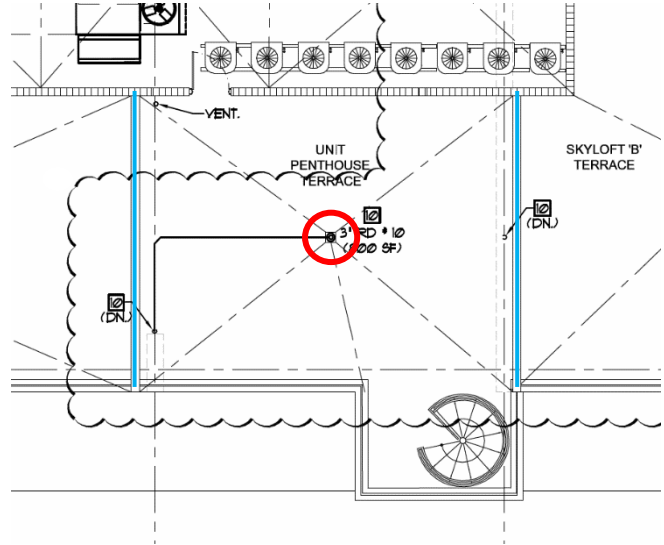
Figure 175

To the right are the plans for the drains on the penthouse terrace. The drain (circled in red) can clearly be seen in the center and not underneath either of the dividing walls (blue lines).

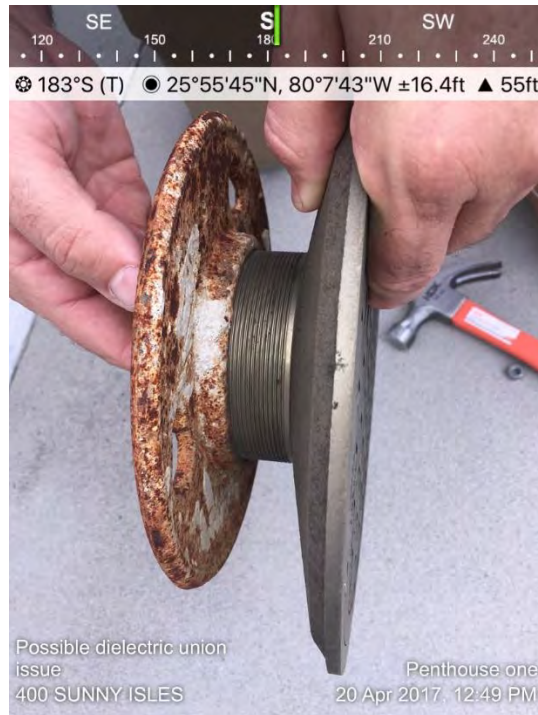
Figure 176

A close-up view of the drain above, after it was easily removed due to not being secured to the floor.

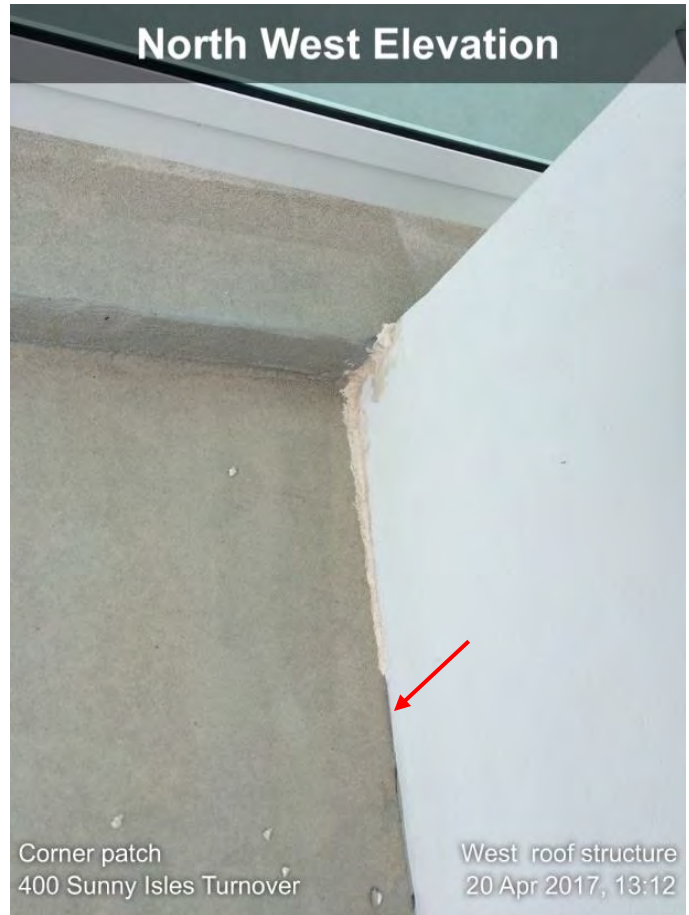
Figure 177

A corner of the dividing wall was patched but gaps can still be seen between the concrete slab and the wall.

Sealant is considered a temporary measure, not a permanent waterproofing. The waterproofing membrane on the terrace should turn up the wall 4 to 6 inches, and the wall finish should extend down over the upper boundary of the waterproofing.

The same principle should be applied at the curb detail.

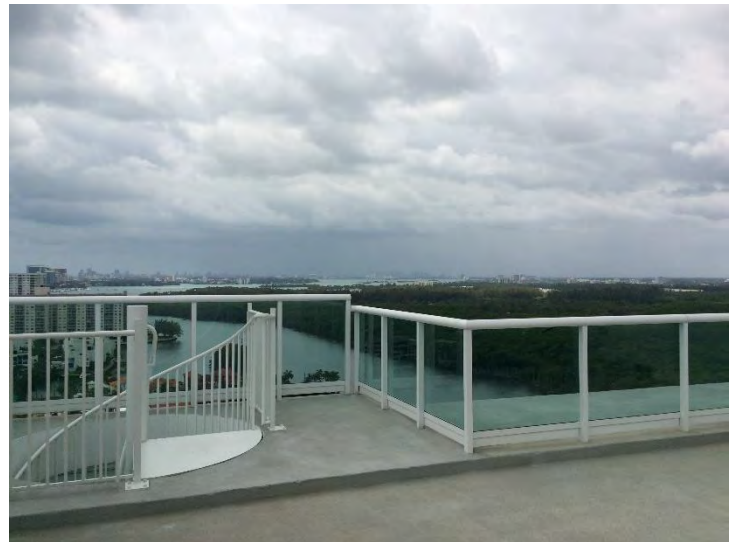
Figure 178

Glass railing on the roof patio is of different heights. All railing sections need to be checked to ensure they meet railing height requirements to prevent the error identified at the pool deck railing.

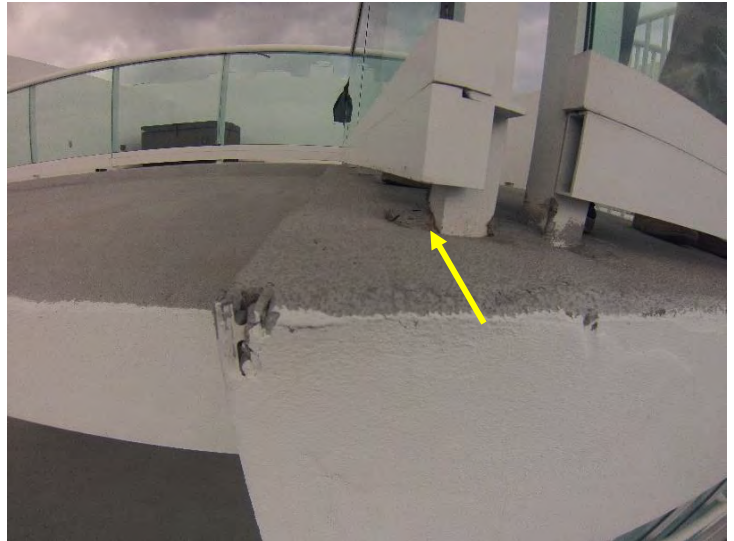
Figure 179

The corner of the railing shown above has recessed areas around the posts, allowing water to collect and stand in these areas. The corner of the building is also badly damaged, as holes can be seen, that will allow water to intrude into the concrete structure.

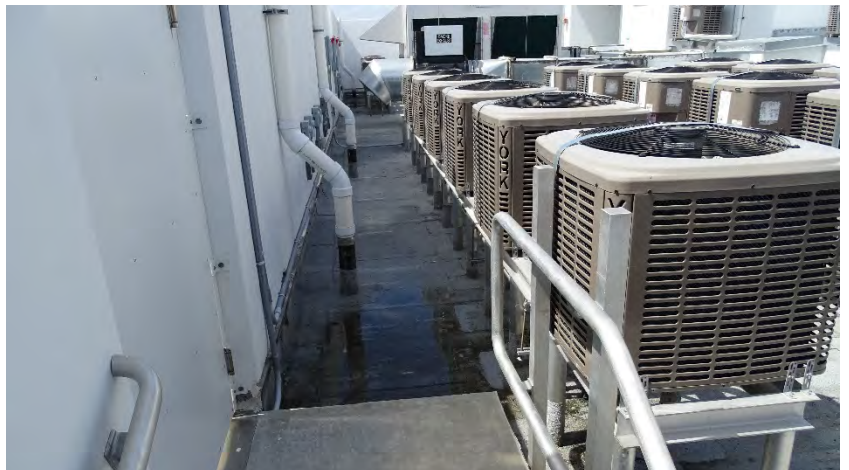
Figure 1

Standing water on roof membrane surface.

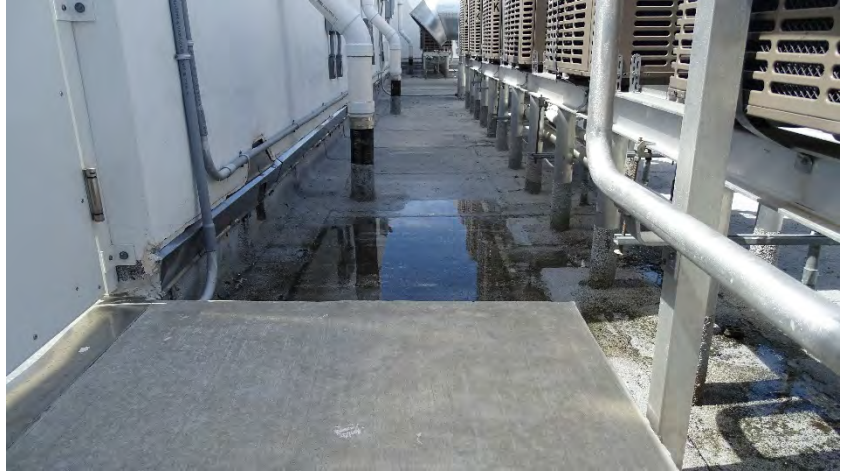
Figure 2

Standing water on roof membranes is non-conforming with FBC requirement of 1/4" per foot to drains.

The expected useful life of the roof system is expected to be significantly reduced when organic growth and standing water are present.

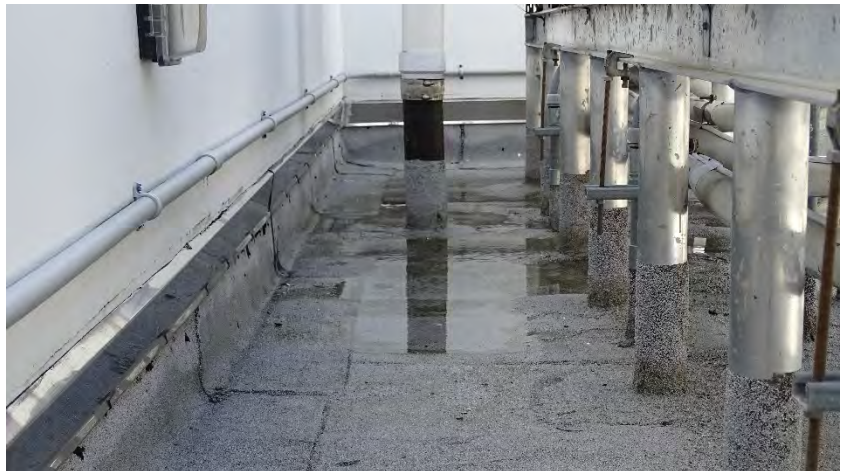
Figure 3

Standing water on roof membrane surface.

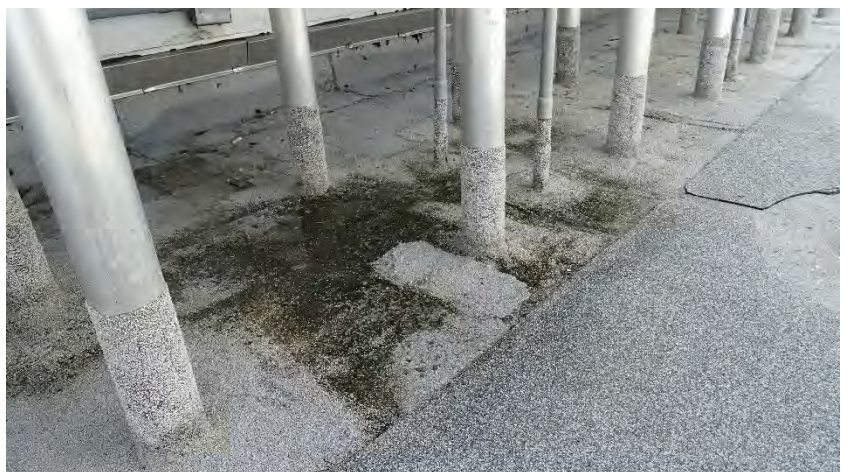
Figure 4

Organic Growth.

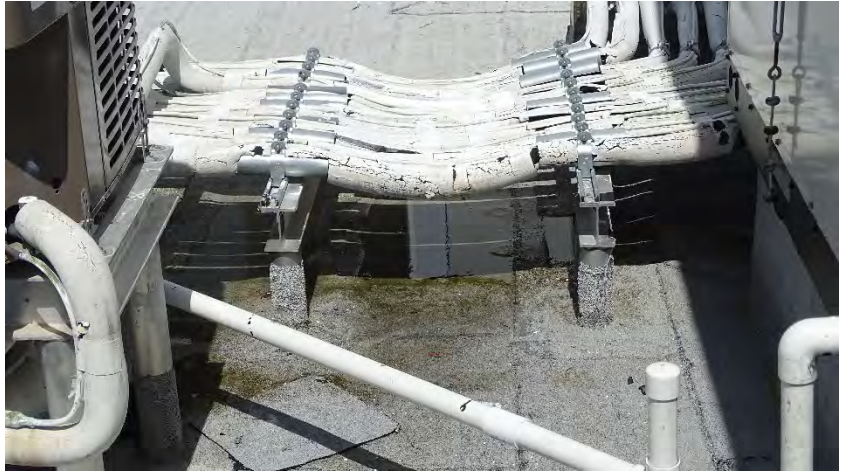
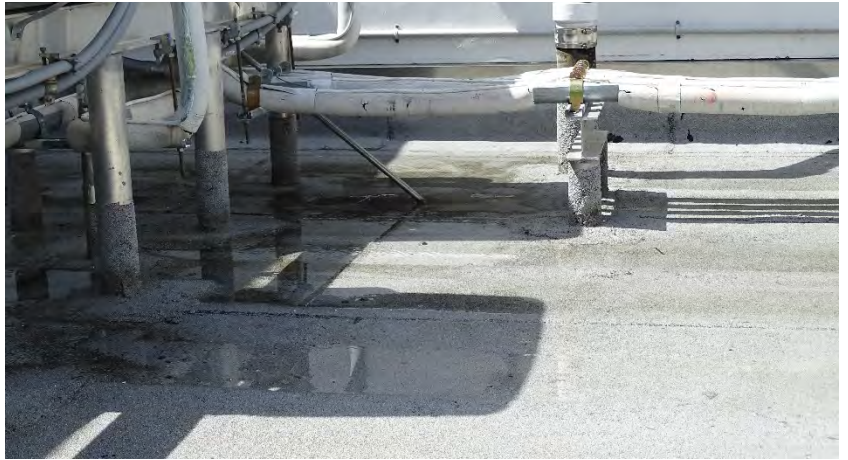
Standing water in shaded locations under pipes and mechanical equipment is particularly sensitive to organic growth development. (Figures 5 and 6)

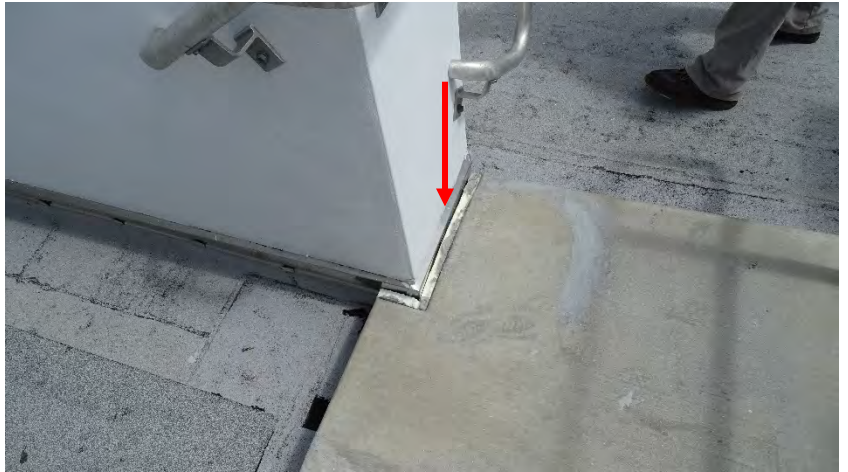
Figure 9

Incorrectly flashed gaps around concrete pads will allow water to enter and become entrapped within the assembly.

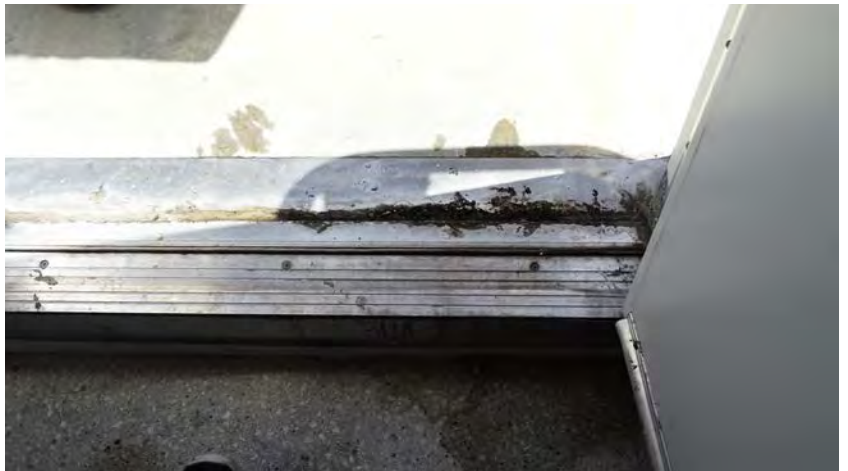
Figure 10

Organic growth in the door threshold is evidenced by the dense growth of organic material.

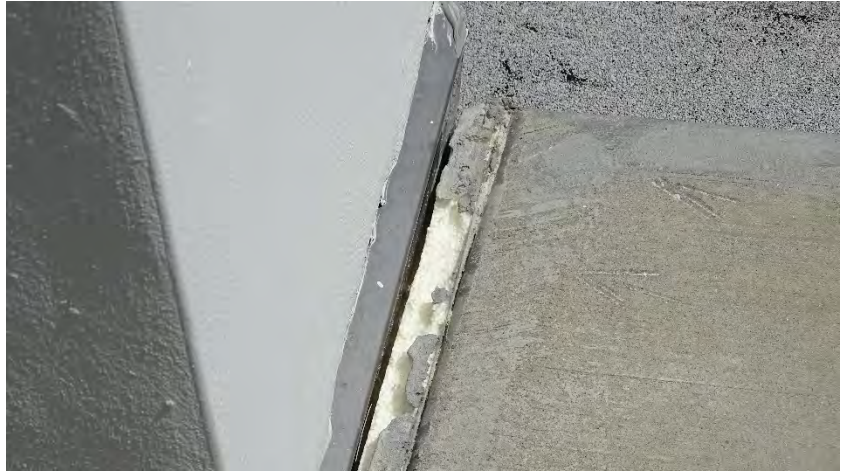
Figure 11

Polystyrene foam between the wall and concrete slab is not waterproof and will entrap moisture.

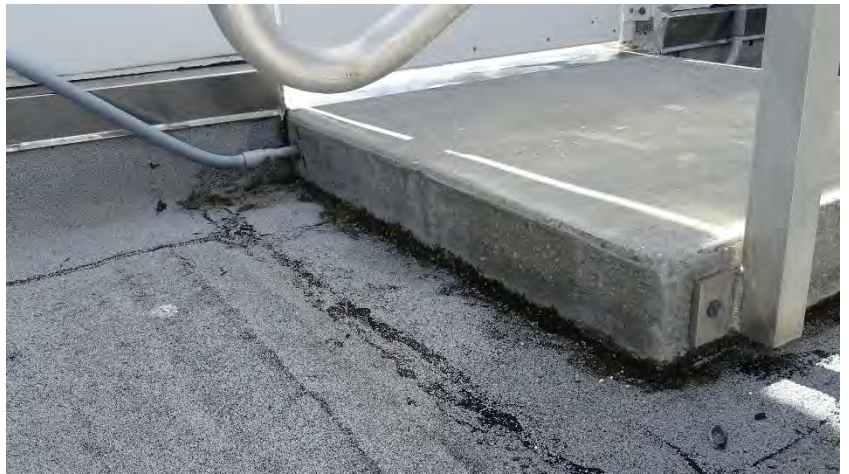
Figure 12

Moisture is evidenced by the organic growth at the bottom of concrete pad and roof membrane juncture.

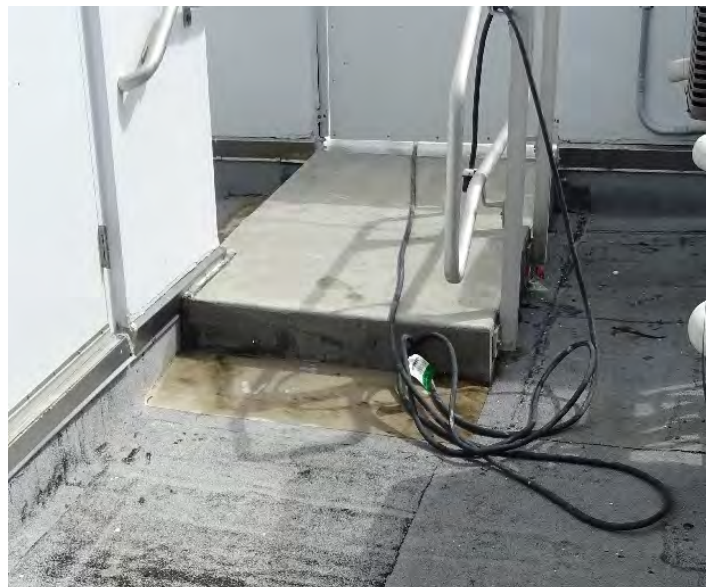
Figure 13

This concrete landing has a tapered concrete material on the roof membrane which will entrap water under it.

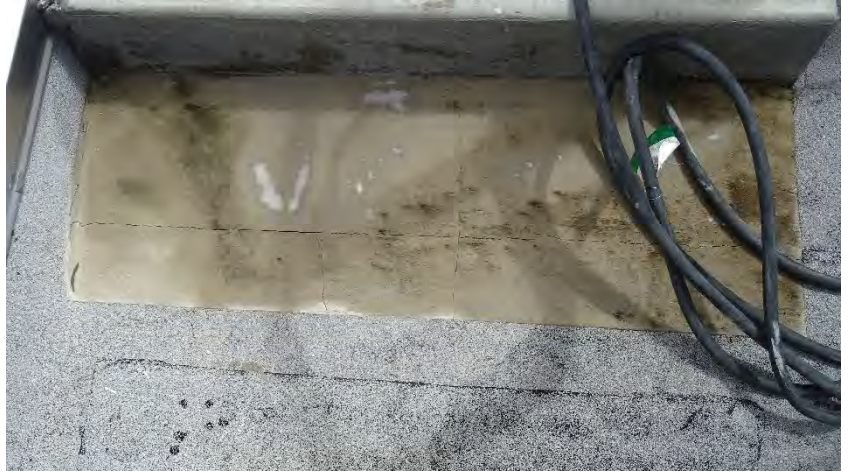
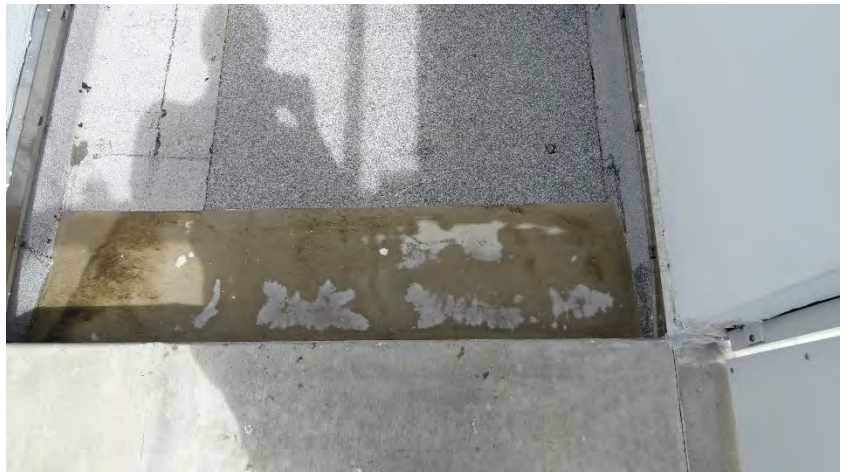
The tapered cementitious topping is seen to be cracking and maintaining a perpetually moist condition. (Figures 14 and 15)

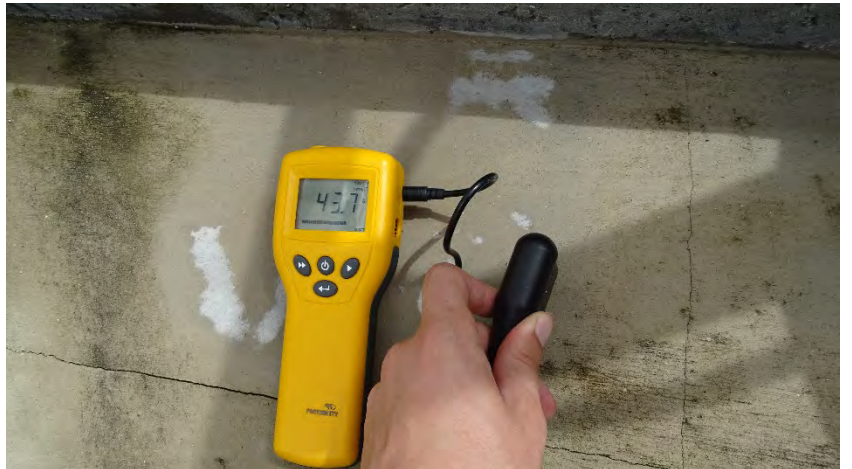
Figure 16

Moisture meter reading in this area were 4 times higher than the dry concrete areas adjacent.

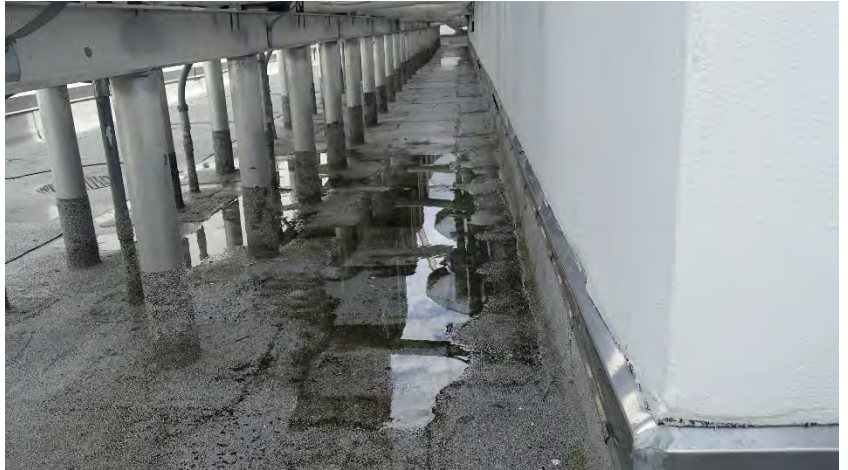
Figure 17

Standing water in shaded areas are detrimental to the roofing assembly.

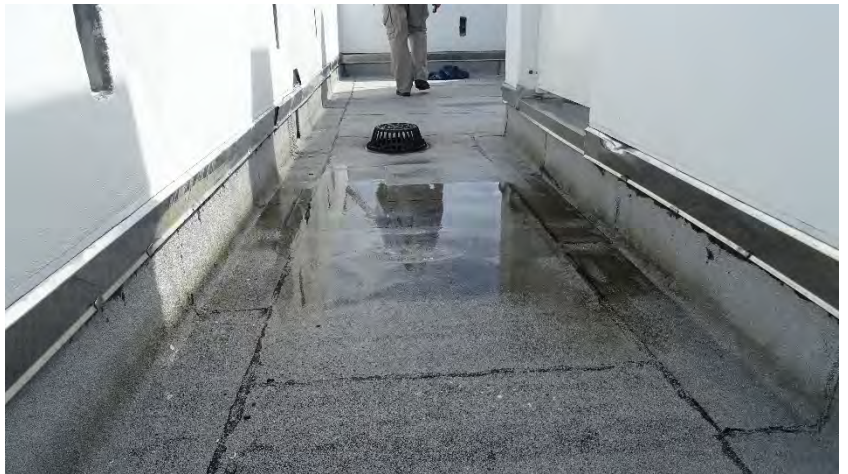
Figure 18

Incorrectly sloping roof surface.

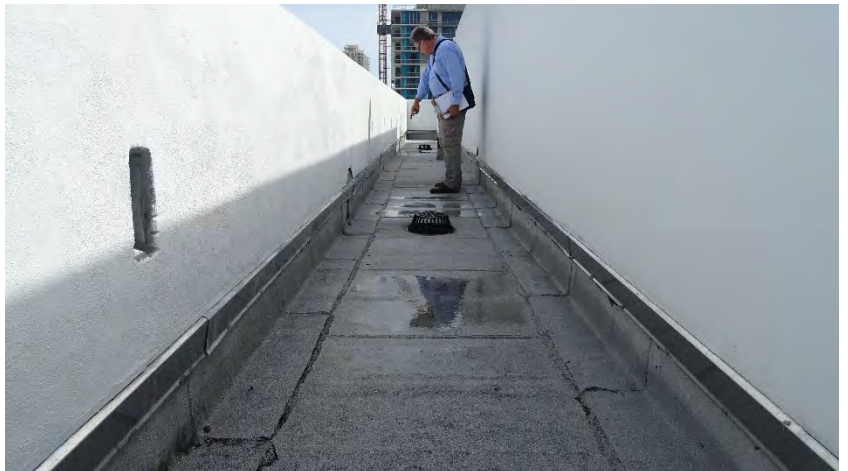
Figure 19

Incorrectly sloping roof surface.

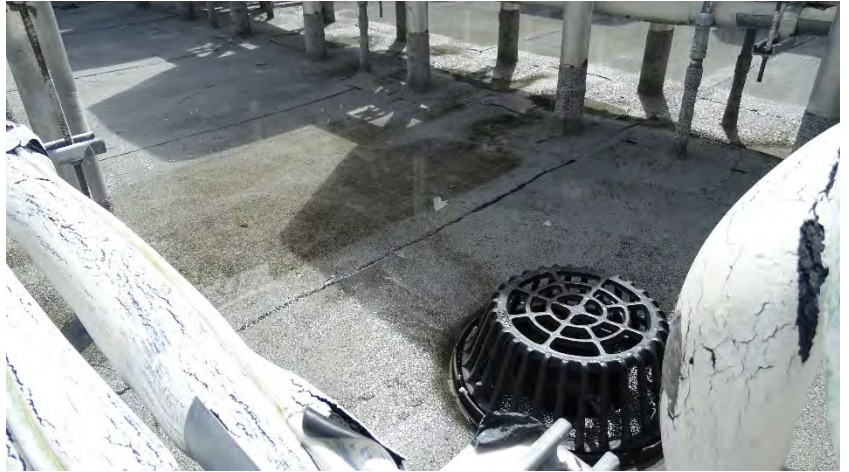
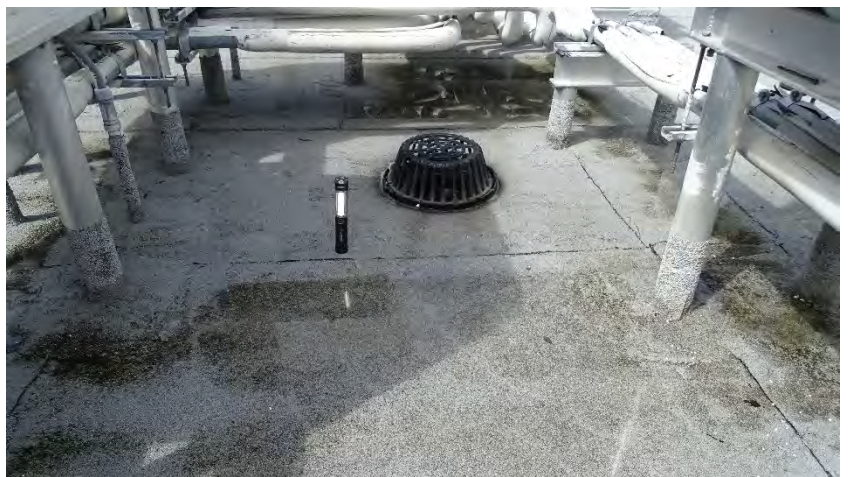
Incorrectly sloping roof surface.

Note also the continuation of the deterioration of the insulation placed on coolant lines. The white paint is applied here to prevent UV radiation. (Figures 20-22)

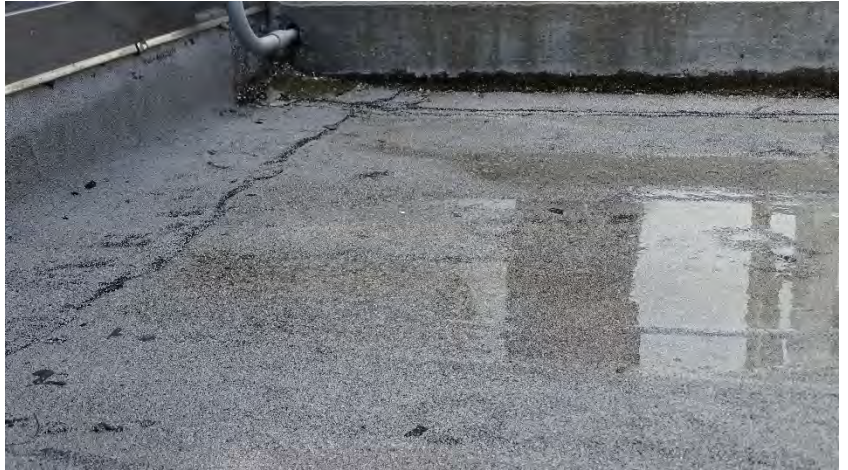
Figure 23

The concrete landing has a penetration about 3 inches above the membrane, which is subject to water intrusion. Note the organic growth at the bottom of the concrete pad.

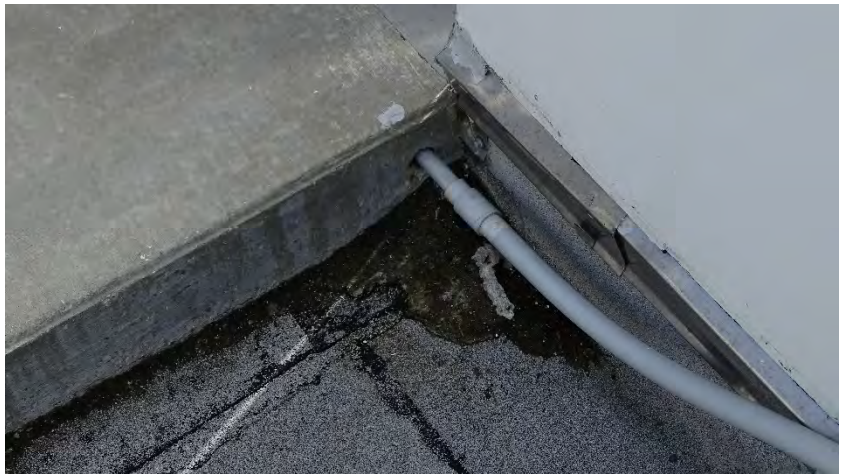
Figure 24

The similar condition observed from the opposite side.

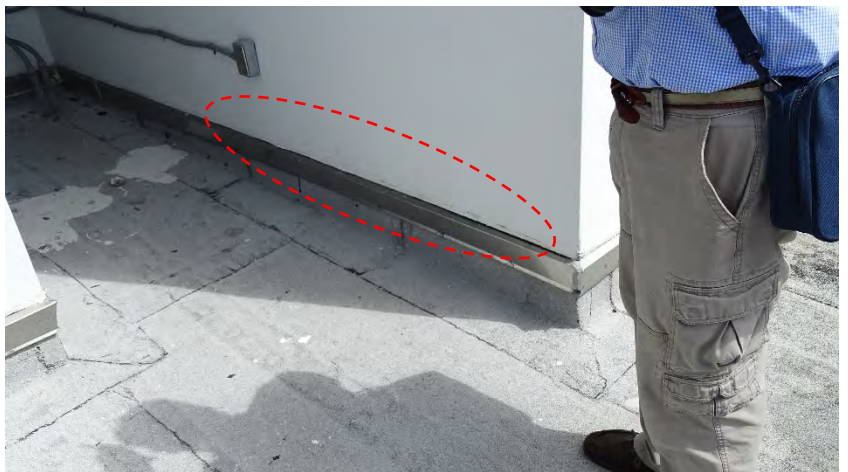
Figure 25

The white stucco wall is the exterior wall area which is experiencing water intrusion within the East building (core 4) electrical room. Within the electrical room water has routinely been accumulating on the floor.

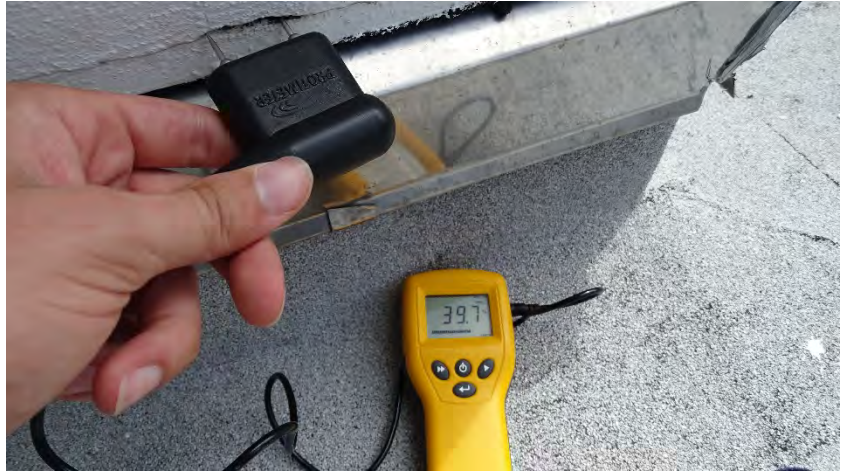
Figure 26

The stucco area just above the metal counter-flashing had a moisture meter reading four times higher than the typical condition.

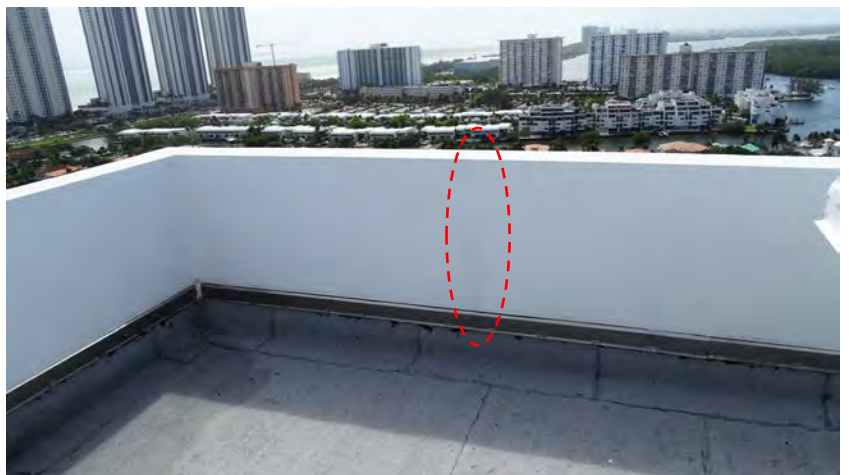
Figure 27

The stucco roof parapet was cracked at the top, interior stucco face and at the exterior stucco face. This would be susceptible to moisture intrusion, particularly at the flat upper surface where precipitation can accumulate.

This area is immediately above the electrical room with the water intrusion issue.

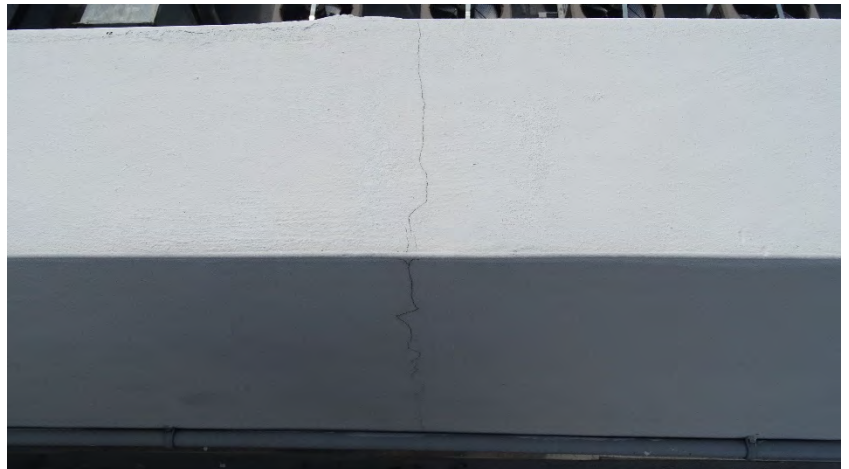
Figure 28

Top view of stucco parapet crack.

This area is immediately above the electrical room with the water intrusion issue.

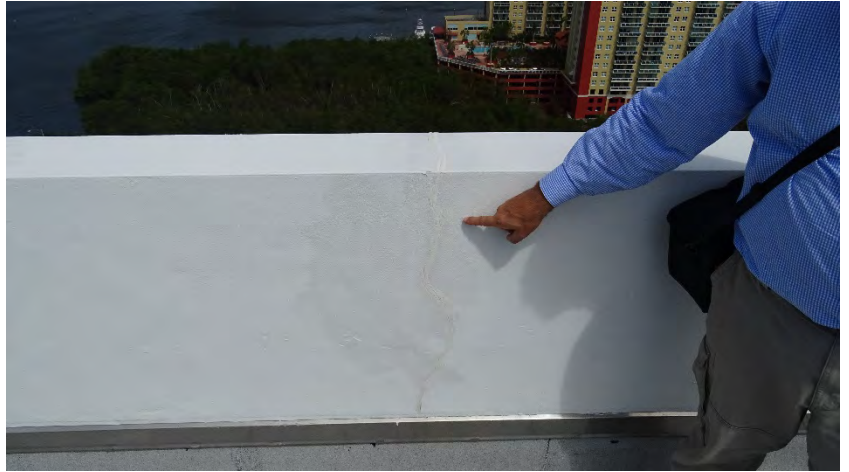
Figure 29

The opposite side of the small roof has a similar parapet crack (top, interior face, exterior face) which is also located above the electrical room where the water intrusion occurs.

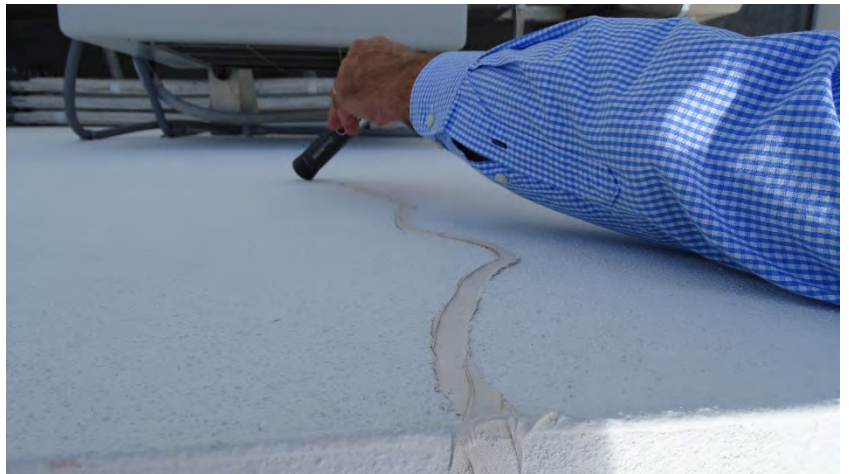
Figure 30

This view shows the top and exterior face of the wall. Again this is also located above the electrical room with the water accumulation on the floor.

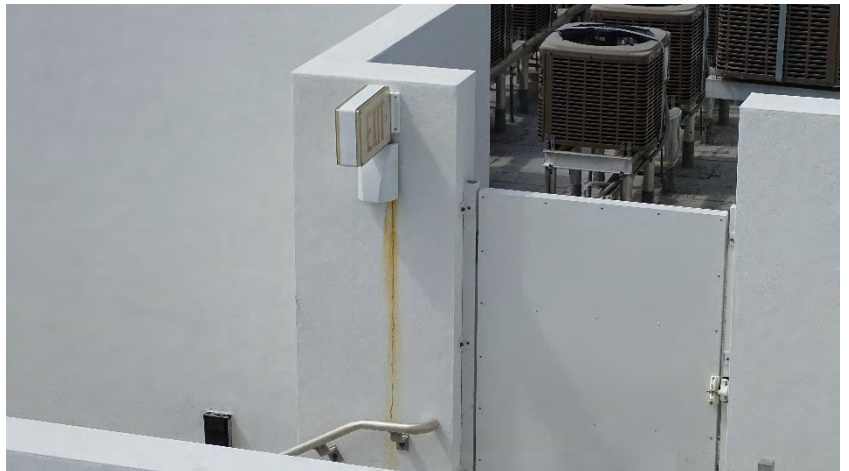
Figure 31

Heavy rust staining was observed just below the exit sign mounted beside the exit door at the top of the stair. The rust is likely due to the installation of a metal fixture that is not appropriate for use in an exterior marine environment. This presents an unreasonable maintenance problem.

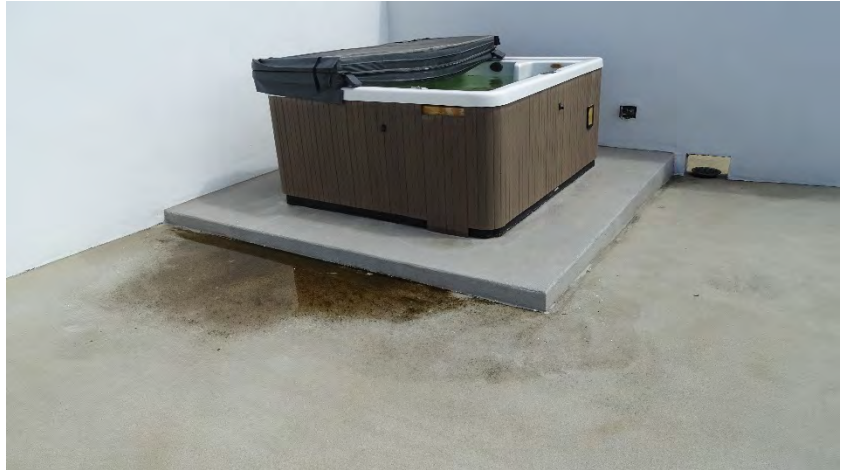
Figure 32

The photo at right is a inadequately sloped roof made more acute by the addition of a secondary slab that dams the moisture as well.
