CASE NO.: 2020-024374-CA-01

**NOTICE OF FILING**  
**EXHIBITS “A” THROUGH “E” OF COMPLAINT**

***Re: 400 Sunny Isles Condominium East Association, Inc.  
Section 558.04, Florida Statutes, Notice of Claim of Construction Defects***

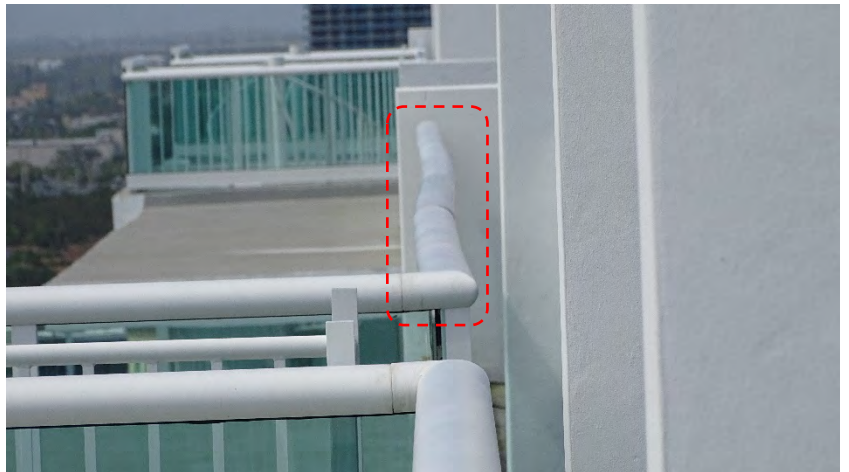
Figure 33

Loose railing was found in the east building roof top terraces which had deflected beyond the code permitted distance and which were no longer fixed at the railing-post to deck juncture.

This condition is considered a life safety concern which should be reconstructed as soon as possible.

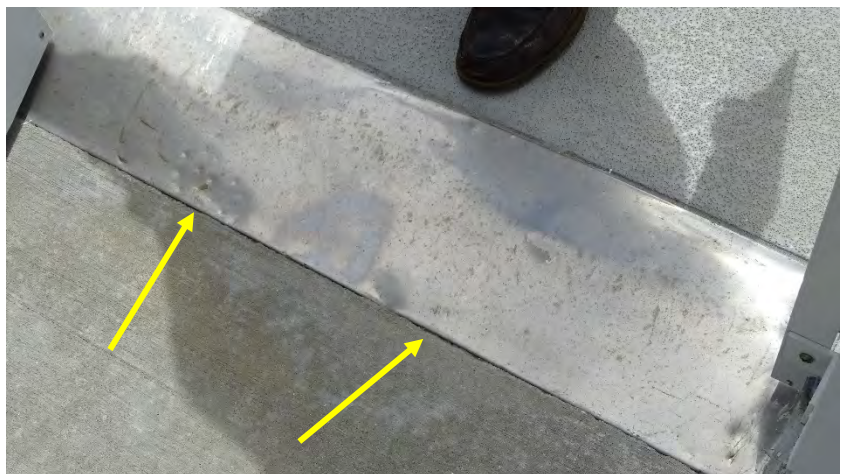
Figure 34

The door thresholds at the wall juncture between the terrace side and the mechanical side, are open to water penetration at the un-waterproofed juncture.

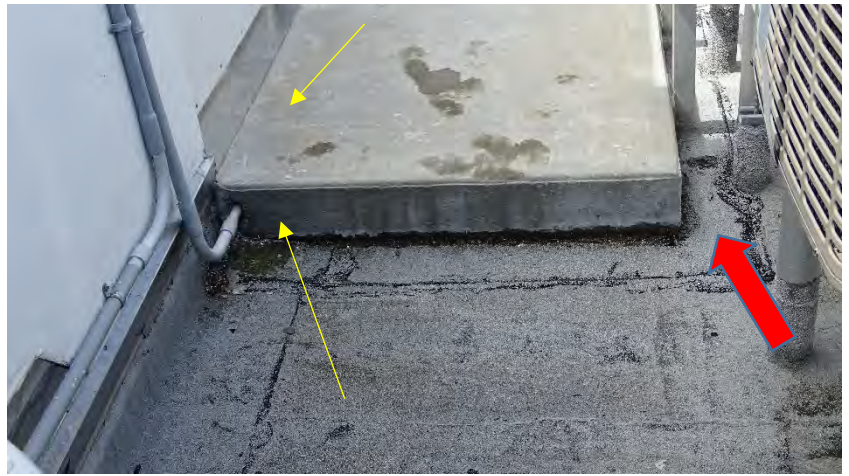
Figure 35

The wider view of the concrete pad at the door (pictured above) shows the result of the concrete surface that is subject to water absorption, along with the two arrows pointing out additional moisture entry locations. The heavy moisture laden zone at the bottom of the concrete pad, where the organic growth developed at the juncture with the roof membrane.

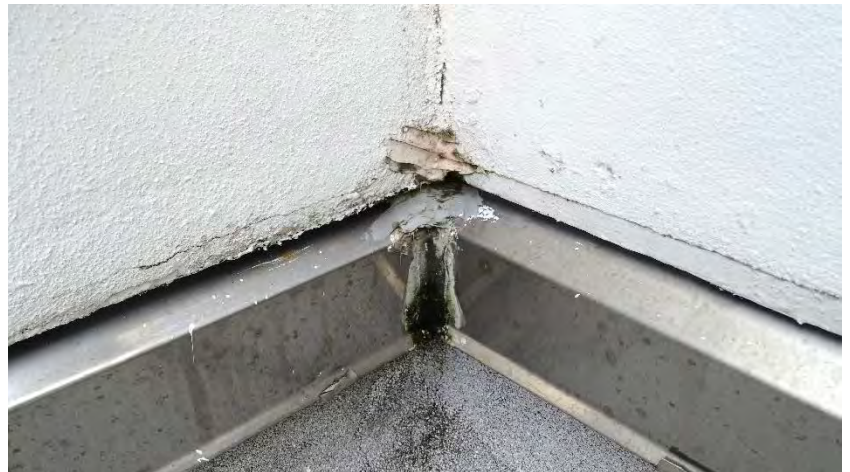
Figure 36

The corner detail of metal counter-flashing between the roof assembly and the stucco cladding appeared to have developed a substantial organic growth in the corner. The topical application of sealant on a condition where moisture is present is considered counterproductive.

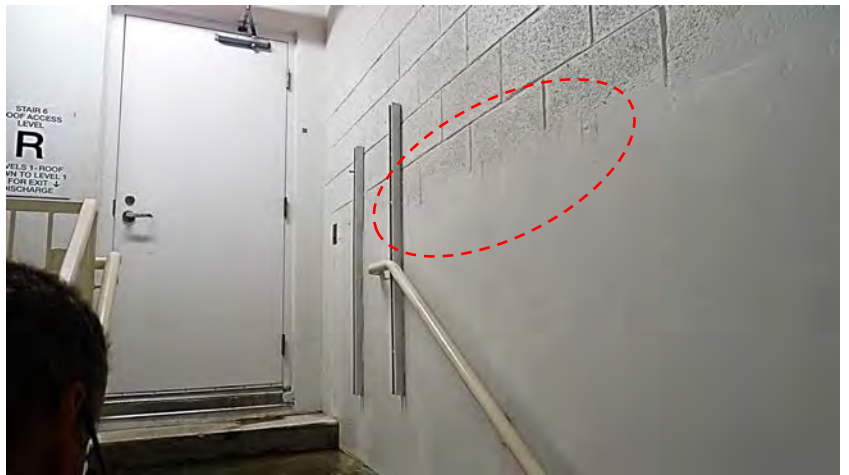
Figure 39

Water intrusion was occurring at the juncture of the block stairwell wall with the cast in place wall below.

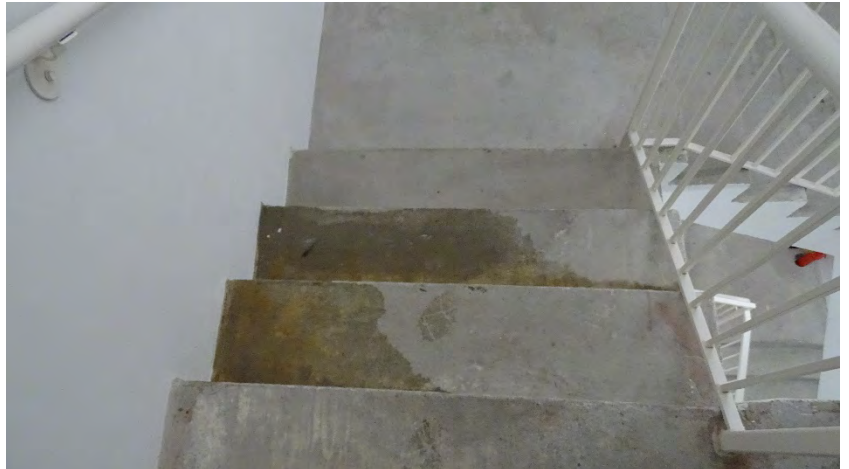
Figure 40

Below this wall area, water accumulation on the stair treads was observed.

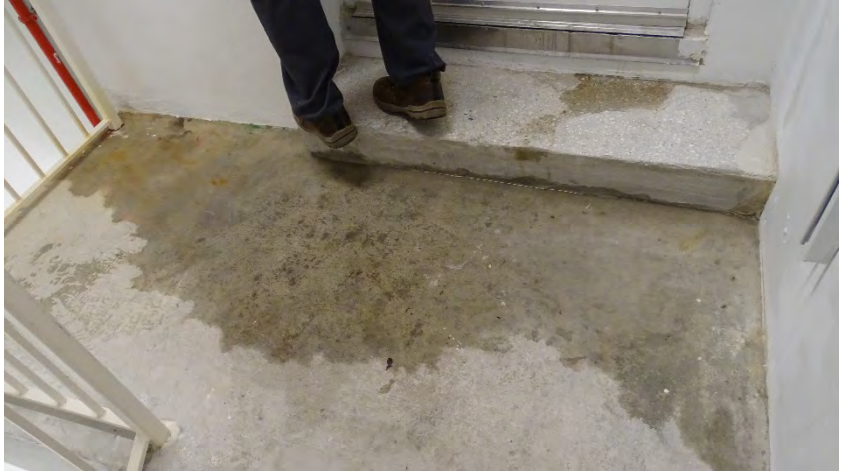
Figure 41

Landing was also subjected to moisture entry under the roof access door threshold.

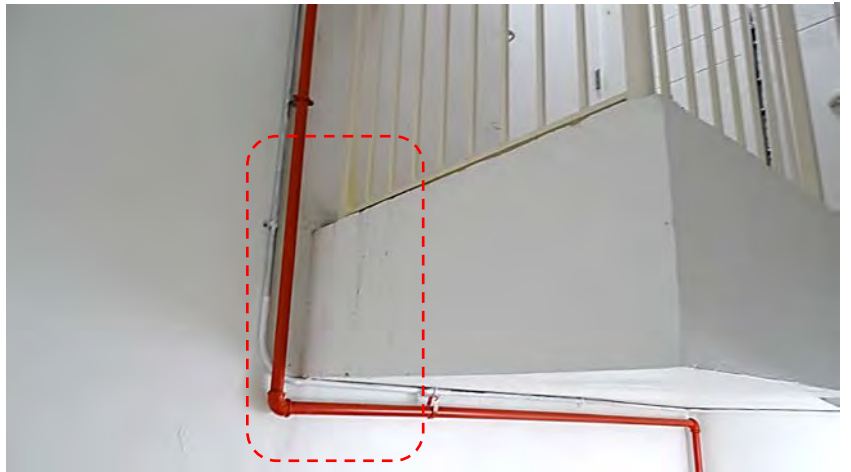
Figure 42

Water was progressing down the side of the upper stair landing structure.

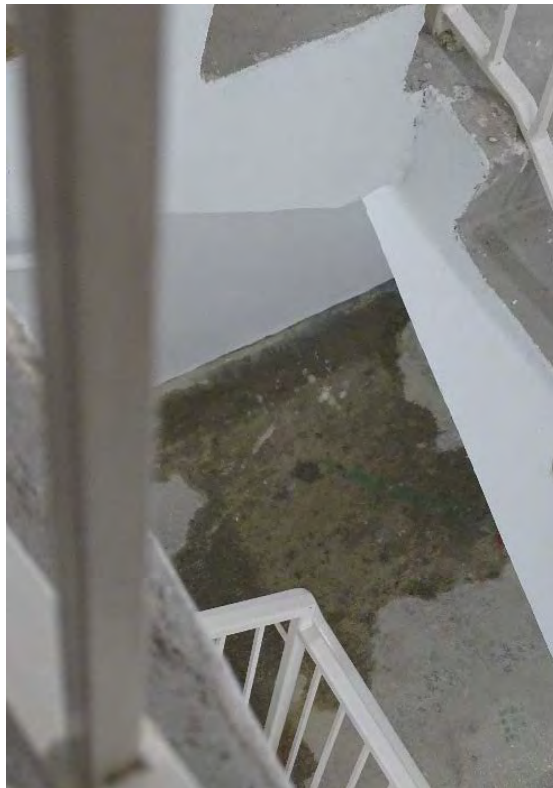
Figure 43

Water was flowing to lower level landings.

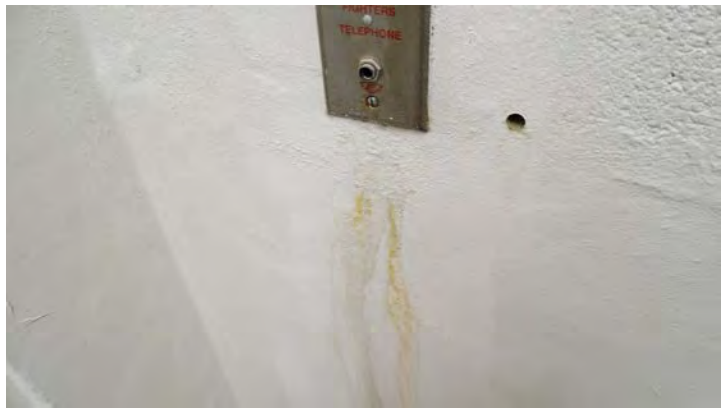
Figure 44

Water was entering through the wall penetration associated with the emergency phone plate at the upper stair area.

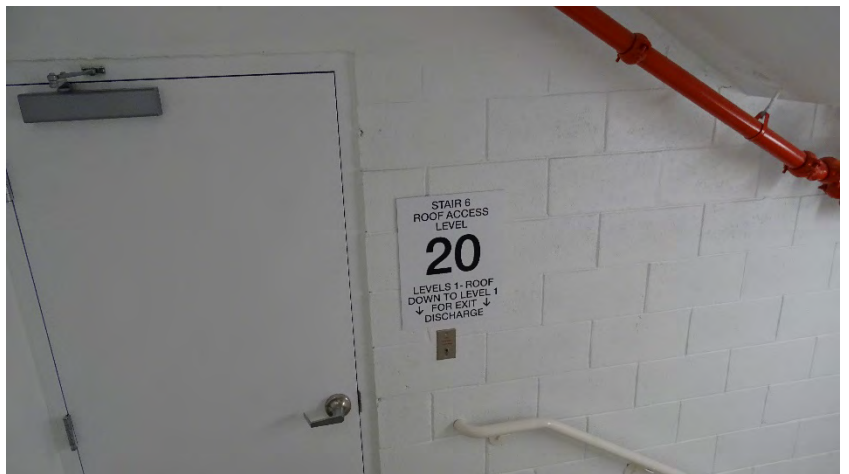
Figure 45

Water was entering near the hinge side of the door.

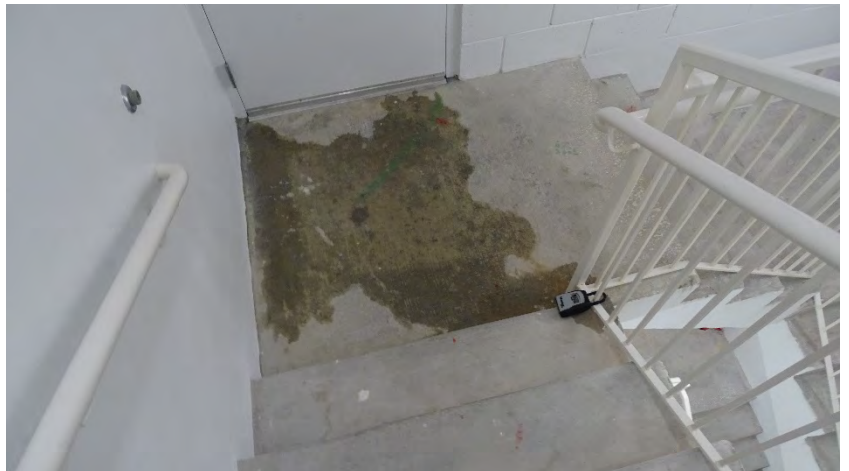
Figure 46

View of the landing at the 20<sup>th</sup> floor where water was accumulating.

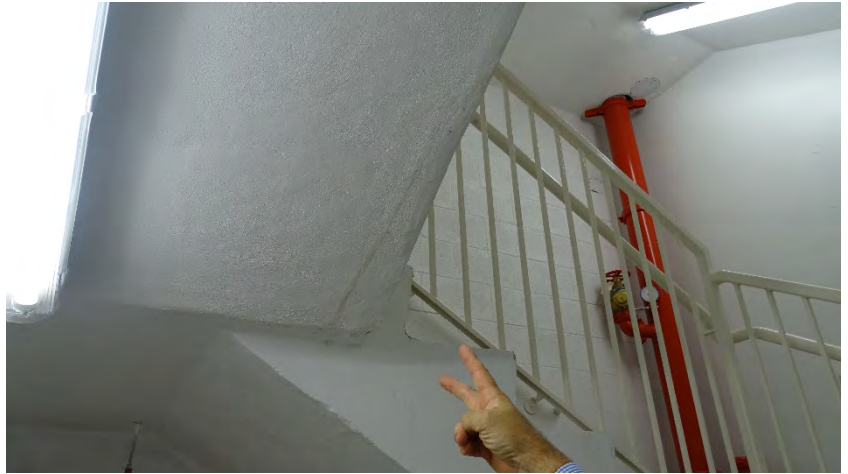
Figure 47

Water was running under the stair structure and flowing to lower levels.

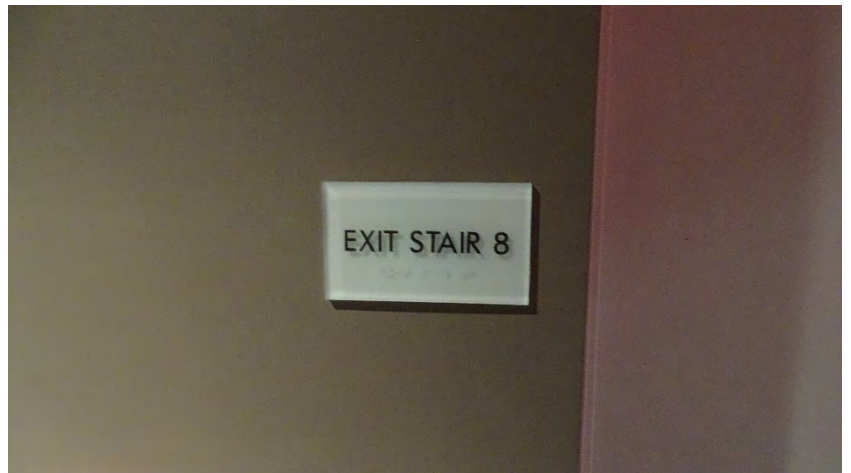
Figure 48

The east building 7<sup>th</sup> floor was accessed and was immediately found to have a musty odor. Further investigation discovered the west end of the corridor was flooded with standing water above the carpet.

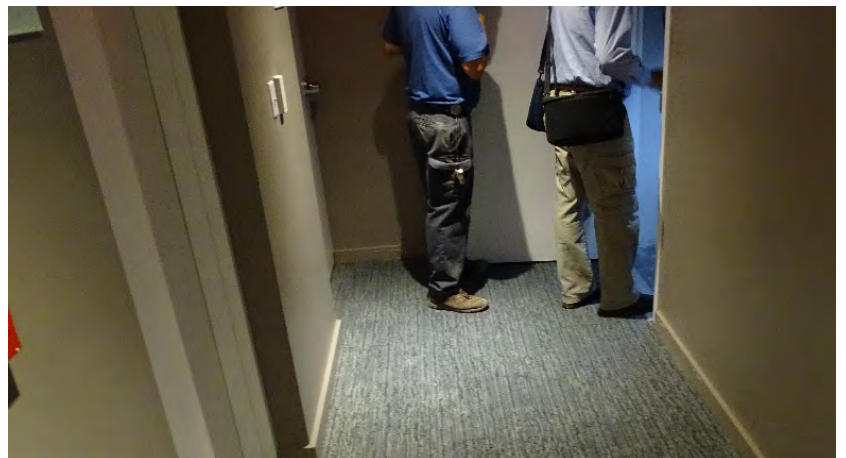
Figure 49

The source of the water intrusion was found to be the mechanical room where the air handler was not provided with a condensation pan.

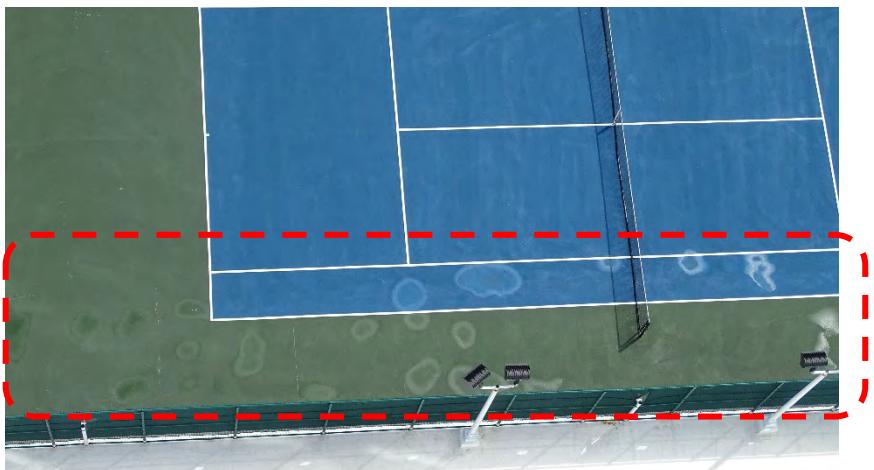
Figure 52

Large number of ponded areas is generally not desirable on roof assemblies.

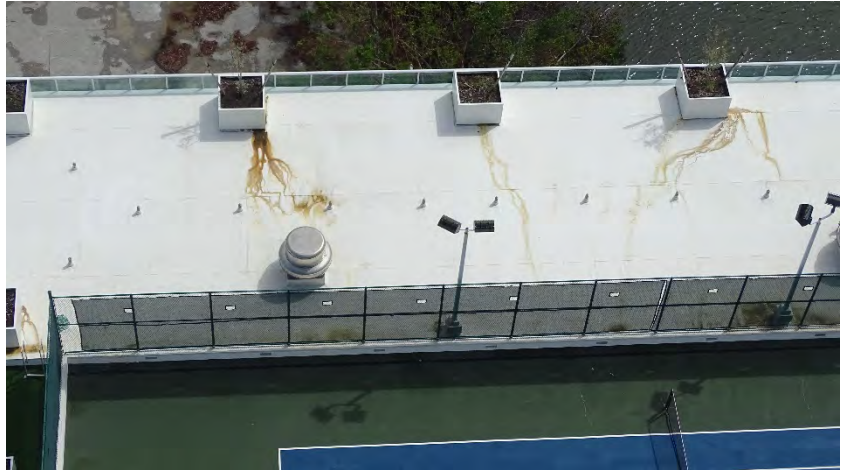
Figure 53

Iron oxide or other chemicals carried in water draining from the planters on the roof will have acidic pH and could expose the polymer roof membrane. Other problems related to chemical exposure could also occur.

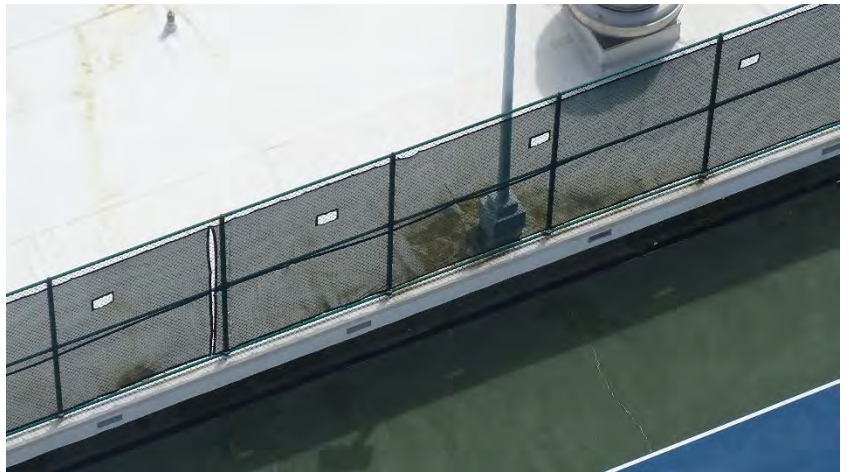
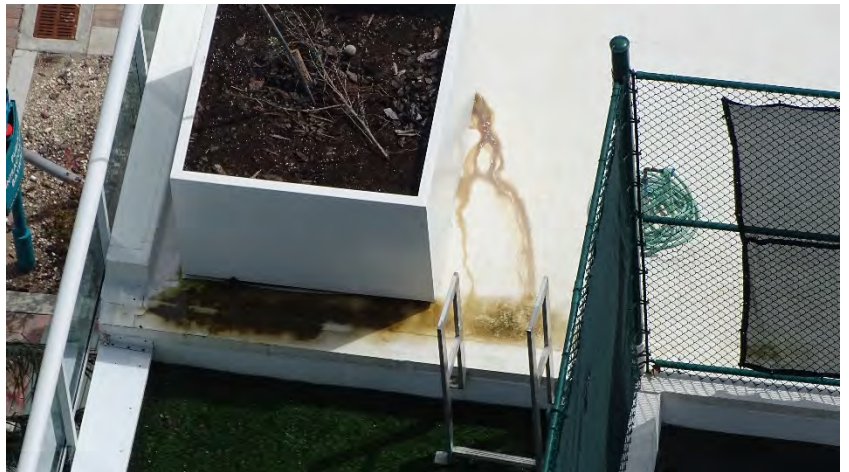
Moisture running downhill to the west, eventually dams along the knee wall under the fence. This standing water is subject to organic growth and the associated deterioration affects. (Figures 54 and 55)

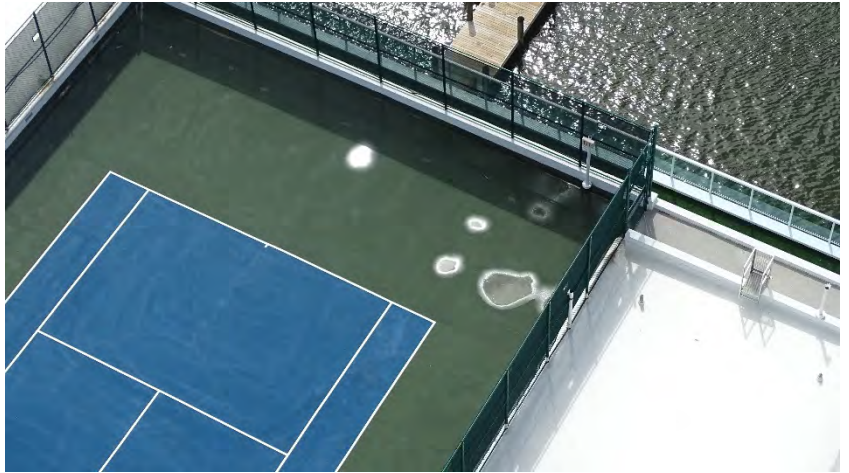
Figure 56

Pooled water on the otherwise hot tennis court surface are visible and considered a concern in terms of the effective useful life of the roof membrane.

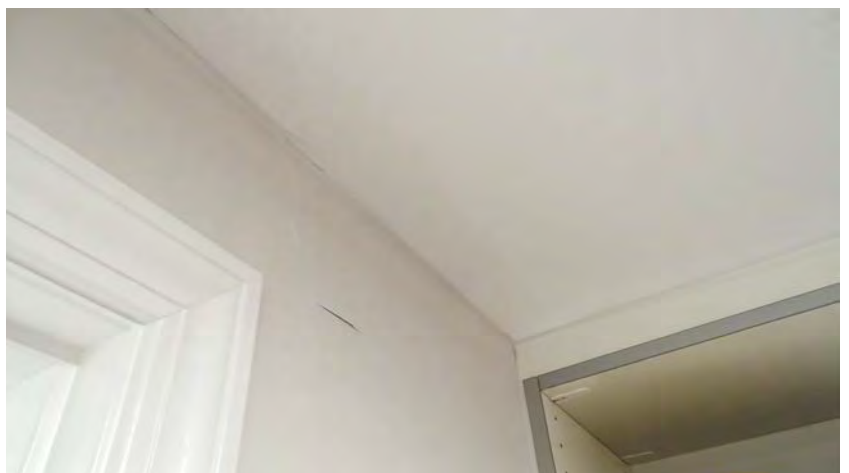
Figure 58

Water damage was noted, but the areas has not been wetted by precipitation events since Irma.

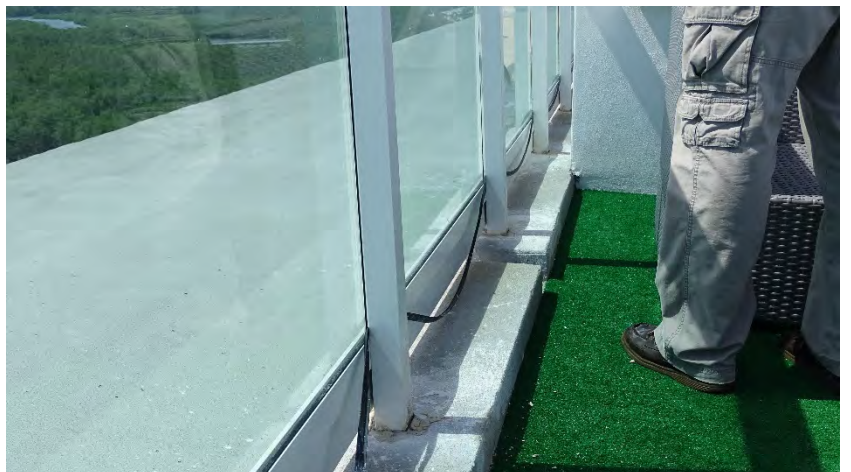
Figure 67

The east building roof level terraces along the south façade are provided with glass and aluminum railings that have become loose. The problems with the railings having become severely loose were reported after hurricane Irma.

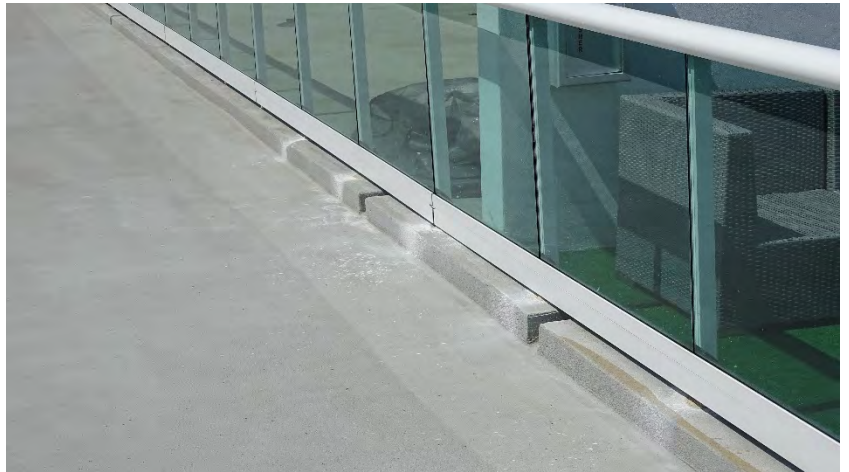
Figure 68

It was observed that light grey powdery residue was found around the railing post pockets where the loose conditions occurred.

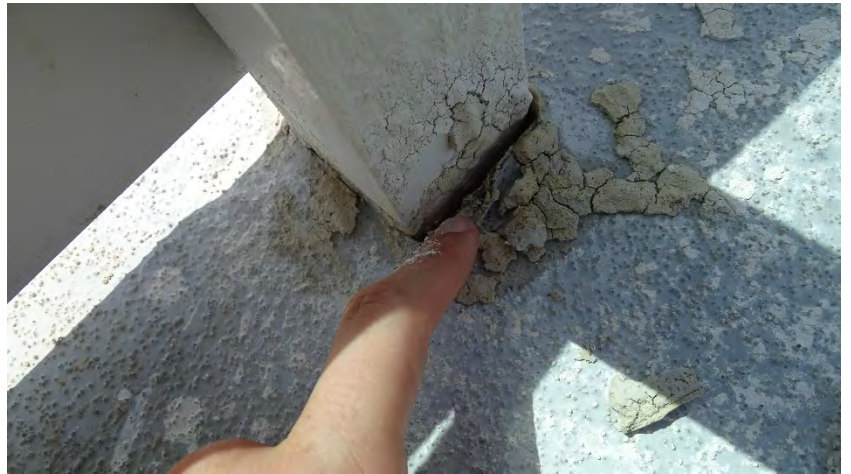
Figure 69

Large gaps between the railing posts and the surrounding pockets resulted in loss of adhesion at the base.

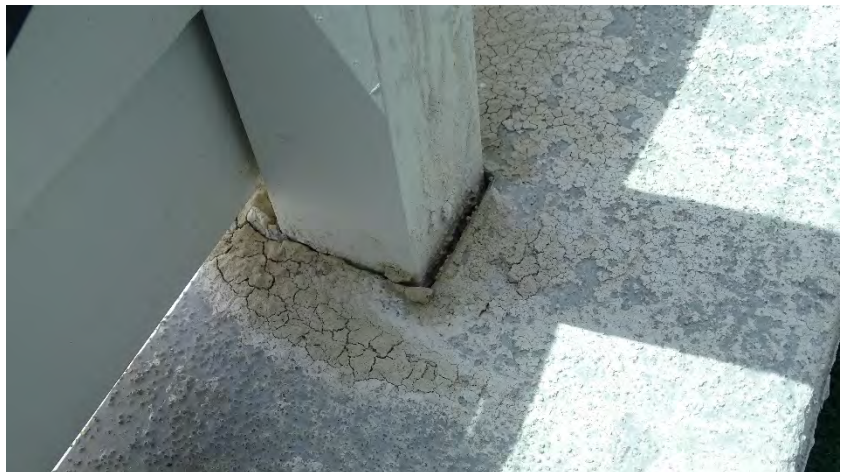
Figure 70

The railing post grout material had failed to set correctly. It seems quite possible that sand or other inappropriate material (other than the proper high strength/low shrinkage grout) had been placed in the railing post pockets.

It is recommended that additional destructive investigation should be performed by the Association's engineer. The defect here should be identified with material testing and dissection of the condition. This is important so that other railing post conditions can be compared and inspected after the failure mechanism is well understood.

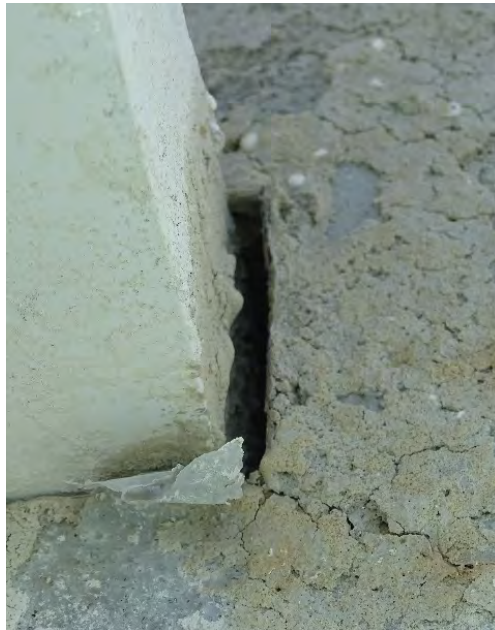
Figure 72

The installed condition fails to prevent FBC requirements for lateral deflection of the railing, and more importantly, fails to provide adhesion of the railing post within the concrete base.

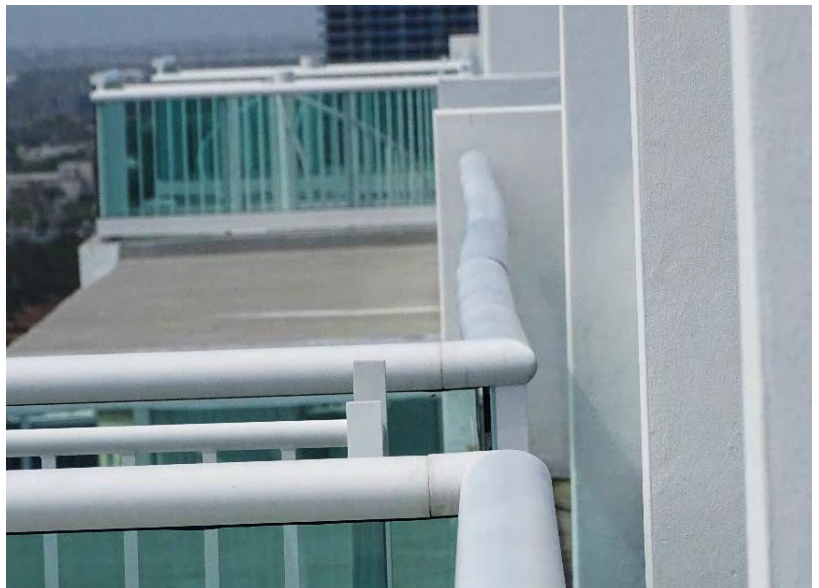
Figure 73

The photo at right documents the misalignment of the loose railing. This is considered a serious structural and life safety concern. The condition should be destructively investigated, samples collected, and a test protocol developed to test all the railing posts in the entire building.

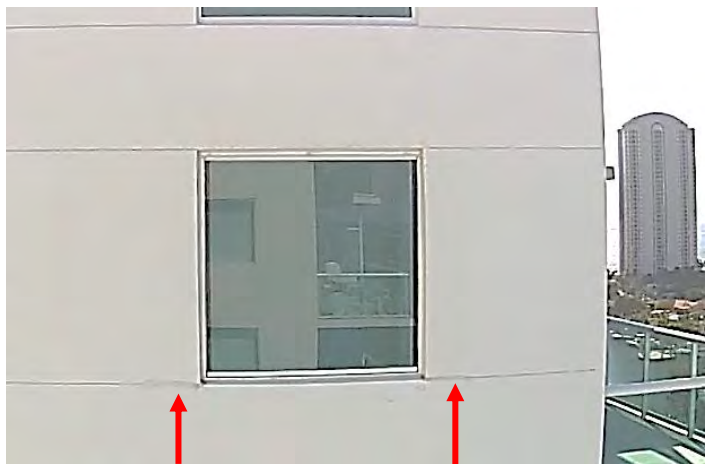
Figure 3

Caulking of the expansion joints near the windows, indicating it may have leaked in the past. The M shaped expansion joint has been surface filled with sealant. This joint type cannot be repaired by filling the solid backed void in the expansion joint. This is considered an ineffective repair of an apparent leak at the corner of the window.

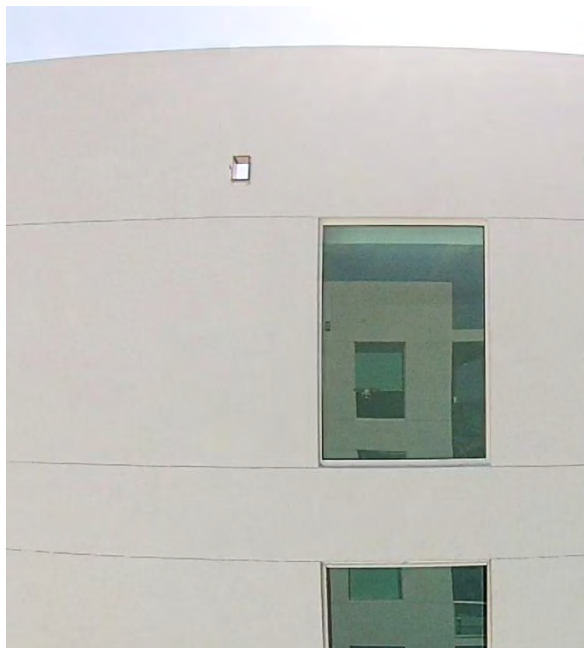
Figure 4

Another view of the expansion joints on the exterior wall of the east building. These joints are much more noticeable on the top levels shown here than on the lower levels (not shown). This was also noticed and documented much clearer for the west building.

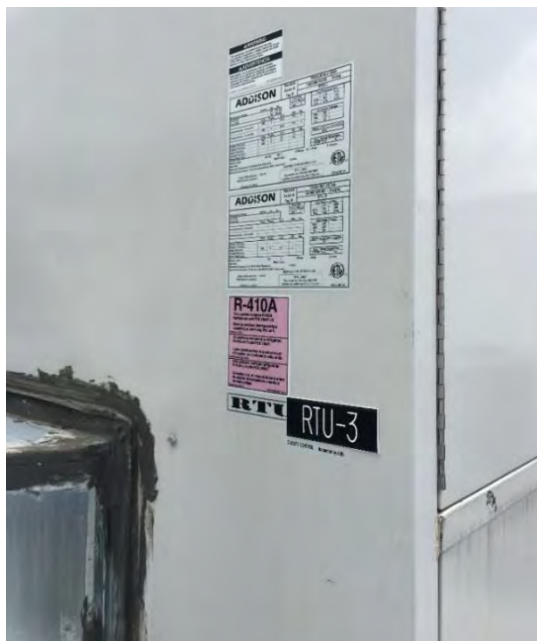
Figure 7

Roof top unit 3 (RTU-3, similar to RTU 1, 2 and 4) pictured at right was reported to have had a preponderance of service calls (estimated as 80% of mechanical service calls by Property Manager). This situation is under further investigation.

Note that the black mastic on the junctures of the ductwork do not provide any corrosion resistance. This material appeared to be roof mastic of asphaltic base chemistry.

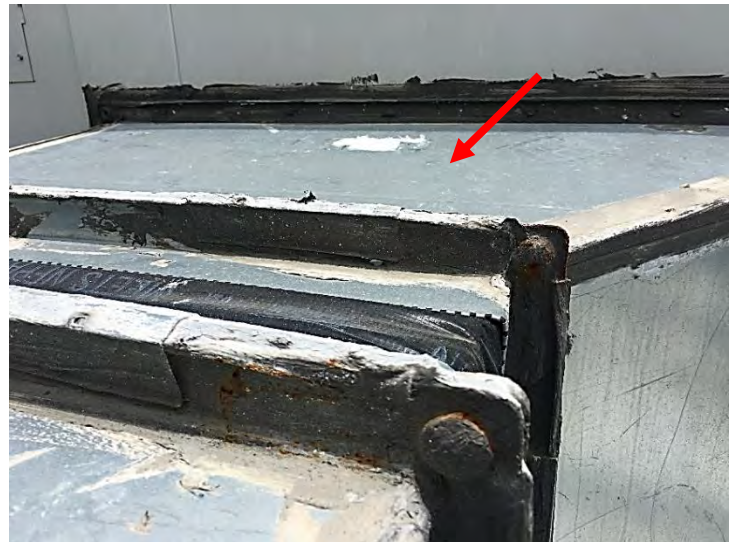
Figure 8

The junctures at right show corrosion taking place along duct junctures and fasteners.

It was noted that, in the vast majority of locations, no top surface break (providing slope to evacuate water) was provided.

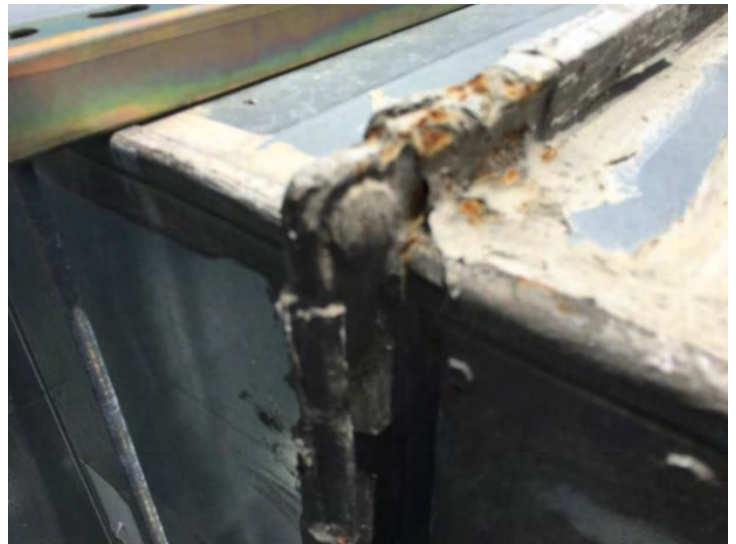
Figure 9

Enlarged view of corrosion taking place at sheet metal junctures and fasteners. Standing water at the upper surfaces of essentially level sheet metal was considered to be subject to concentrating moisture and salt. This is expected to compromise the galvanized coating and corrode the steel ductwork at an accelerated rate.

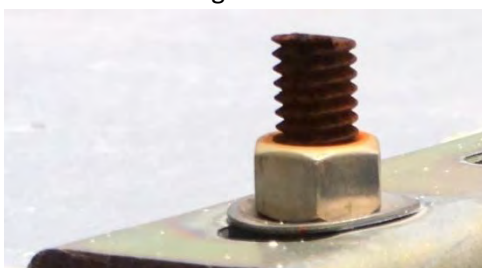
Figure 10

Threaded rod that secures ductwork is rusting above the fastener (red arrow) and below the uni-strut (yellow arrow). Dissimilar metal incongruence connecting a carbon steel threaded rod to a galvanized uni-strut/stainless steel washer and nut. See enlarged view below.

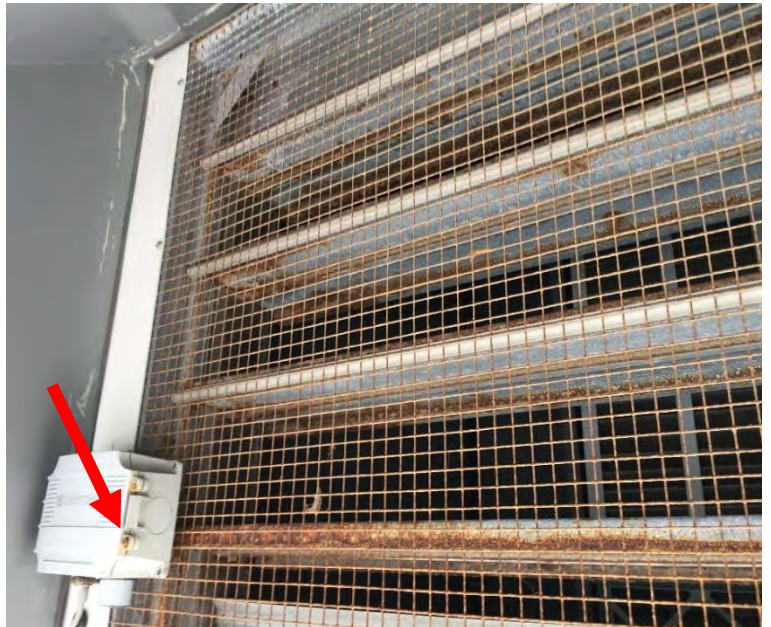
Figure 13

These power actuated louver fins were corroding severely. The finish of this equipment was considered inadequate for the coastal marine environment. Note the fasteners at the equipment box (red arrow) are also corroding.

The hardware cloth (metal mesh) was also severely corroding.

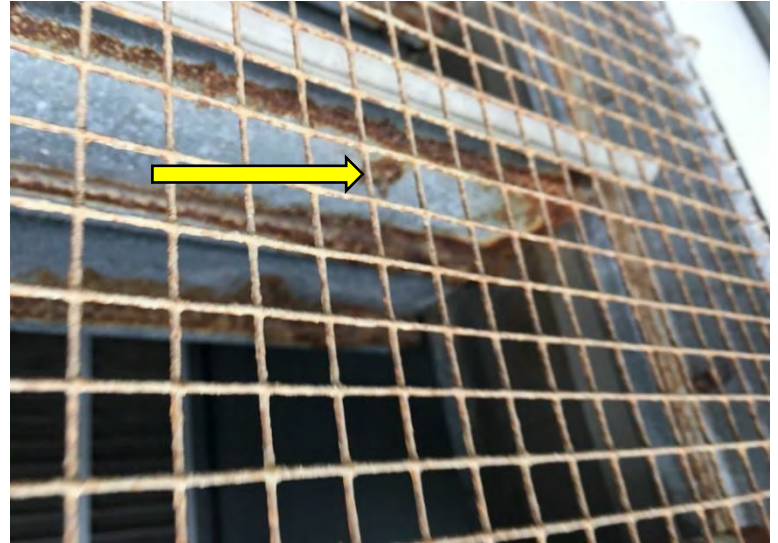
Figure 14

This enlarged view shows the rapid progression of corrosion at the protective hardware cloth mesh, and the inadequacy of the protective coating of the mechanical louver and the fastener beyond the mesh grid.

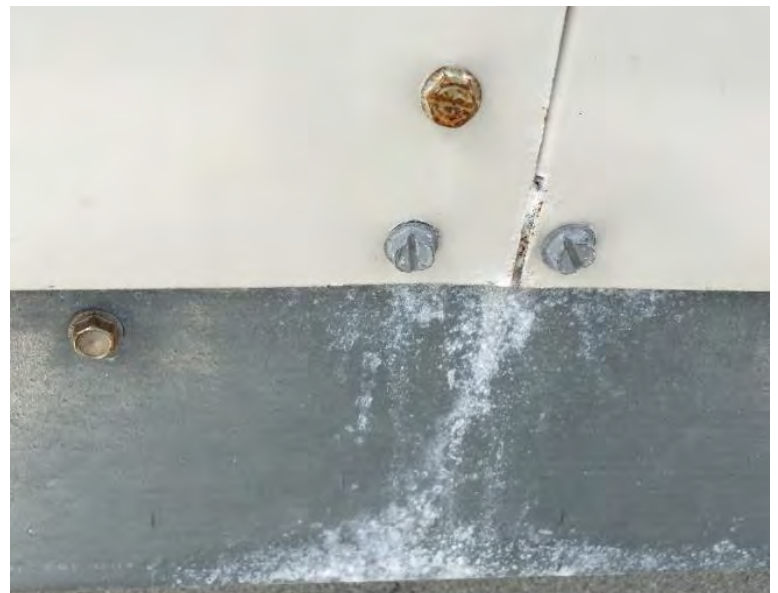
Figure 15

Corrosion of cabinet sheet metal at AHU-3 due to dissimilar metal galvanic corrosion.

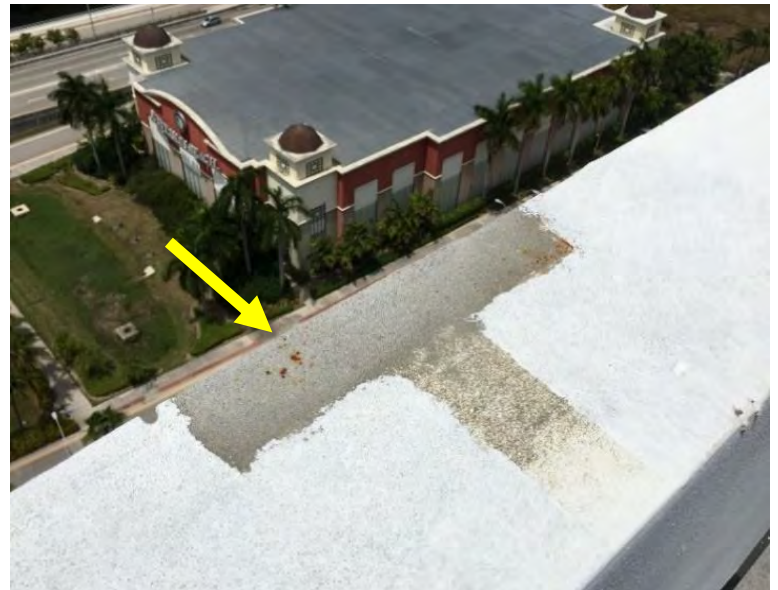
Figure 16

The parapet area pictured at right appears to have had a swing stage support installed at the time of painting. The corner at the outside of the parapet has some corrosion that is likely metal debris left from the stage support. The front exterior vertical surface of the wall (see yellow arrow) that is out of view in this photo, was also missing the finish coating.

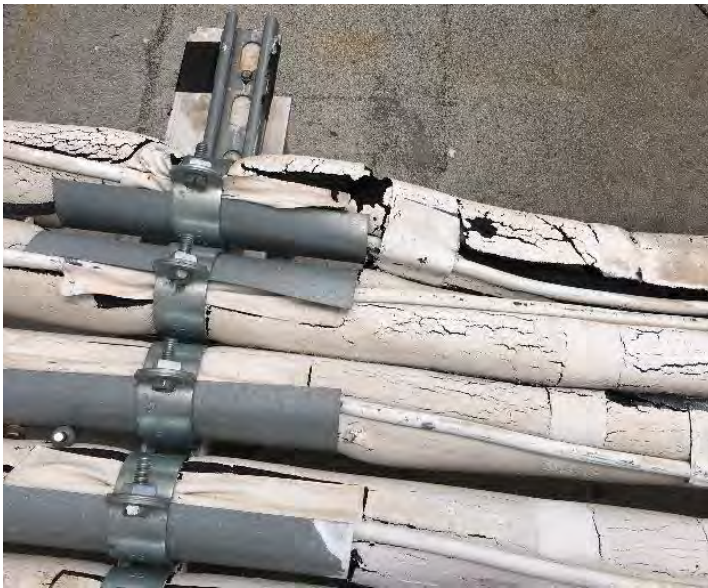
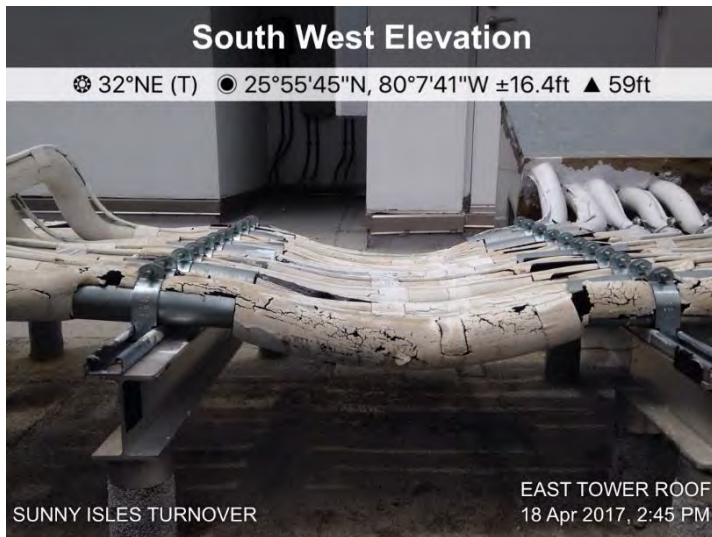
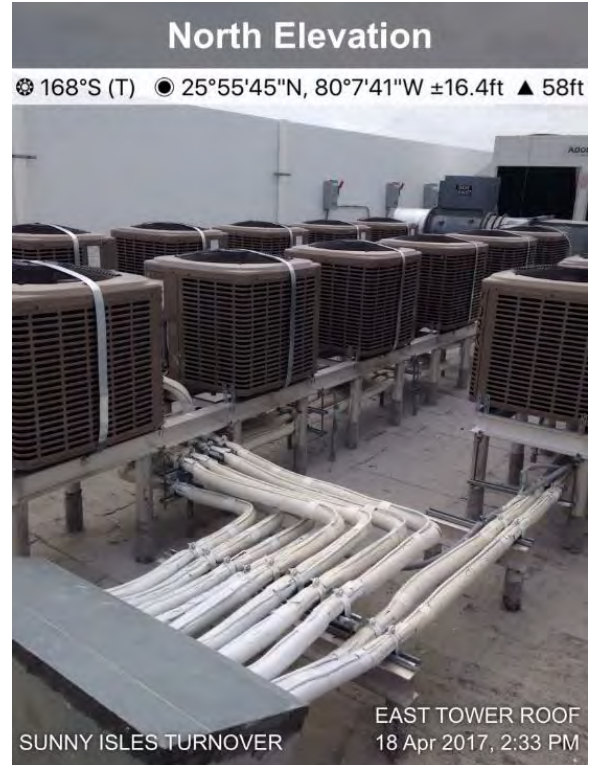
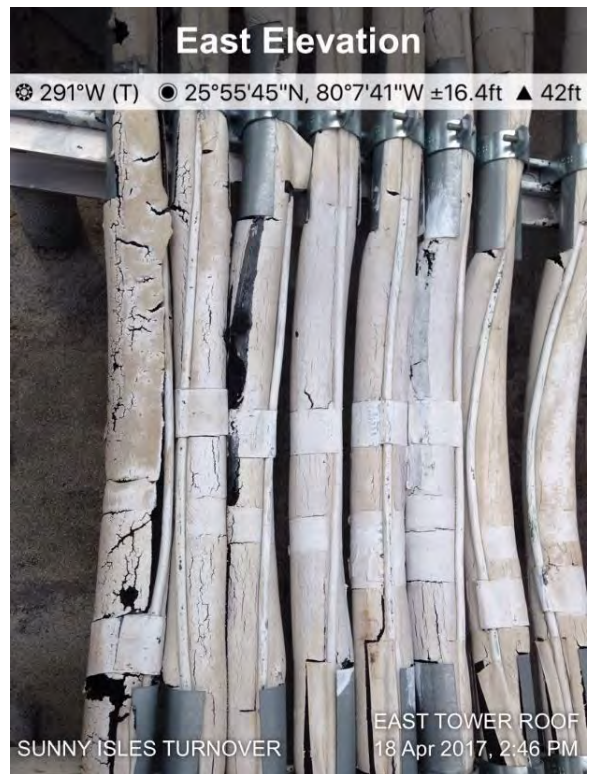
Photos on this page are views of the deterioration of insulation foam placed on chilled tubing of AC coolant lines. The cause is considered to be U.V. light exposure. The insulation should be U.V. resistant foam or have a reasonable quality protective coating that could prevent the failure of the insulation. White paint provided was inadequate. Replacement with new and proper type of foam or replacement with new, improper type foam with UV protection is recommended.

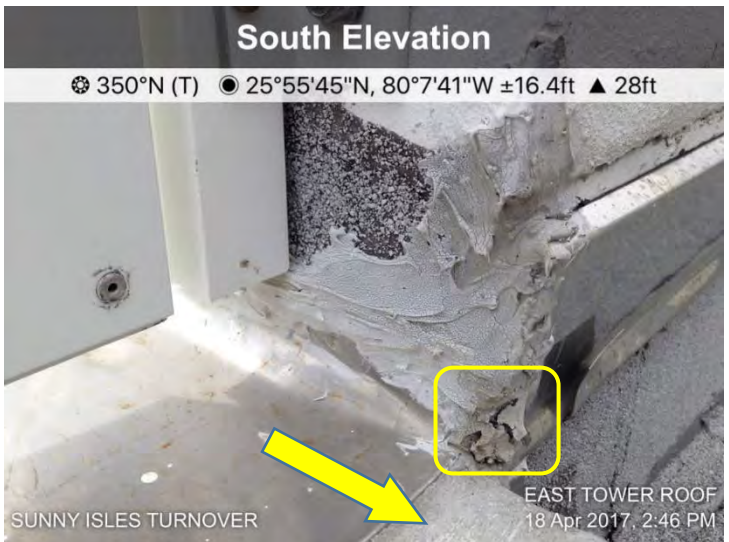
Figure 22

The gate/doorway condition at right is not considered to be water tight. The sealant application of surface caulk is not considered to be permanent nor is this a proper application procedure. A fragment of the flange of a PVC corner bead is visible within the yellow box. The bottom right area is the horizontal surface at the concrete step at the door threshold that separates the north parapet from the mechanical areas of the roof. No waterproofing on this flat exposed concrete is considered a location for water absorption under the adjoining roof membrane.

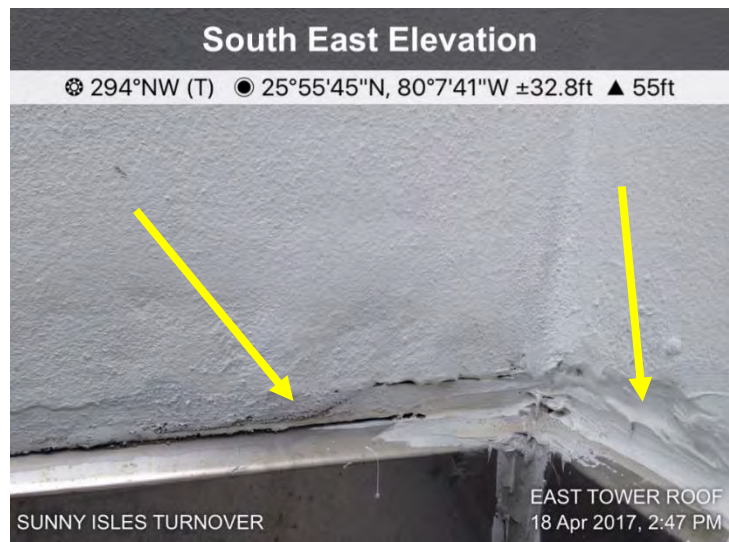
Figure 23

Improperly terminated stucco field at the bottom of the metal counterflashing was not considered a permanent watertight installation.

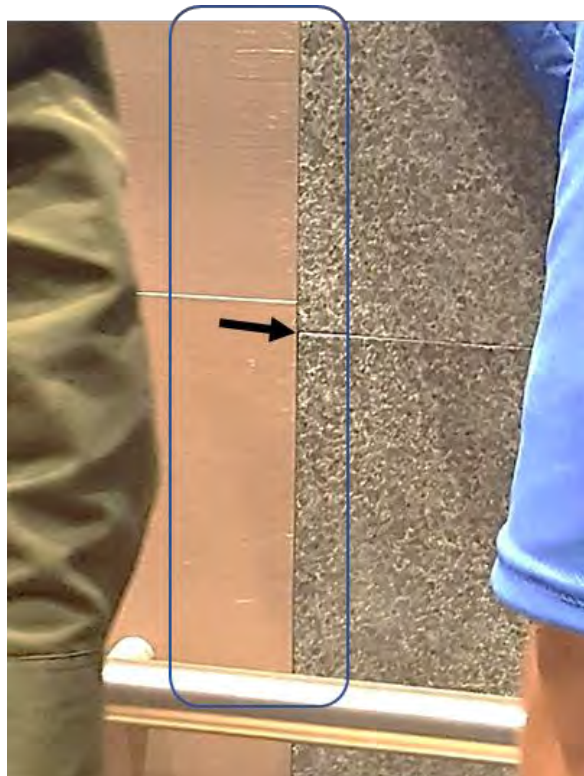
Figure 25

Gaps were present in the elevator between the wood and stone finishes. The wood panels finish was deteriorating, see inset box. It appears there is a connection where humidity or normal application of cleaning liquids is expected, that shrinkage/swelling of the edge of the wood panel is occurring. This would appear to be a material specification problem, as typical modern elevator cab materials (such as wide format thin porcelain sheet or waterproof phenolic) or other materials would provide a serviceable finish without unreasonable maintenance requirements or surface failure.

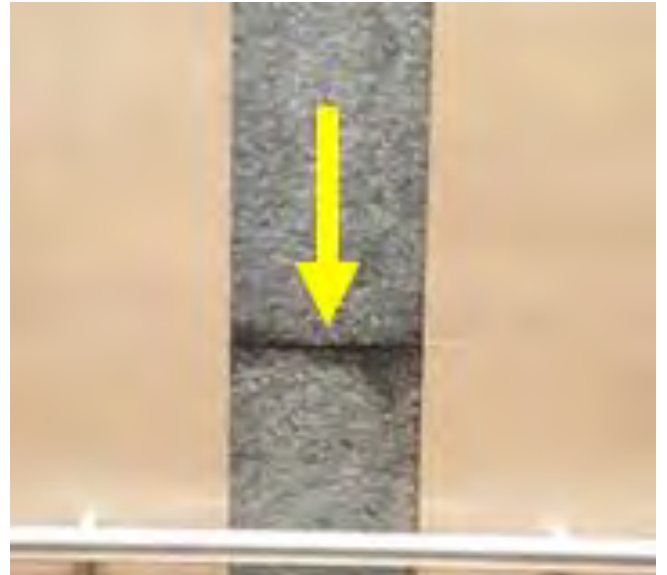
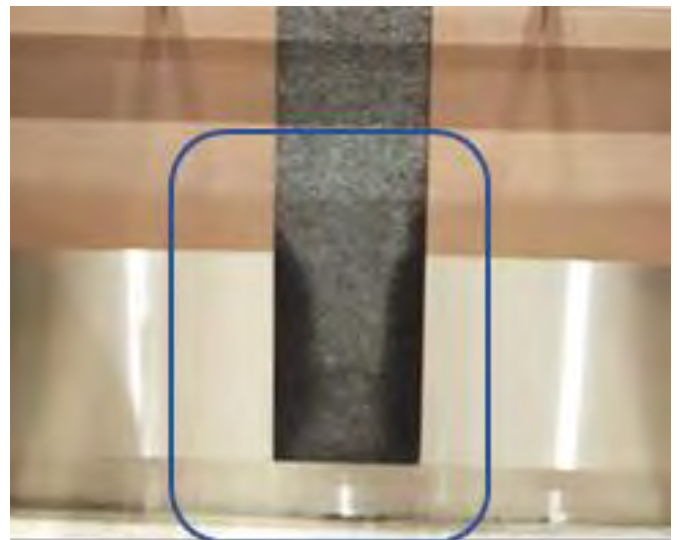
Staining at the joint between adjoining stones (yellow arrow), and at the sides beginning just above the metal lower cove (blue box). Excessive lippage in some of the stone blocks was evident at the upper condition. The dark areas appear to be a chemical infiltration into the stone matrix that will be researched further to try to identify the cause of the staining. The material specification problem as discussed previously would have avoided this condition.

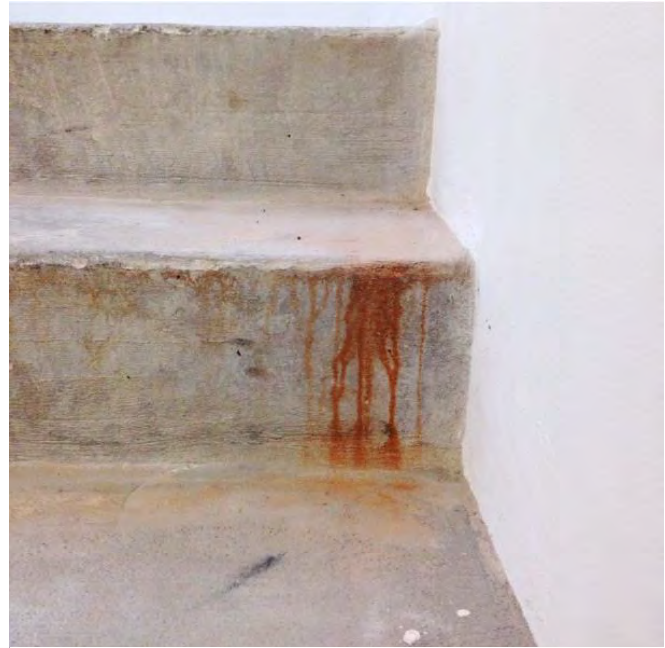
Figure 29

Apparent rust stain on the fire exit stairs leading from the penthouse (21<sup>st</sup> floor).

This is considered a water intrusion issue. Concrete nosing reinforcing appears to be positioned too close to the surface and ACI cover requirements to protect reinforcing steel from corrosion have not been met.

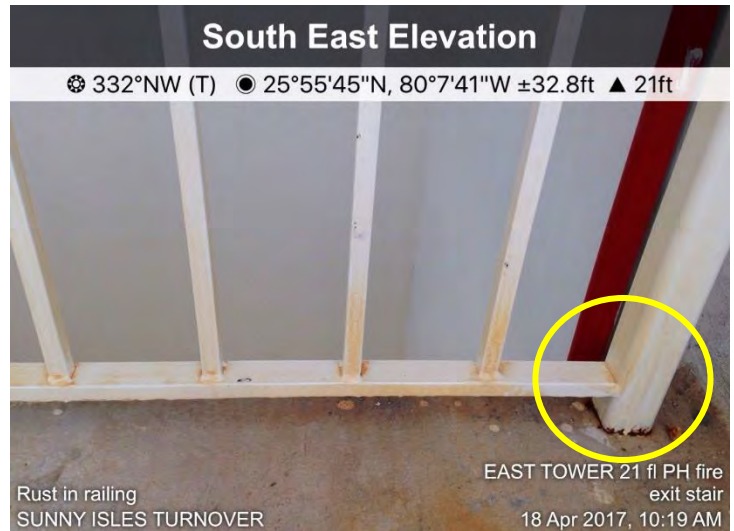
Figure 30

Rust was found all over the railing inside the fire exit stairwell leading from the penthouse (21<sup>st</sup> floor). Based on observed staining, water intrusion has occurred. The problem cause is the unpainted steel railing post (circled) and the corrosion of steel pickets at the weld locations. It could not be verified that the steel had been primed. Corrosion-resistant zinc or another system should be provided or an aluminum railing should be installed.

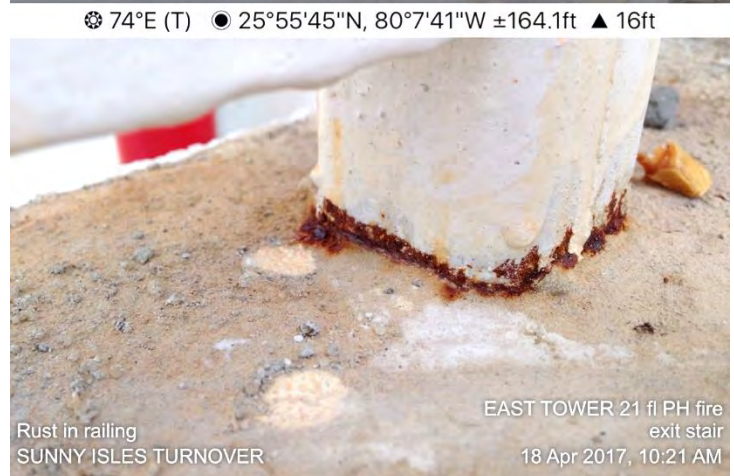
Figure 31

Severe rusting in the gap between the fire exit stair railing and the concrete slab, zoomed in from location shown above.

(Enlarged view of condition above.)

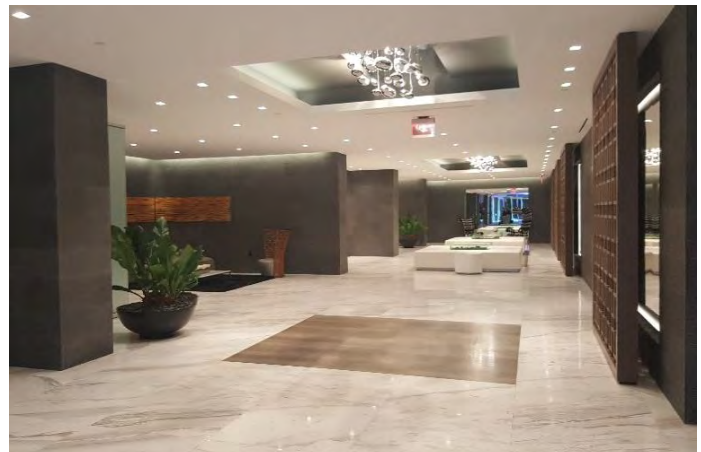
Figure 33

Stone tile in lobby:

Many blocks in the lobby walls were not flush with the surrounding blocks, leaving gaps and lips where they join, as pointed out in this picture. This workmanship is considered to exhibit excessive lippage (out of plane dimension beyond tolerance) and should be corrected.
