CASE NO.: 2020-024374-CA-01

**NOTICE OF FILING**  
**EXHIBITS “A” THROUGH “E” OF COMPLAINT**

***Re: 400 Sunny Isles Condominium East Association, Inc.  
Section 558.04, Florida Statutes, Notice of Claim of Construction Defects***

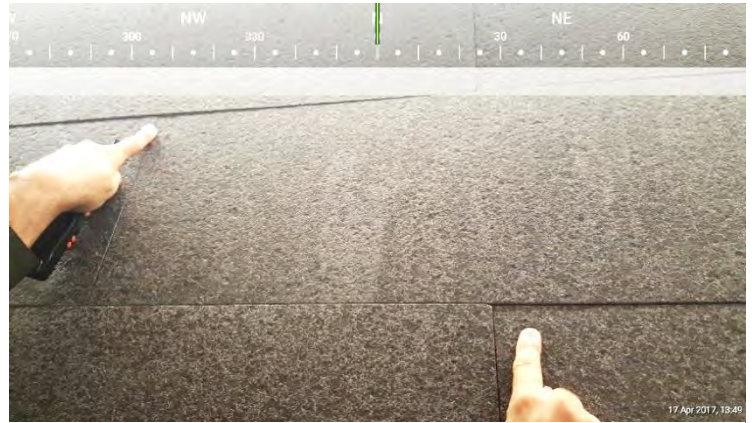
Figure 34

Stone tile in lobby:

Another example of gaps in the blocks in the east lobby walls. Both the lippage and inconsistent joint spacing and provision of joint material were considered poor workmanship.

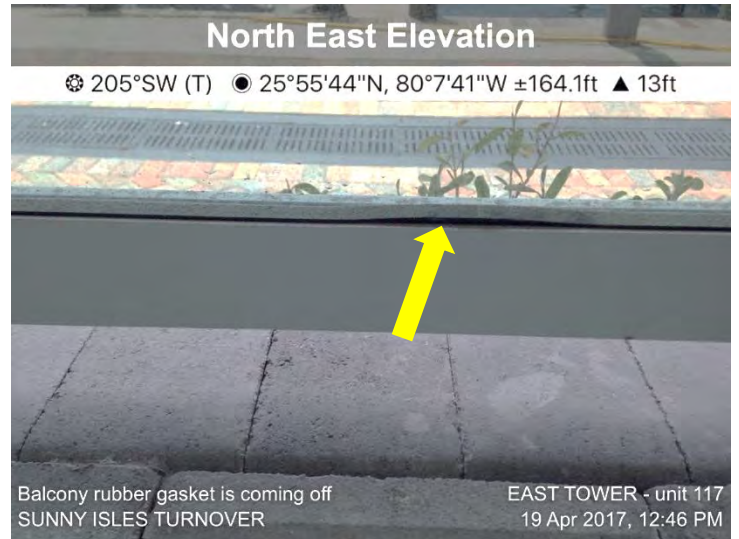
Figure 38

Rubber gasket on the glass railing on the balcony is coming apart, allowing for water intrusion and possible corroding of the aluminum frame.

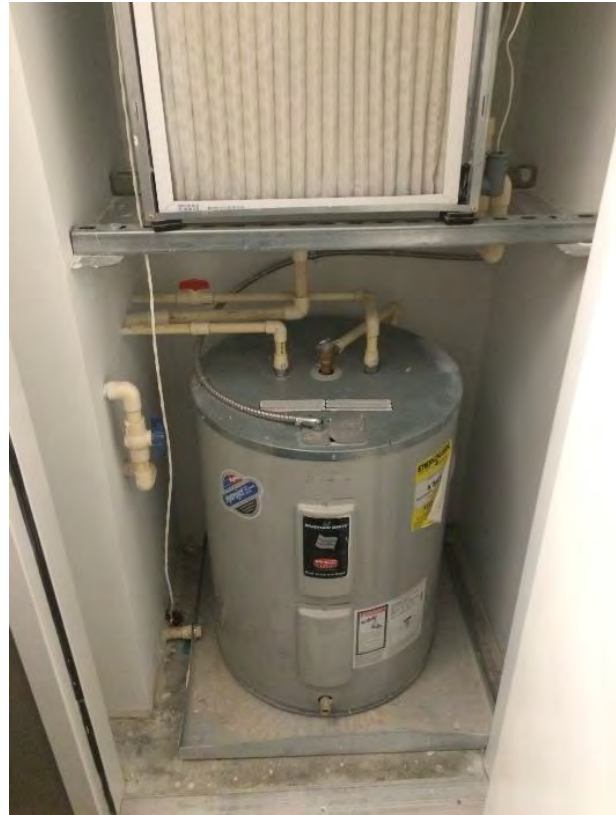
Figure 40

This unit does have a pan under the water heater, while many units were found to not have pans, such as unit 117 E above.

Unsure about the inconsistency regarding this issue.

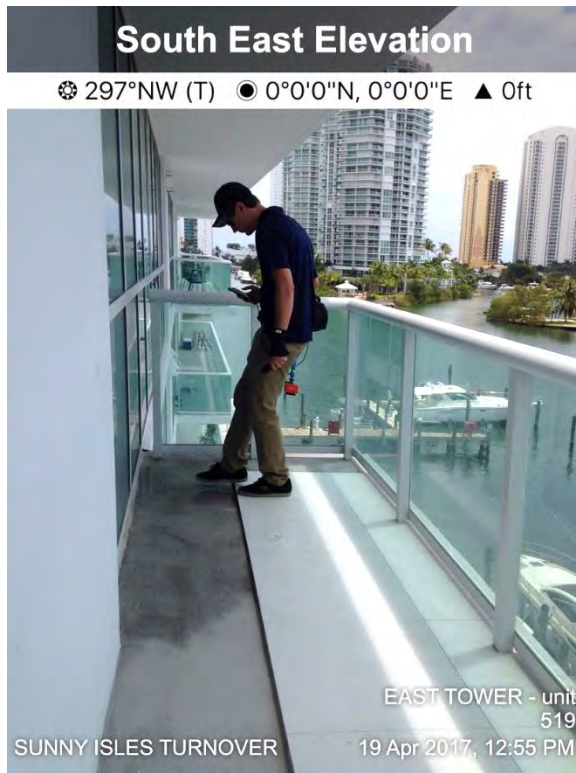
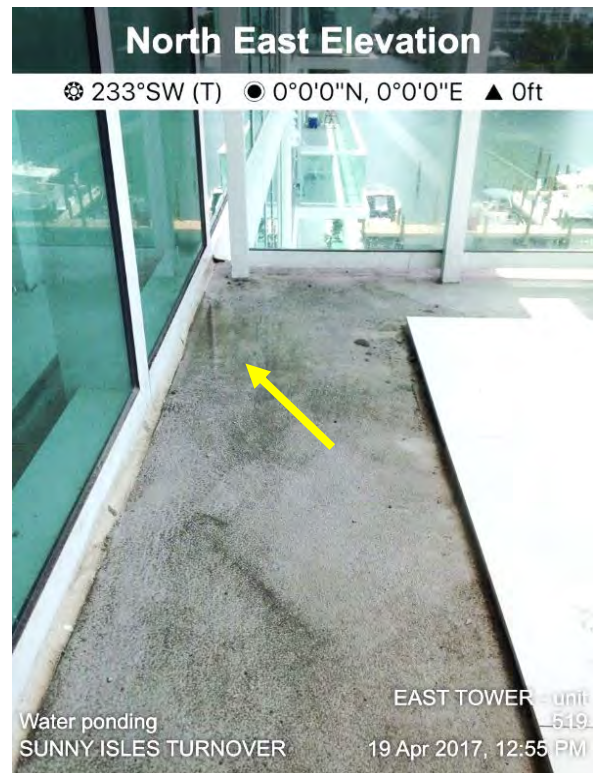
Dark areas on the unit's balcony indicate water ponding. In this photo, standing water is clearly seen in the corner between the window and the glass railing.

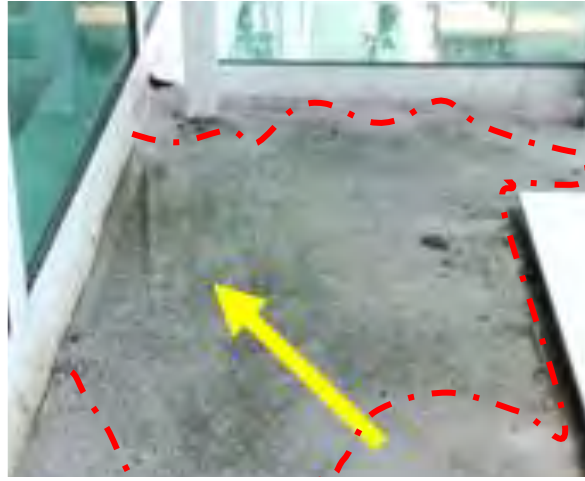
Figure 43

The slope of the patio floor is almost level in some areas, not conforming to the architectural plans for proper drainage.

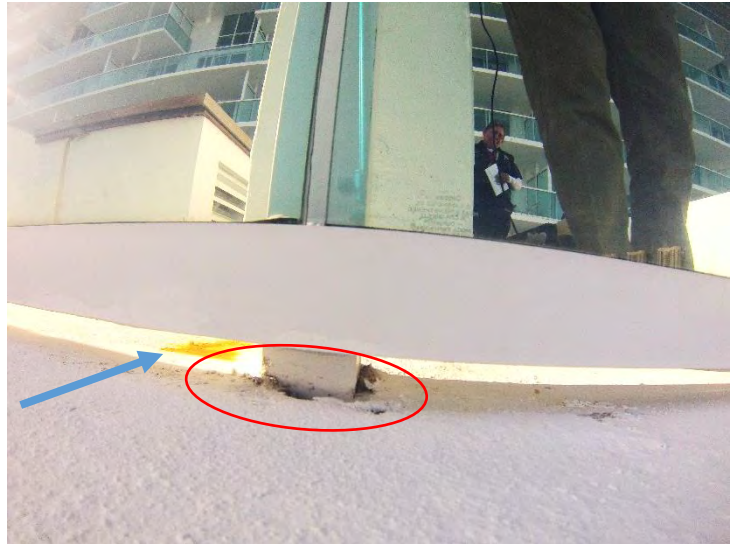
Figure 52

This is a similar area to the one above, where the yellow arrow indicates similar areas of inconsistencies around the railing post pocket where water may intrude.

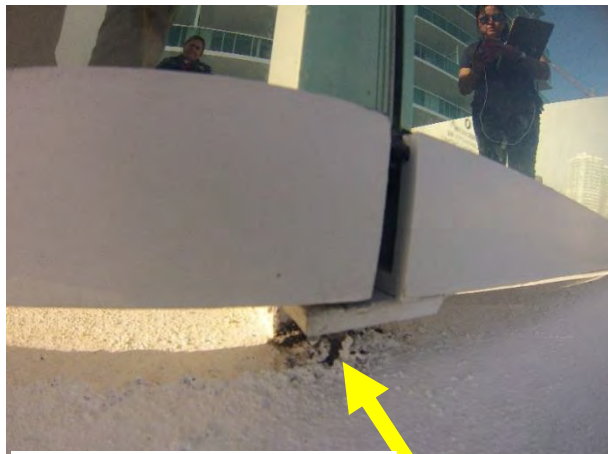
Figure 53

Gaps and cracks were noticed around the railing posts on the balcony. Water can thus freely flow between the concrete surface and aluminum post, causing corrosion to occur.

Another crack can be seen propagating from the corner of the railing post as well.

Terrace slab membrane had been patched (below) where the initial waterproof membrane appeared to be distressed.

This area should be water tested to verify that the drainage of the surface is positive to the drain locations, and that it conforms to the architectural requirements.

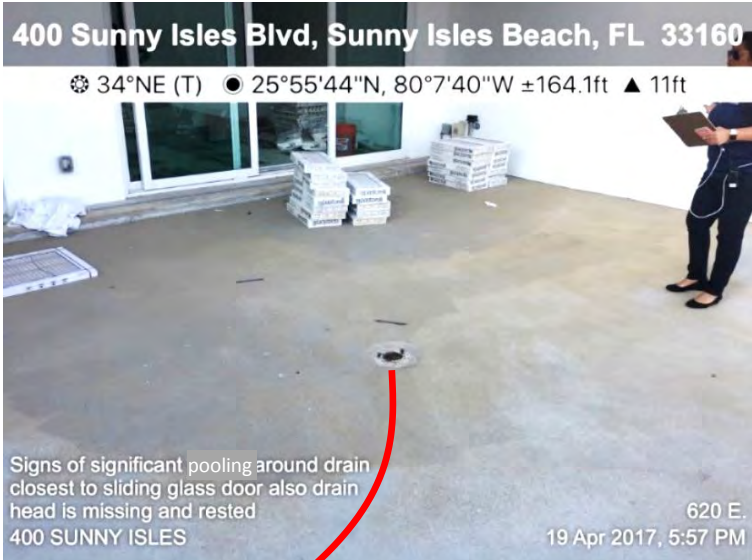
Figure 57

Dark areas around drain closest to the sliding glass door show signs of significant ponding. Repairs involving addition of waterproof coatings appeared to have taken place. The drain location installed under the waterproofing did not appear to have the bi-level capacity of a promenade-type bi-level drain that would typically be utilized. Note below that the turned-up inner pipe flange of the provided drain would not effectively drain water at the membrane elevation. The corroded drain was not considered a suitable substrate for the waterproof membrane.

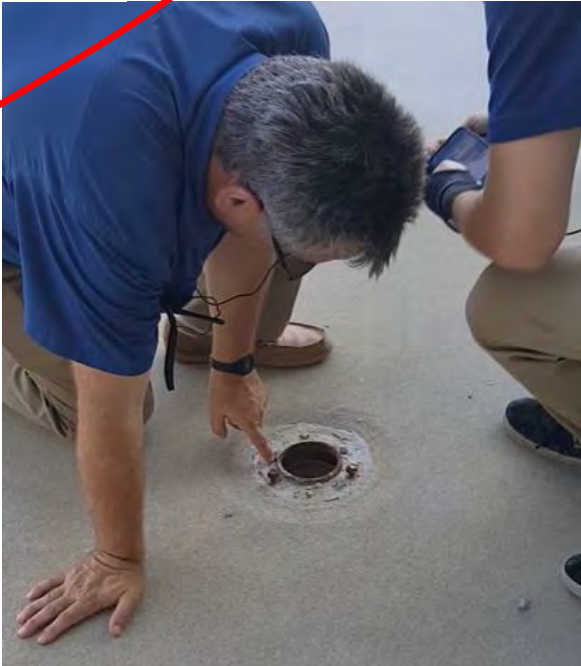
Figure 58

Open penetrations and tear of waterproof membrane of concrete terrace slab were observed.

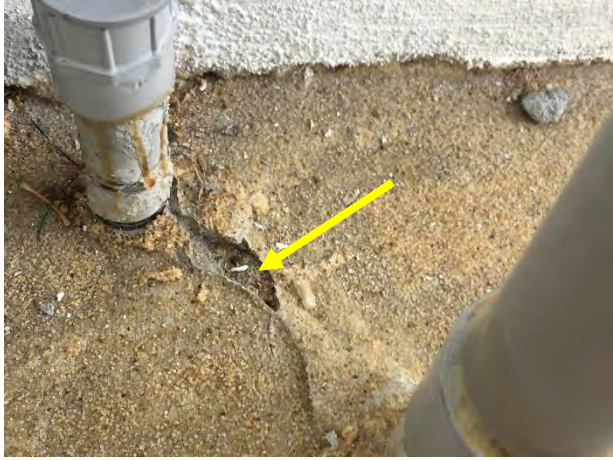
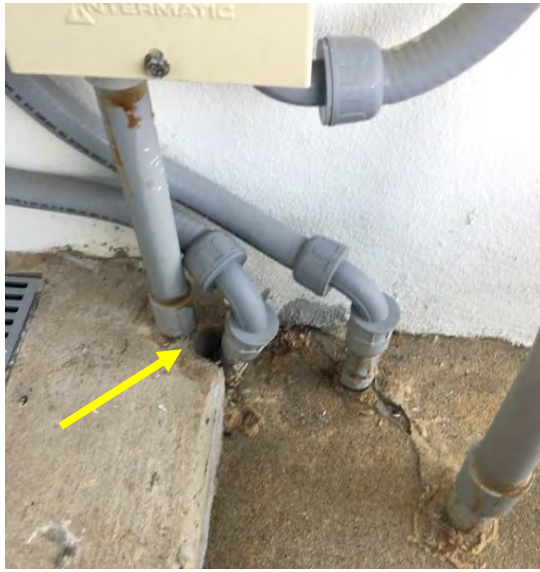
**Sliding Glass Door Trench Drain:**

Cracks in the concrete adjoining the linear trench drain were considered to be excessive. The concrete may be lacking sufficient crack control reinforcing. Additional investigation is recommended for verification, while associated repair of the cracked material is performed.

This particular photo was at a location in from of the living room sliding door. The crack spans the entire width of this section of concrete from the drain to the edge. Moisture entering porous, cracked concrete migrates below the adjoining Waterproof membrane seen at bottom of photo (white arrow).

How can water on concrete surface run in to trench drain and not run **down** into segregating crack at plastic drain/concrete juncture (yellow arrows)?

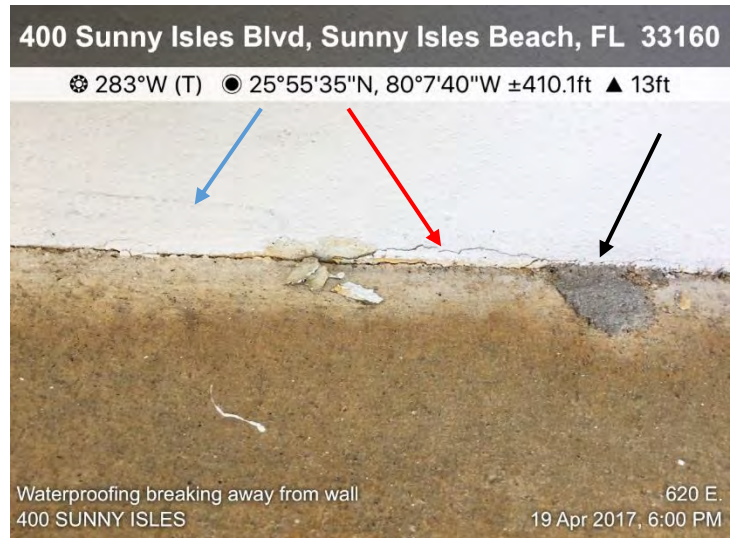
Figure 63

Multiple instances of the concrete waterproofing cracking and breaking were found. This shows the juncture between the wall and the concrete floor of the patio. Waterproofing turned up the wall from the terrace should be verified by further investigation and repaired/provided if found lacking.

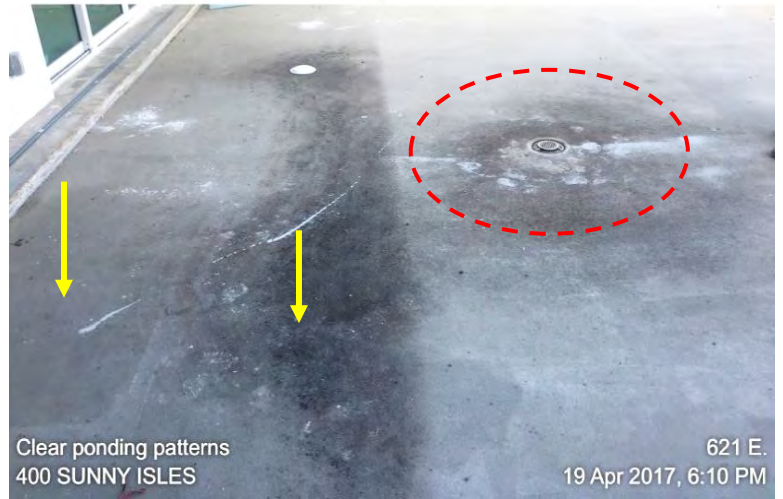
Figure 64

The ponding areas are evident here (black surface staining considered due to mildew/organic growth) around the drain (red circle) as well as the large area on the left half of the photo (yellow arrows). Ponding was also found around the drain furthest from the sliding glass doors.

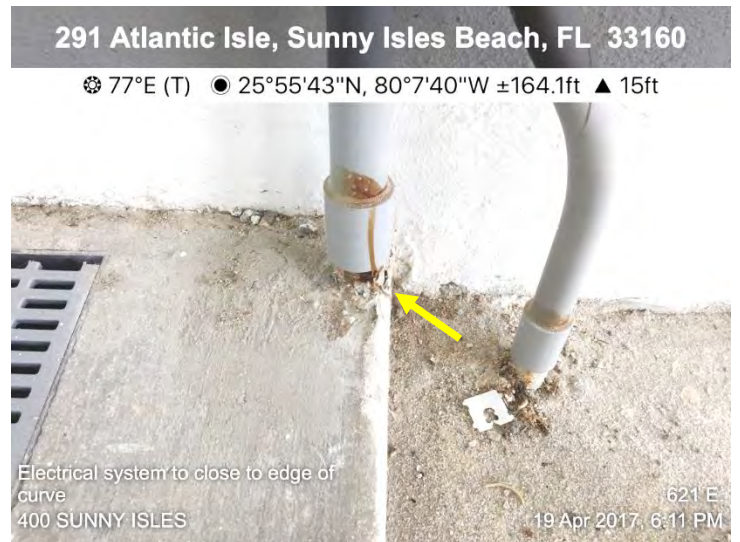
Figure 65

This electrical system conduit appears to have been placed too close to the edge of the concrete step containing the drain. The concrete seems to be cracking along the edge of the slab (yellow arrow). The smaller conduit is also unfortunately located, away from the wall. Both locations appear to have some corrosion issues at the slab penetration. Slab penetration in an exposed marine environment should be installed in a watertight manner as was seen on the roof, but these conditions fail in this regard.

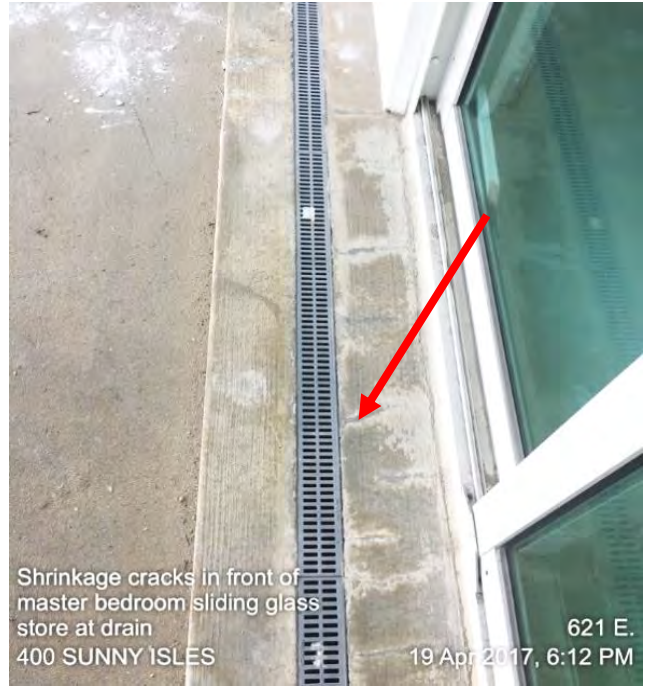
Figure 66

Multiple shrinkage cracks were found in the concrete curb between the drain and the sliding glass door. This was most likely caused by a lack of an expansion joint for the concrete to shrink and expand without cracking, and lack of crack control reinforcing. The vertical plastic drain would effectively dam moisture outside the door that could get through the membrane (not seen here) or the cracks perpendicular or along the drain edges.

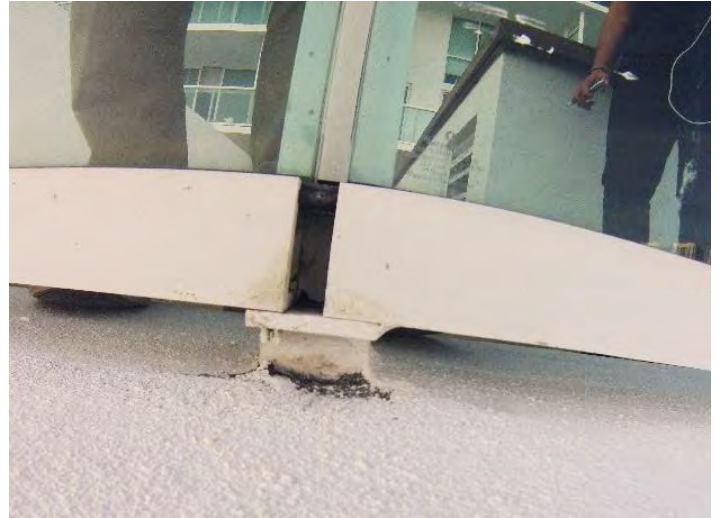
Figure 68

Cracks in the concrete near the base of the railing has darkened, stained areas around railing post base. This is considered an indication that organic growth has collected in the area as a result of moisture entry around rail post/pocket.

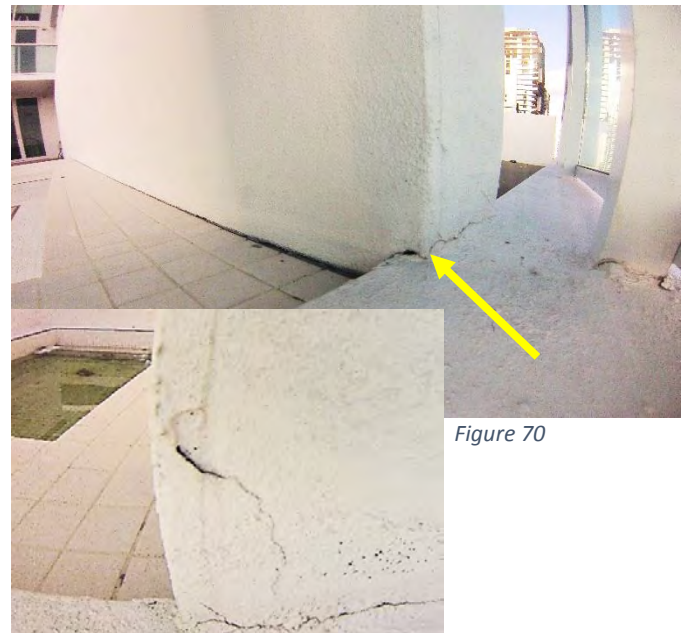
Figure 69

There was a large crack spanning the width of the dividing wall between the unit and the neighboring unit, with cracks propagating up the wall as well. This intersection of large counter-oriented concrete members would be expected to crack at the juncture. The overlapping material of the vertical face over the horizontal may also be stucco excess. A sealant bead cast into the juncture for a base depression (such as a V groove) for sealant fill would be a consideration for repair inclusion during repair of this juncture.

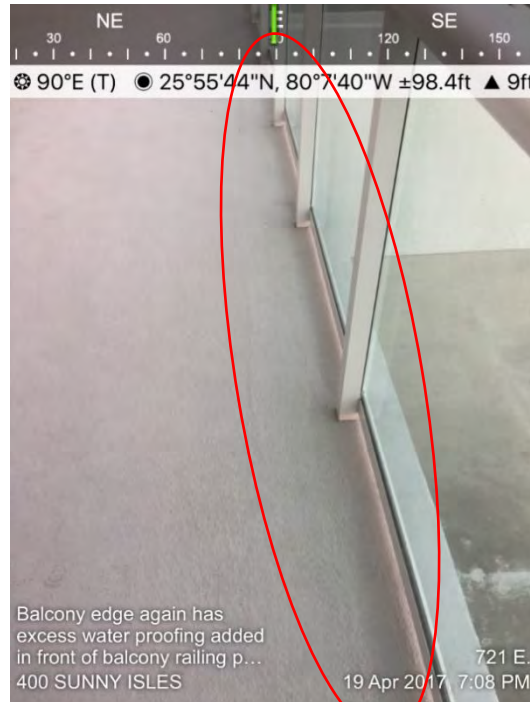
Figure 71

Excess waterproofing appeared to have been added to the top surface in front of the balcony railing (red ellipse) which appears to impede water to drain properly over the edge. The condition where waterproofing would be excessively applied, thereby wasting expensive material, and defeats the water drainage slope requirement seems curious. The other possibility is that the deck pour was short on material and the edge was built up to appear to be the correct depth, while the interior area of the deck was thinned a bit of material. Additional examination is recommended.

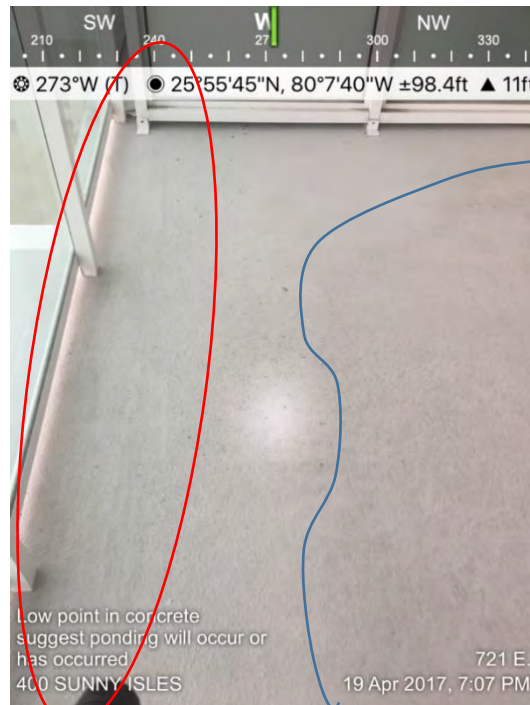
Figure 72

This area seems to be a low point in the concrete floor of the balcony, which can lead to or has already caused ponding to occur here. Dirt spots may be indicative of ponding having already occurred (blue area).

The area within the red ellipse appeared to be high and several balconies were water tested and found to have counter-slope near the perimeter edge (which impeded water flow/drainage).

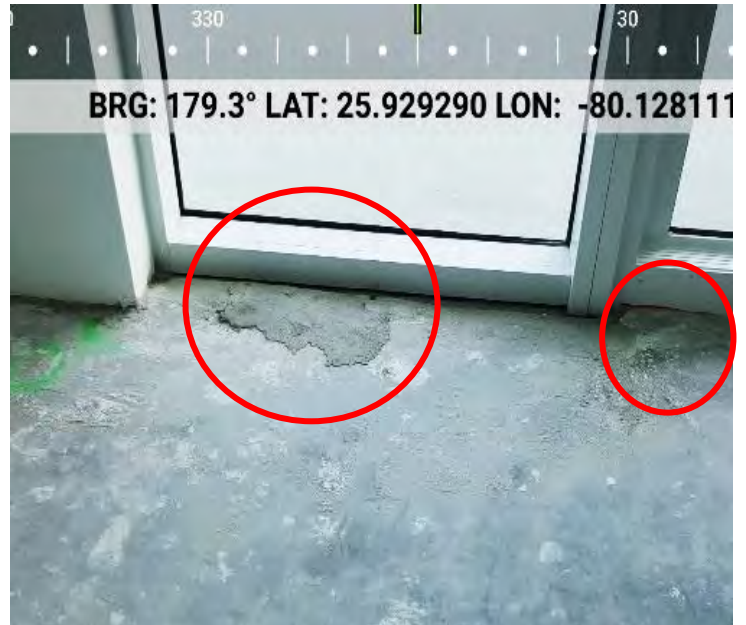
Figure 73

Patching was noted at floor elevation transitions (interior/exterior depressions) shown here. A significant gap was commonly noted between the concrete slab transition and the interior SGD/window frame. The slab depressed transition (typical under exterior walls or sliding glass door thresholds) appeared to have been oversized a bit, likely to accommodate the deeper dimension of the vertical framing members as seen here. Some areas at the step in the slab edge were noted to have been broken out (for unknown reasons, but perhaps by hammers to facilitate door installation) or due to floor slab placement problems. These slab patches occur at critical wet/dry boundaries and the repair should conform to ICRI/ACI standards.

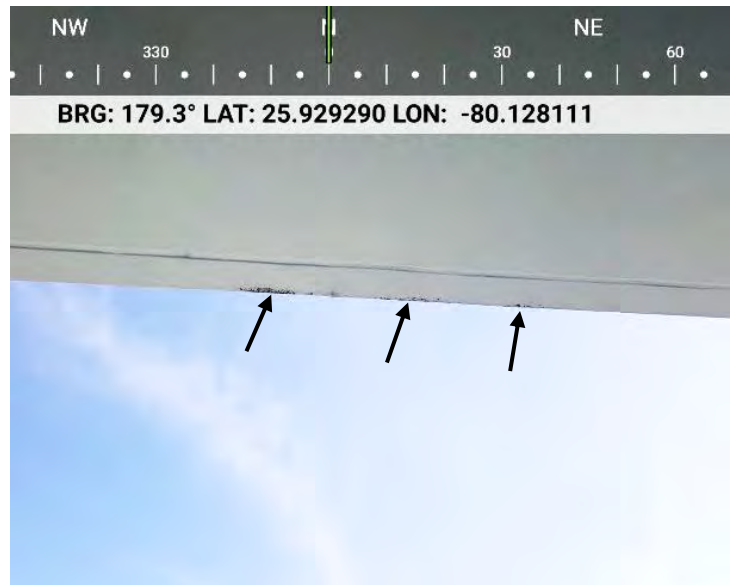
Figure 76

Dark deposits, appearing to be organic growth (possibly mildew), were found at the corner of the balcony above this unit (1115).

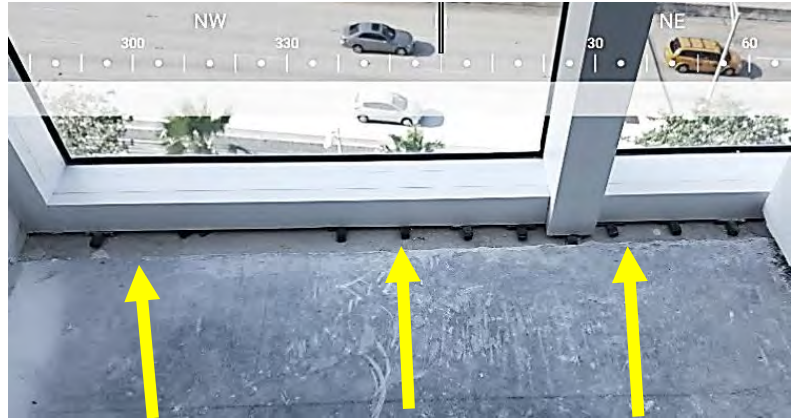
Figure 77

There was a large gap between the window frame and the concrete slab. This appeared to be intentionally done to allow clearance for the large vertical framing member as well as the working space to shim the window. Because this transition in elevation is the wet/dry or interior/exterior boundary, the patching of the area should be performed as a concrete repair in keeping with the importance of this boundary. If block mortar or gypsum mortar was used or if concrete is haphazardly infilled (or patched in the case of an irregularly broken out area) moisture and related concrete damage would be expected to occur at this critical transition line.

If the intent of the code requiring stepped elevation change is to define moisture to the under wall area and not the interior, the wrong patch material would thwart this intent, and spalling prevalent at slab edges would have greater likelihood of extending inside the window/door line.

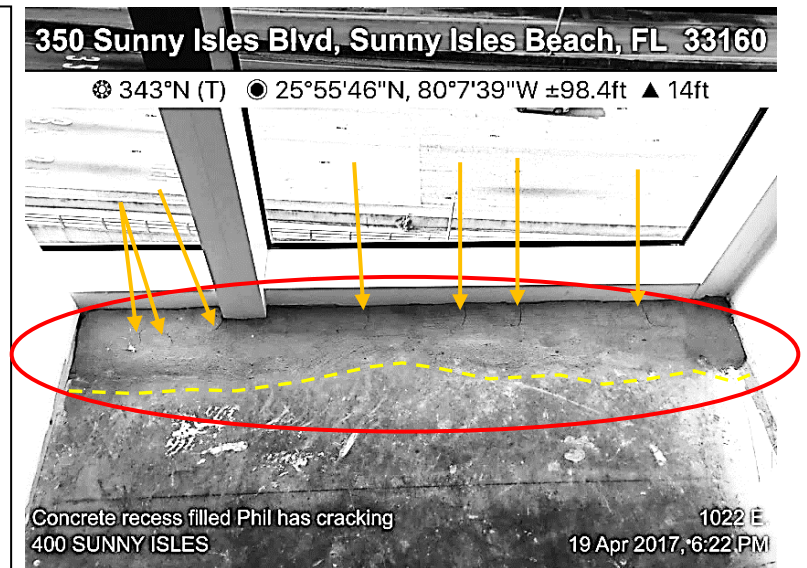
Figure 79

Concrete recess in front of the window was filled but cracks have formed. If the intent of the code-required elevation change is to define moisture to the under wall area and not the interior, the wrong patch material could thwart this intent. As described above, this would be considered a problem if the concrete is being repaired, as the repair does not follow ICRI/ACI repair standards and does not have any crack control bars in the patched material. Water intrusion and spalling to interior slab is a concern. The orange arrows point out shrinkage cracks.

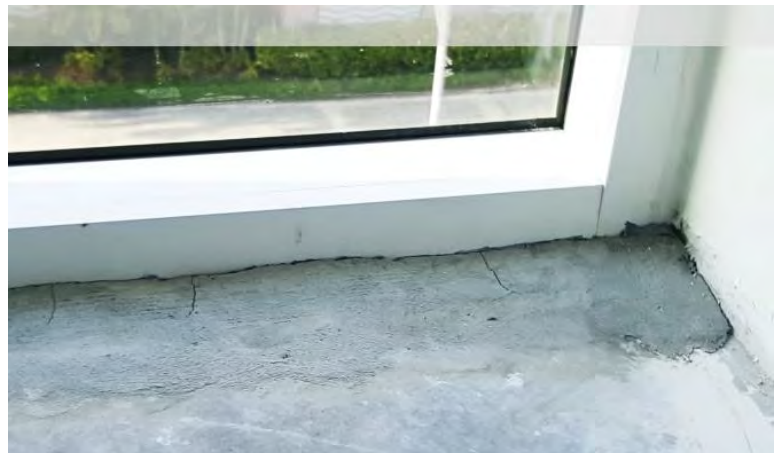
Figure 78

A close-up view of the cracks in the filled concrete is shown to the right.

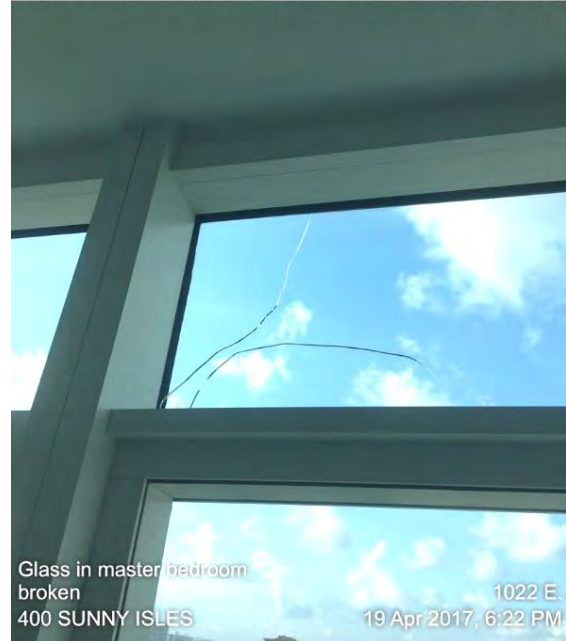
Figure 80

The glass in the master bedroom was found with two large cracks in it. The cracks do not appear to be impact related, but do appear to be stress induced. Recommend the window supplier visit site to meet with Association's engineer.

Glass in master bedroom broken  
400 SUNNY ISLES  
1022 E.  
19 Apr 2017, 6:22 PM

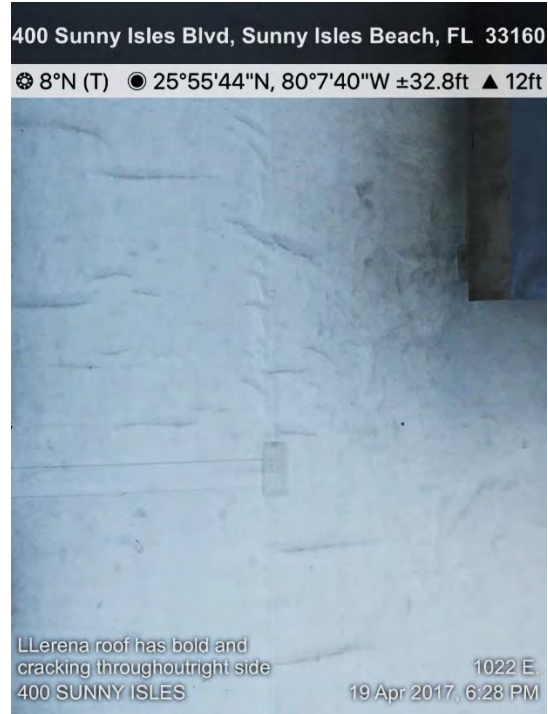
Figure 83

Cracks were noticed in the stucco ceiling and walls, allowing water to penetrate beneath the stucco and eventually the concrete. This will cause corrosion damage to the slab reinforcing bars.

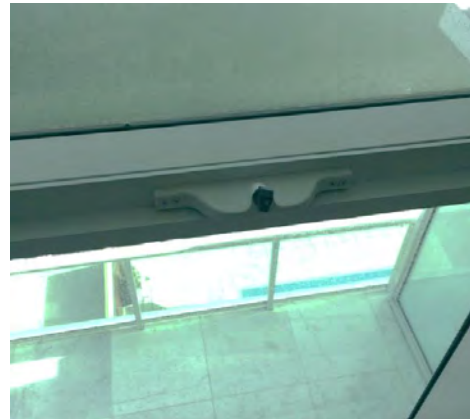
Figure 84

A broken window crank handle was found at one window.

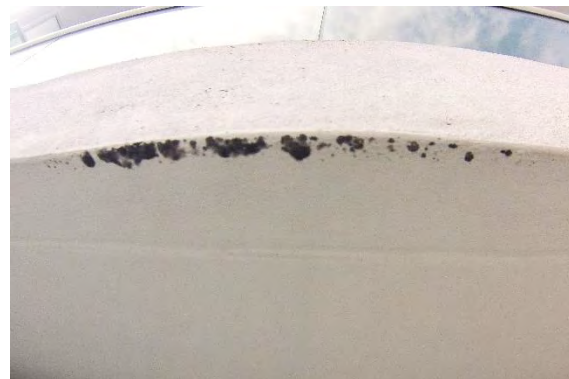
Figure 85

Black organic growth was observed on the ceiling of the balcony of the unit (on the balcony slab of the unit above, 1416). This is considered typical where drainage from balcony surfaces is slow and limited to small areas (as was observed). This causes long periods where moisture lingers in certain areas.

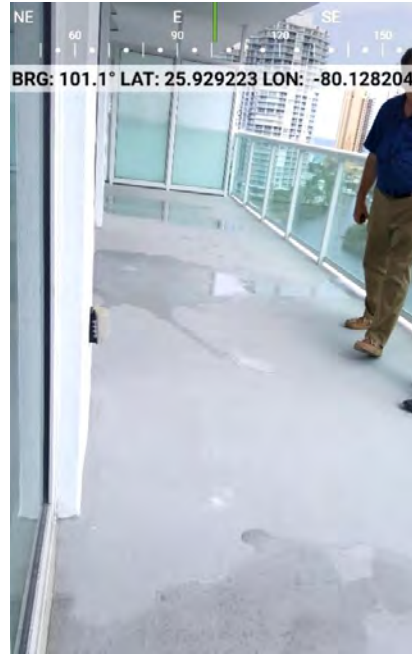
A water test was performed on the balcony of the unit. Water tended to pond in the center of the balcony while only a small area on the edge was able to drain the water. Some areas did not drain at all, such as the area furthest from where this photo was taken.

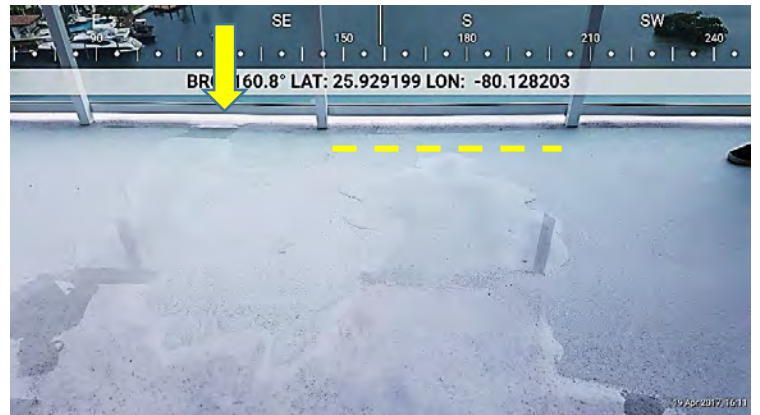
Another view of the water test from above. The area on the left shows drainage at the location of the yellow arrow, while the area on the right has stopped before reaching the glass railing (dashed line).

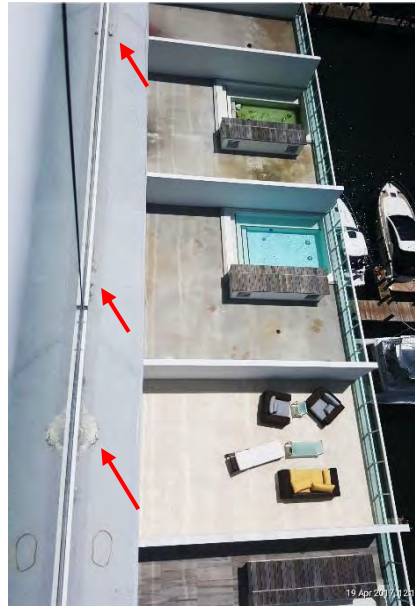
Figure 86

Excess mortar from flooring consistently found underneath the entire length of the railing on the balcony.

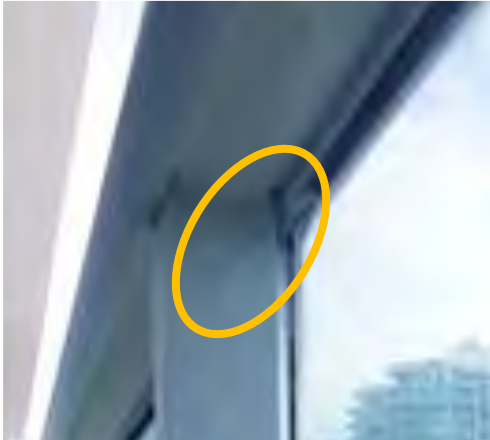
Figure 88

Rubber gaskets in the glass railing were often missing or did not run the entire length of the glass panel, leaving a gap.

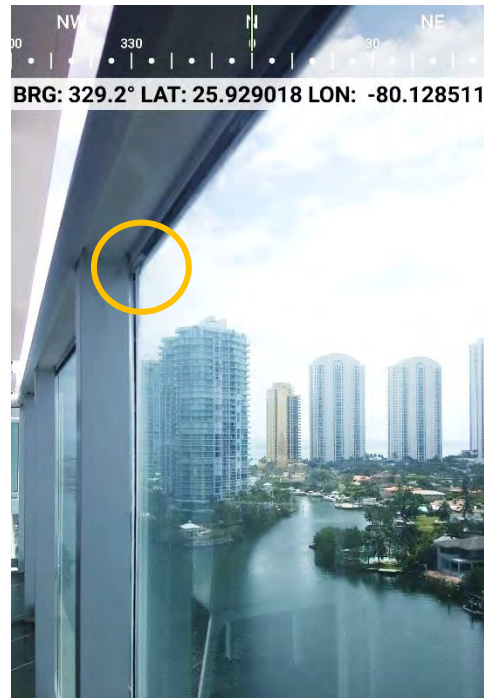
Figure 87

Several gaskets were found hanging out of the aluminum frame as well.

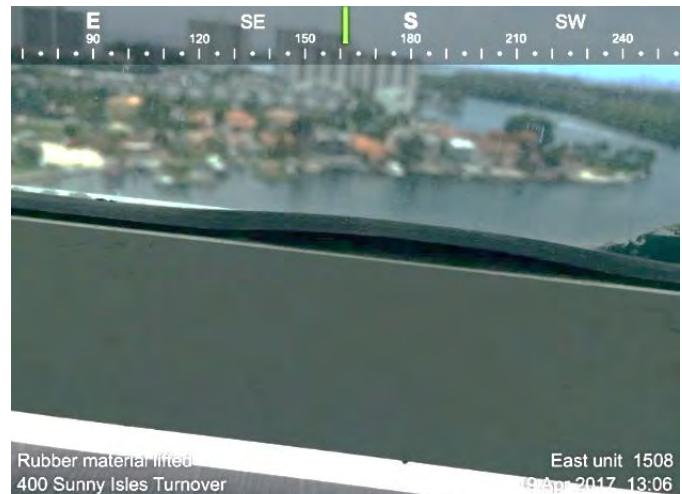
Figure 89

Rubber gasket on the balcony distended out of place, not sitting flush against the glass and the aluminum railing frame.

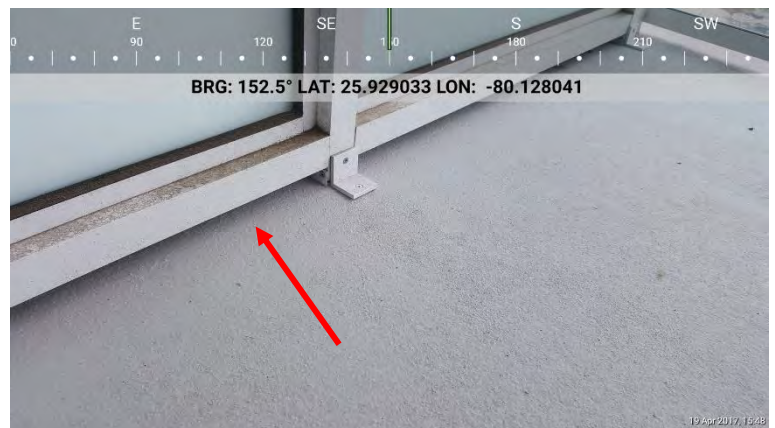
Figure 90

Large gap between divider and concrete is an issue when the neighboring have tile and mortar bed finishes installed. Many unit owners have opted to install tile on setting bed mortar over their waterproofing surfaces. When both balconies have tile, the resulting trough under the aluminum demising panel becomes a depressed area between two adjacent tile floors.

The condition then allows water entry under the (typically impermeable porcelain) tile, where the entrapped water wets the mortar and keeps the waterproofing perpetually wet. Water will not drain adequately in these cases, due to inadequate and inconsistent slope of the concrete balcony surfaces. Over time, the minerals leaching from the entrapped water condition under the tile will further block any drainage as mineral deposition takes place at locations of exit and evaporation.

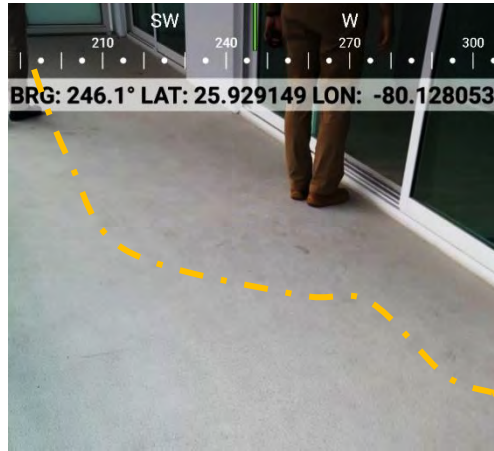
Figure 91

Dark areas on the balcony, especially near the sliding glass doors possibly indicate water is ponding in those locations.

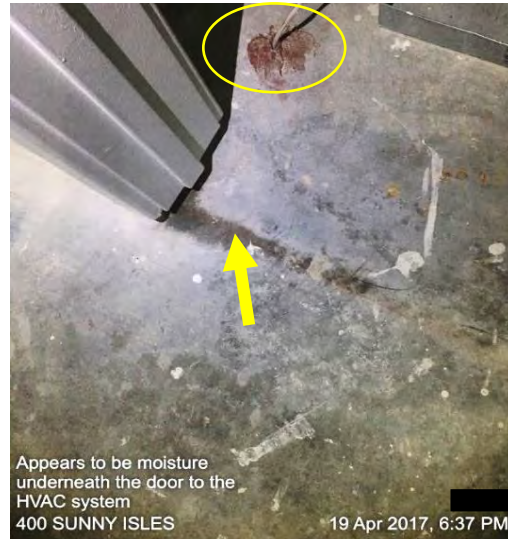
Figure 92

There appears to be a small wire penetrating the concrete floor slab caulked to the middle of the floor between the door jamb and the equipment base/tray. This is the mechanical room floor.

Moisture was also found underneath the doorway (arrow).

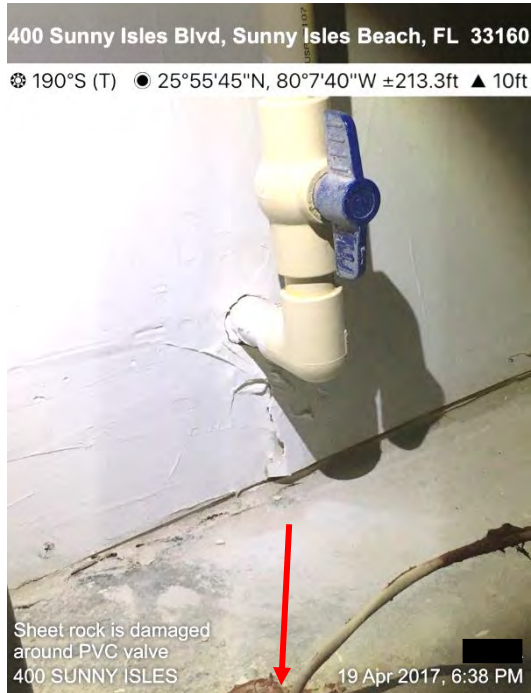
Figure 93

The drywall underneath and around this PVC valve is cracked and damaged. There also appears to be a gap between the concrete and the wall.

Area is considered to display substandard workmanship.

Red arrow shows that the wire was fire-caulked at mid-floor.

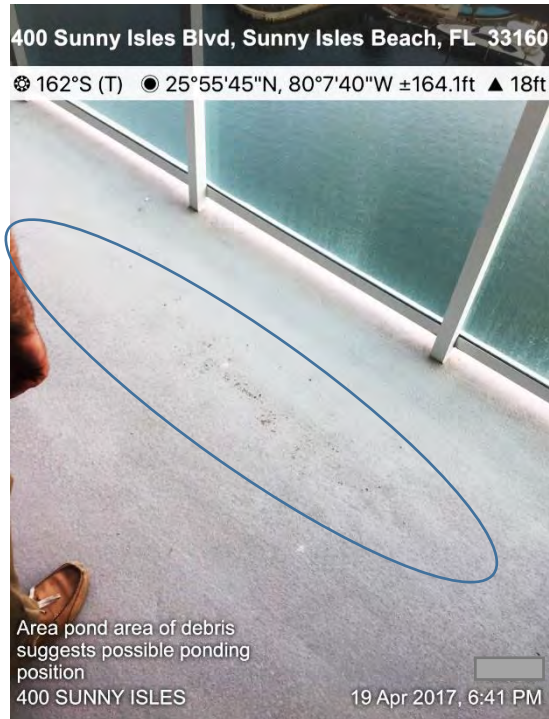
Figure 94

Collection of dirt in this area of the balcony suggests ponding may be occurring. Therefore, balcony may not be draining properly. This appeared to fit the pattern seen in several unit balconies where water applied to surfaces ponded near the perimeter edge.

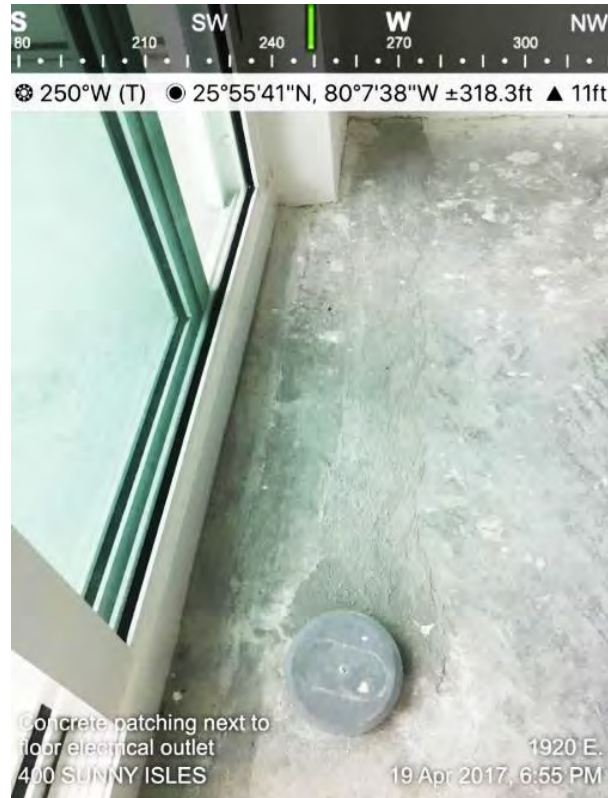
Figure 96

Concrete patching next to electrical outlet on the floor is extensive, reaching all the way to the far wall.

See previous discussion regarding patched concrete at perimeter of building slab and the concern about quality of materials, moisture intrusion, spalling, and ICRI/ACI standards for this type of work.

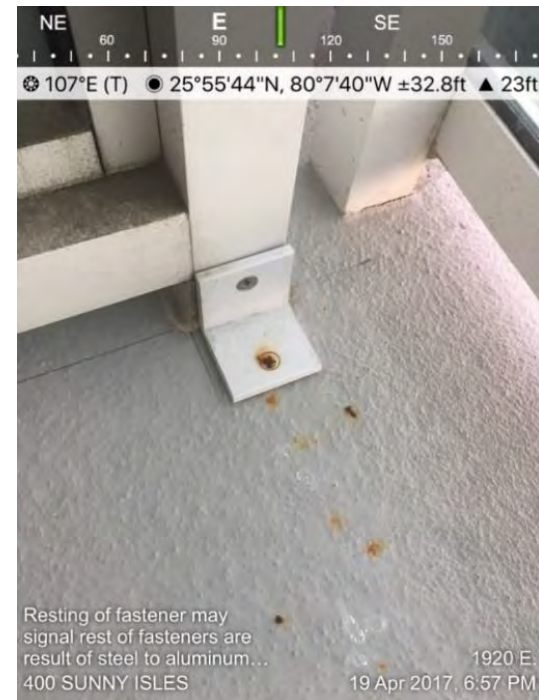
Figure 97

Fastener on the dividing wall between the unit's balcony and the neighboring balcony is rusting, considered caused by dissimilar metals (steel and aluminum) contact. Other fasteners should be checked for corrosion if they are of the same materials as this one.

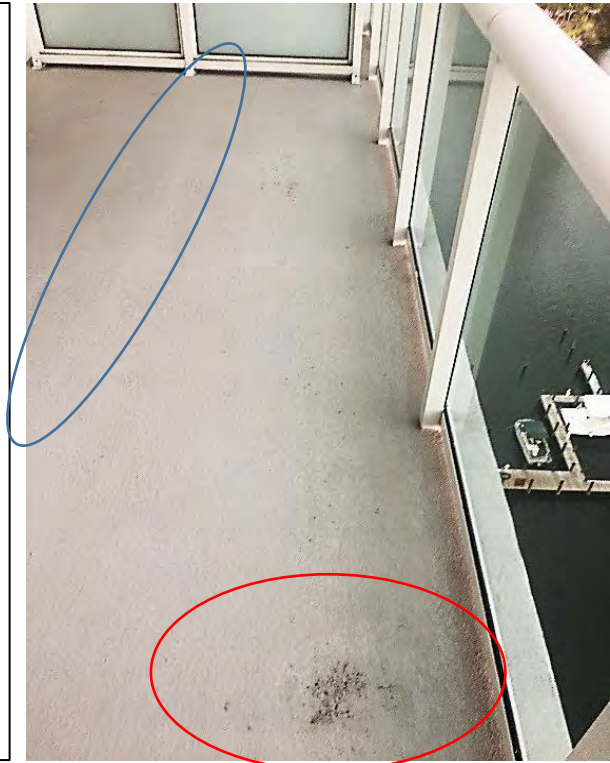
Figure 98

Low spot seen in foreground of photo indicates inadequate slope. Areas were observed where thicker applications of waterproof coating appeared to have been installed.

(Corner behind transition in the blue ellipse.)

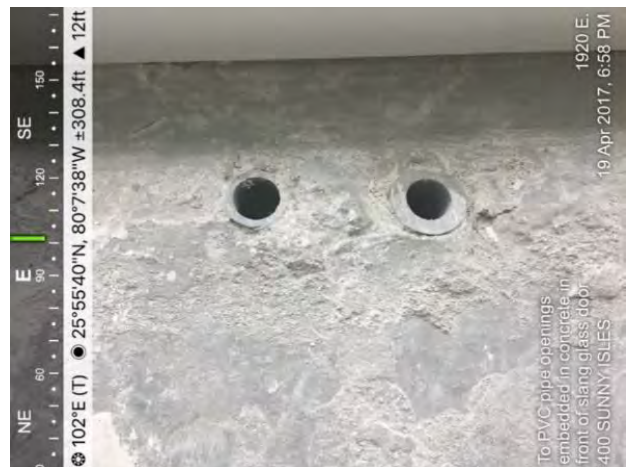
Figure 99

Two PVC pipes were embedded into the concrete in front of the sliding glass door. Possibly unfinished electrical floor outlet.

Repair is required.

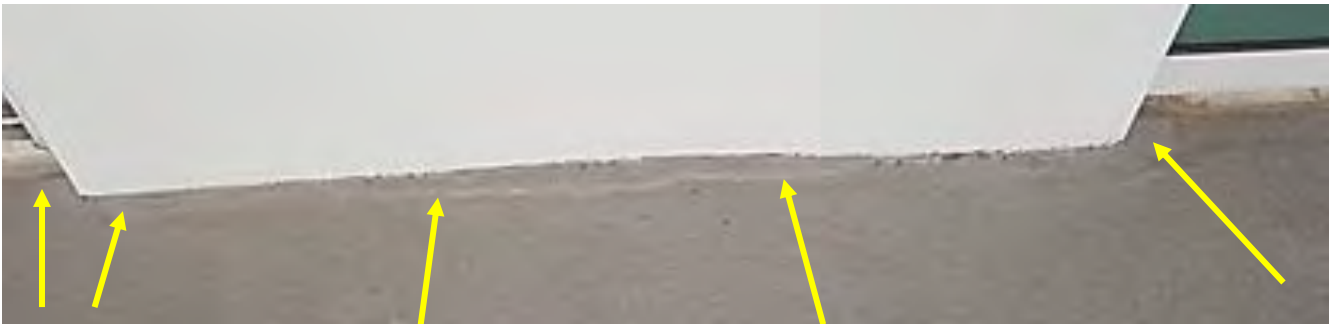
Figure 101

The photo of the wall parallel to the sliding glass door track depicts where waterproofing material appeared to have been poured along the door and juncture with the block wall. It is considered a likely possibility that this material may have been wasted in this manner in an attempt to prevent water damage due to incorrect slope of the slab along the doors.

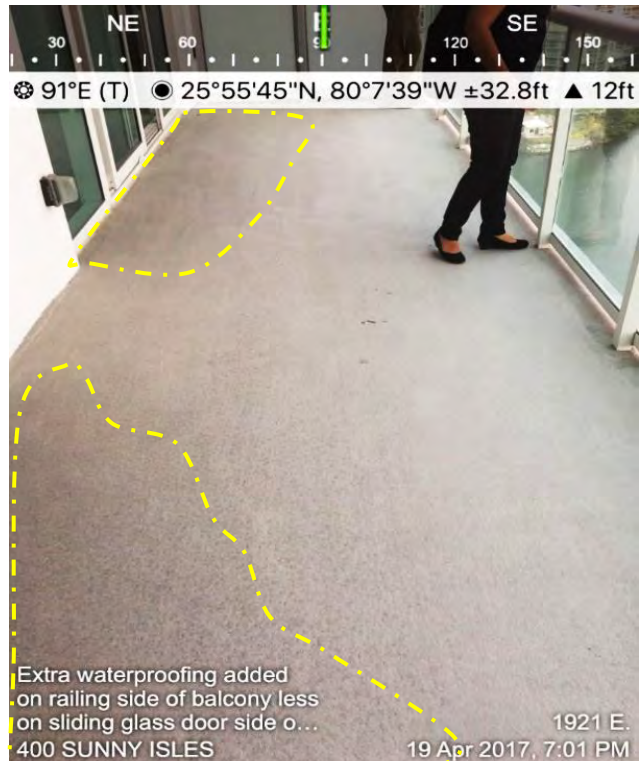
Figure 103

A large flow of thick waterproofing material had been applied at the wall in between the sets of sliding glass doors on the balcony of the unit.

If the reason was to create improved pitch on the balcony wearing surface, this was not successful.

Further investigation is required to understand the purpose of this wasteful protocol.

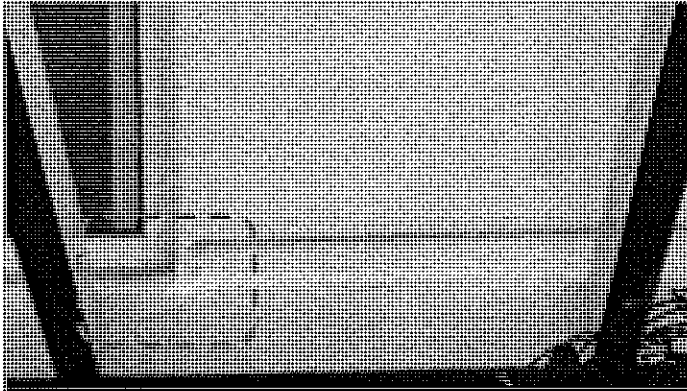
Water intrusion has occurred at the Northeast corner and along the North façade across both rooms within the unit. The yellow arrows show reveal joints in stucco that run vertically to roof and horizontally to windows.

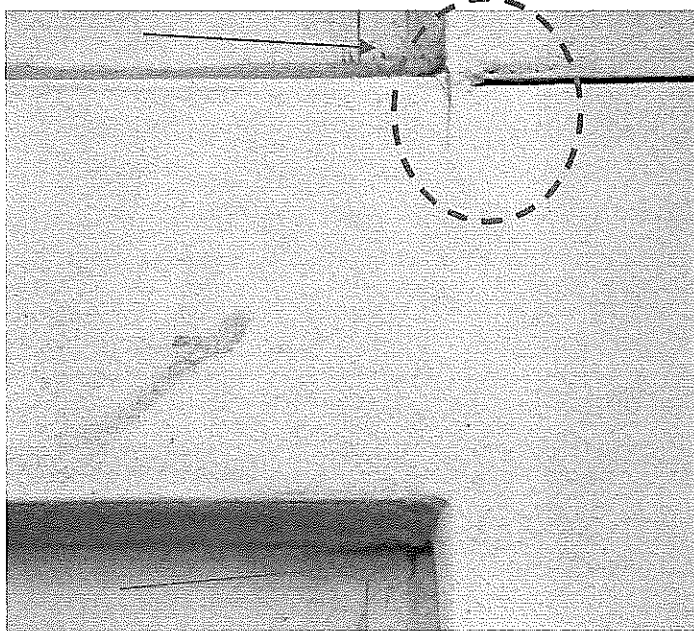
One area where water intrusion was found concentrated was at the bottom sill west end (within the purple circle). The enlarged photo (below) shows the reveal joint stops at a vertical corner bead which continues below the sill and where a crack has followed. Also note the addition of sealant at the corner surface finishes, which is not considered a primary repair of this problem. Sealant cannot repair a joint construction error. It is recommended that the horizontal reveal joint should be removed. (Below) more surface sealant has not solved the water intrusion condition within the unit.

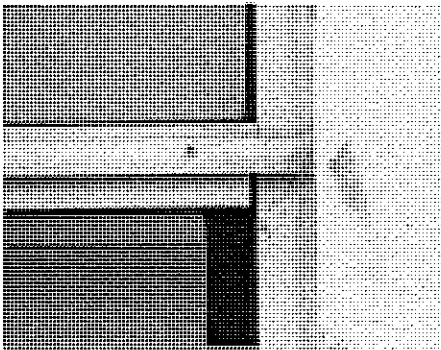
Each vertical PVD reveal joint is 10-foot long. The butt joints at each juncture of these 10 ft. long segments creates a joint subject to potential water intrusion. Butt joints are required to be bedded in sealant behind the joint juncture to prevent water intrusion. Removal of the reveal joint altogether is a recommended consideration.

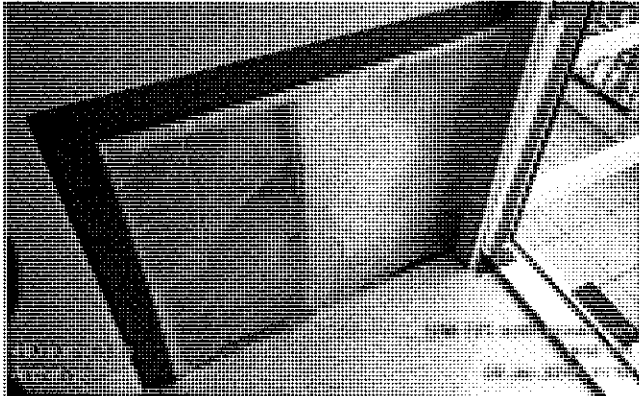
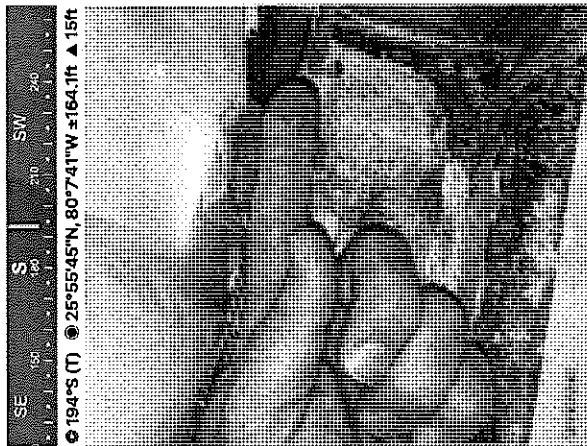
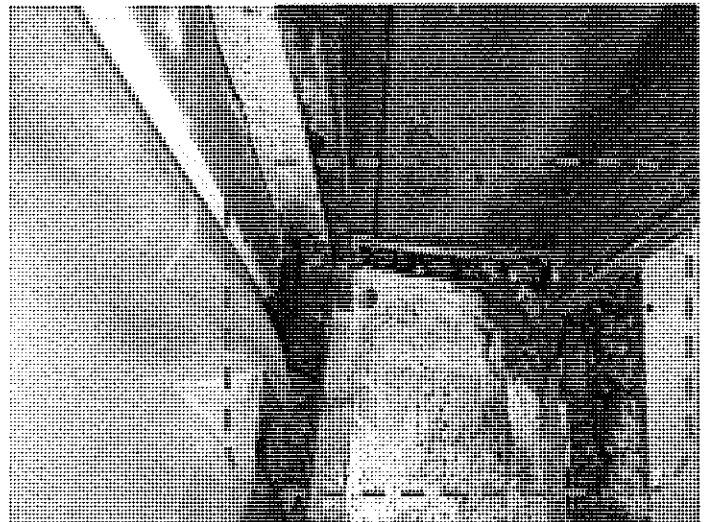
At the window on the west facing façade (see cabana and spa in view), moisture and paint cracking were detected. The moisture reading of 15.8 was substantially higher than the 7 to 8 readings in dry control areas. The photo below shows water retained between the sealant and glass.
