CASE NO.: 2020-024374-CA-01

**NOTICE OF FILING**  
**EXHIBITS “A” THROUGH “E” OF COMPLAINT**

***Re: 400 Sunny Isles Condominium East Association, Inc.  
Section 558.04, Florida Statutes, Notice of Claim of Construction Defects***

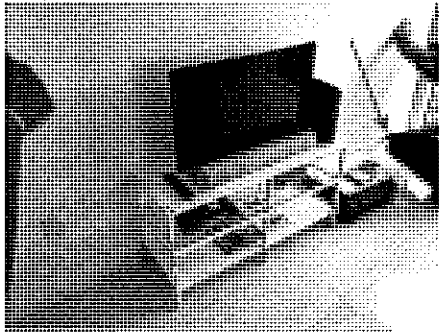
Unit 1208

Two areas along the perpendicular wall in the living room were observed to have moisture related damage. The area at the window sill on the north façade had been wet behind the baseboard and at the juncture with the window frame. The baseboard also showed signs of moisture approximately 8 feet interior of the window considered related to moisture migration along the metal stud track at the floor.

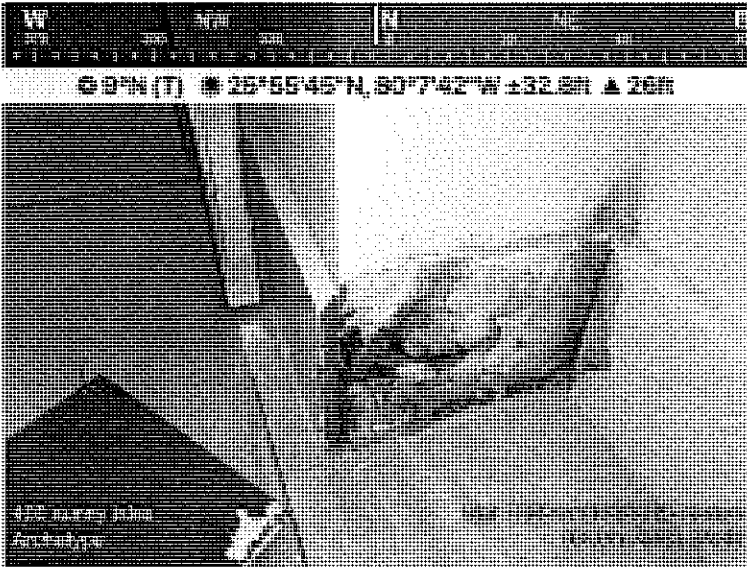
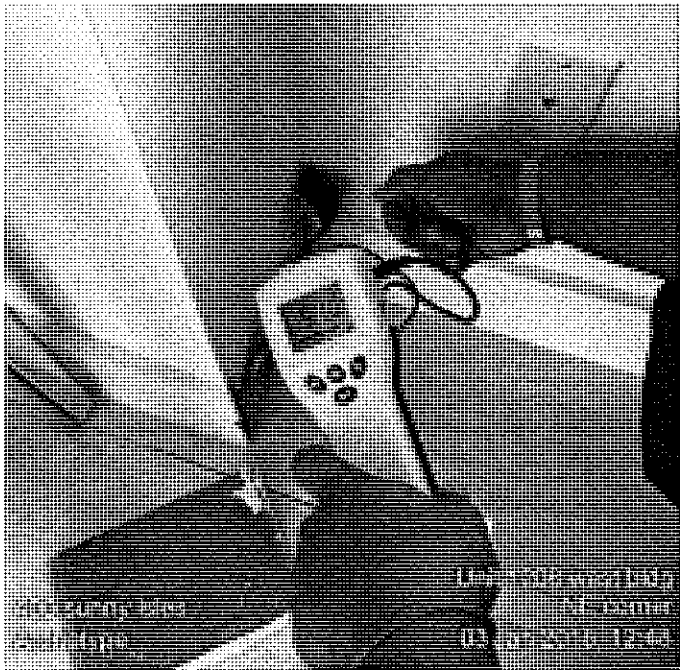
Within the bedroom at the east facing wall two areas of water intrusion damage were noted. The red arrow shows the location of the baseboard damage pictured below. Moisture reading of 51.8 was much higher than the dry control moisture readings of 8, confirming this to be an active water intrusion condition.

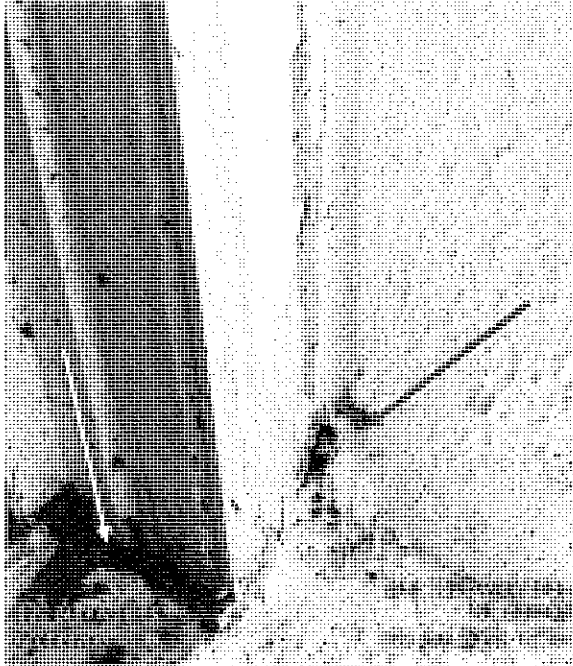
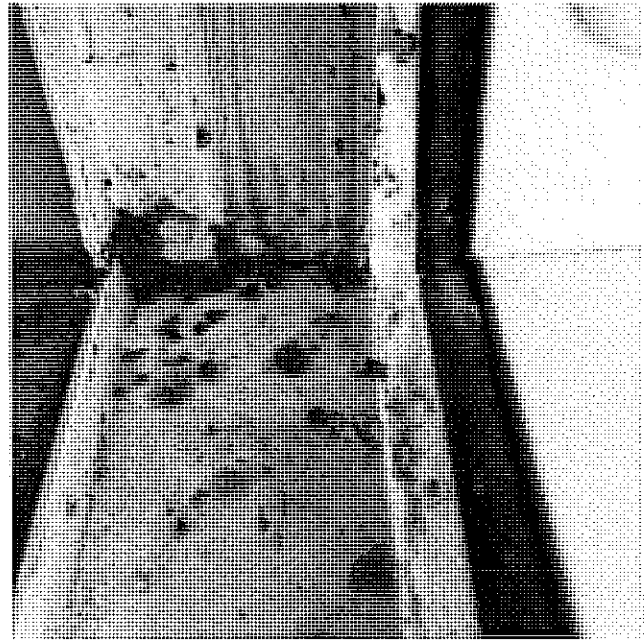
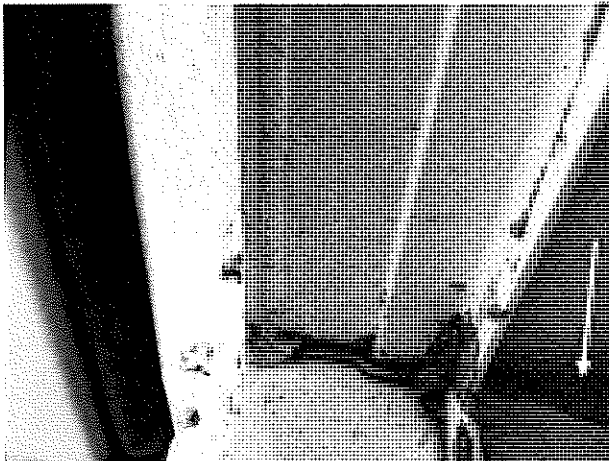
The three photos seen here show general workmanship problems with the finishes installed around the exterior windows in this unit. The red arrow at left shows the sealant bead installed between the exterior stucco jamb (interior face) and the exterior window frame. As the sealant joint nears the sill, the sealant ends and stucco with what appears to be mildew growing within voids is seen. The yellow arrow shows stucco spatter that has been left on the window frame. This stucco spatter is extremely alkaline, and the anodized aluminum finish will be damaged where it is allowed to remain in contact with the frame. This is seen also in the photo above as the spattered stucco has been allowed to lie in contact at the juncture of the aluminum sill and jamb frame. At left, the yellow arrow shows stucco spatter and a deposit in the interior corner of the aluminum frame and what appears to be a sealant bead applied to the exterior portion of the frame, possibly to halt moisture intrusion (short term).

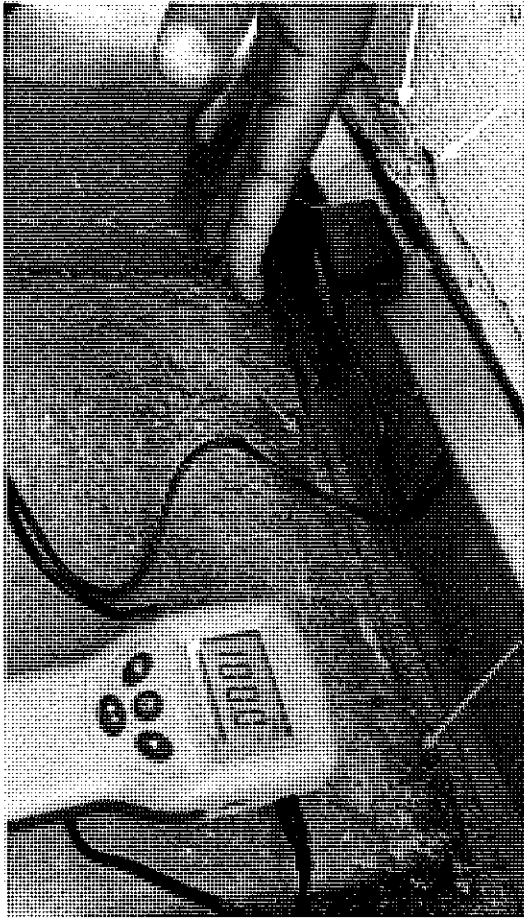
The photo at left shows one of the concrete rooftop landings installed to the exterior of the doorways of the roof stairwells. The upper left corner of the photo shows the concrete step at the threshold of the door. The yellow arrows point out the bottom edge of the wall stucco field where a sealant joint and cracking of the stucco is observed. The red arrow at the probe insertion of the moisture meter points to mildew growing from the sealant joint, and the moisture meter has topped the meter indication the presence of water within the joint. The small red arrows at the perimeter of the concrete landing show areas where mildew is also growing at the juncture with the wall. The concrete landing is installed on top of the roof membrane and is considered to be absorbing moisture. This detail is not on the drawings and was explained as an improvised detail to satisfy the fire department's request for an intermediate step. The solution as constructed created a moisture retention problem, and a perpetually wet condition on this portion of the roof membrane. This condition should be corrected in all locations with a waterproof landing and water-tight juncture with adjoining walls, door thresholds and surrounding roof membrane surfaces.

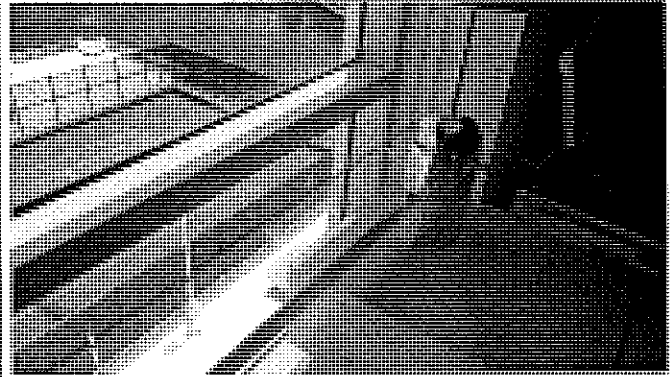
The concrete paver bricks along the seawall and running parallel to the trench drains of the sidewalk are settling in the interstitial zone between. This has created a trip hazard that must be addressed. The cause is considered to be due to lack of adequate compaction of the soil and the condition could be corrected by taking up the pavers, compacting the soil to the required elevation and resetting the pavers.

The measured lippage between pavers far exceeds the standards of the tile council of North America and the Interlocking Concrete Paver Institute.

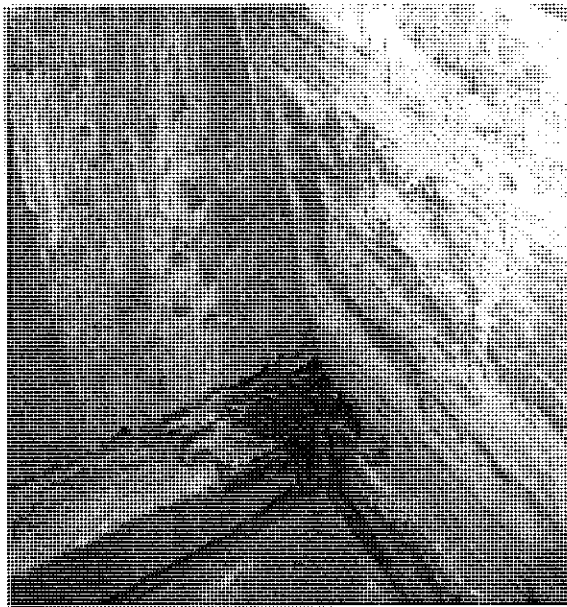
The concrete walls behind the lobby fountain have fractures in multiple locations which have allowed water to insinuate into the interstitial space. This would be due to a failure of the waterproofing membrane located behind the finished surface stone of the fountain. The water leaking does not have any significant pressure at these leaks so a solution with minor injection of hydrophilic grout would seem reasonable. If the leaks become worse or cannot be contained, eventually the extreme repair option of removal of finish stone and reinstallation of the waterproof membrane might be required.

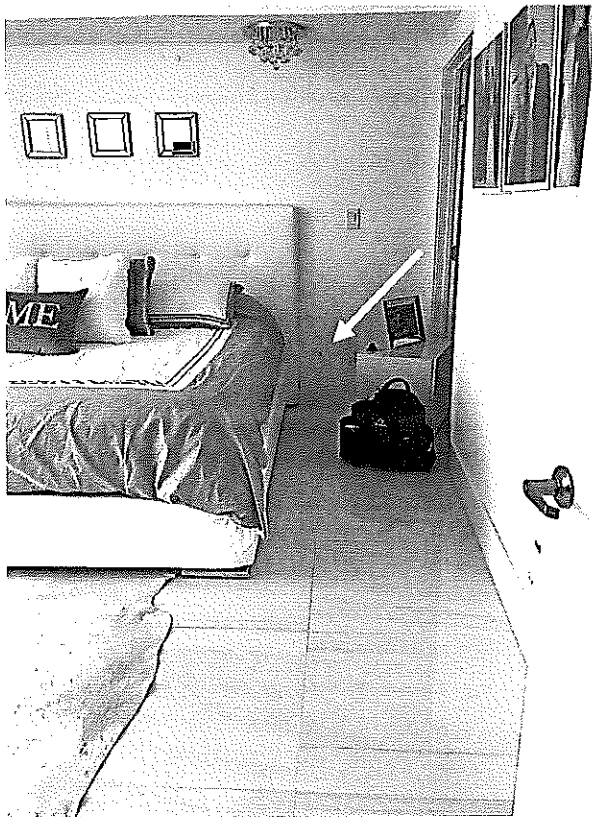
The photo at left shows the location where the small hole was made behind the furniture. Insulation was found at this point as well but, appeared to be very thin. Due to the reduced amount of insulation in the wall, it did not appear to be adequate for the required sound absorption value. The bore scope was inserted several inches into the wall space before any insulation was observed.

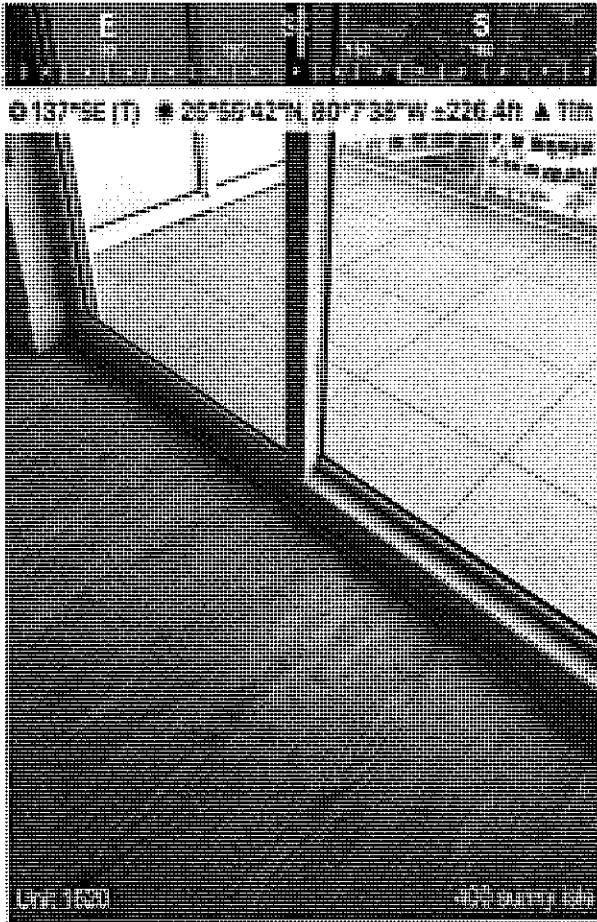
## Unit 1620: Water Intrusion Investigation

Unit 1620 had sustained water intrusion during Hurricane Irma. During visual inspection, it appeared that water had entered at the bottom of the track system of the sliding glass door.

The interior floor had some variation in elevation relative to the aluminum track. Some composite wood fiber planks can swell if wetted. This appeared to have occurred along the door track where the water intrusion entered.

Since the unit owner was not present during the storm and the wind pressures were not significant enough to force water over the water dam at the door, a pressurized water test is recommended.

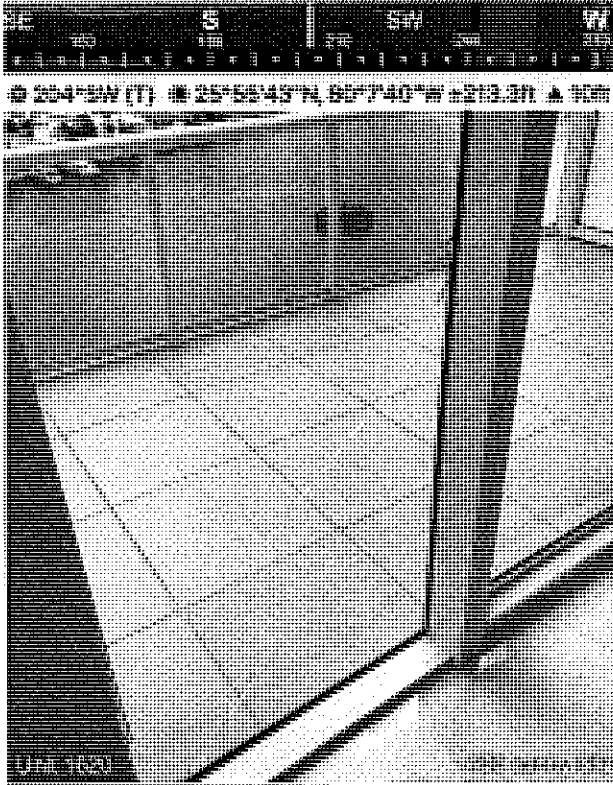
Same unit West, sliding glass doors also leading to the same balcony, the impact glass has been compromised. Per unit owner, "The glass had a small crack and it just grew larger and larger after it was discovered". Unit owner claims crack was found upon returning after hurricane. This is considered to be a manufacturer defect and may be considered for manufacture warranty or insurance claim.

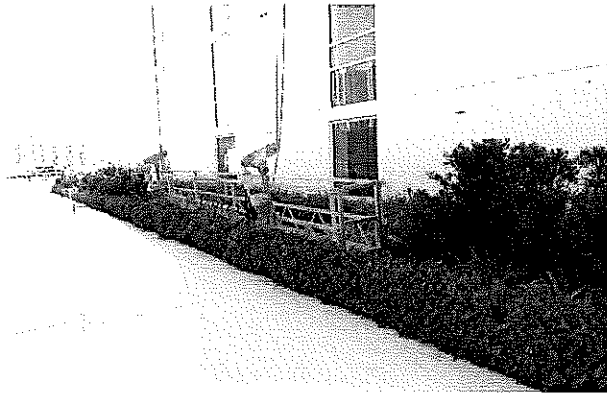
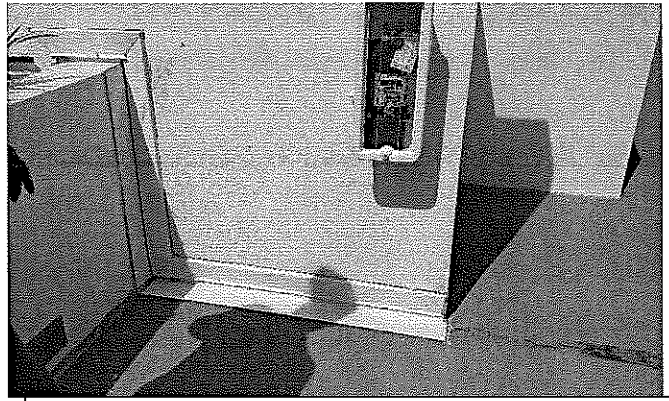
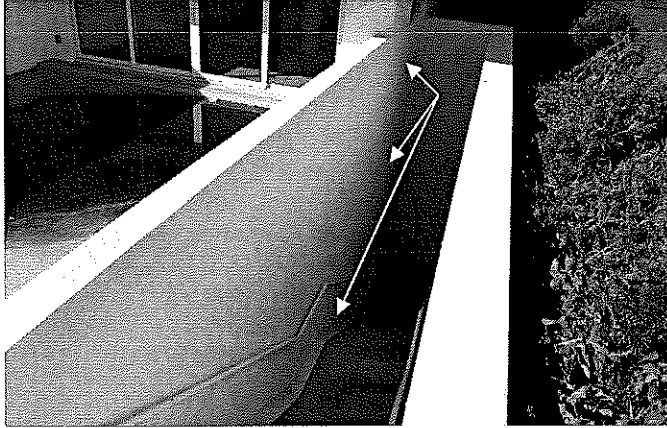
The juncture of the east side of the east tower is filled by a planter. (see upper left) The planter requires an expansion joint running between the tower and marina building. (above) This expansion joint is a source of water intrusion, (below) and this same joint runs down within the fire exit stair

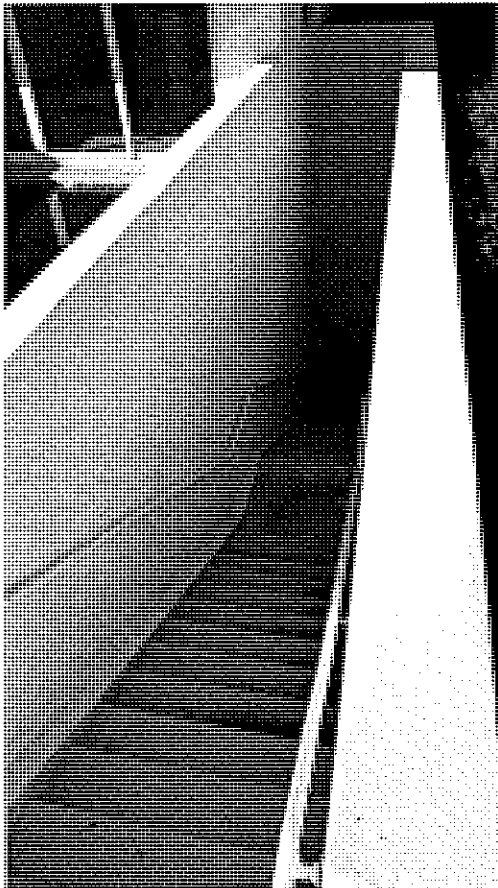
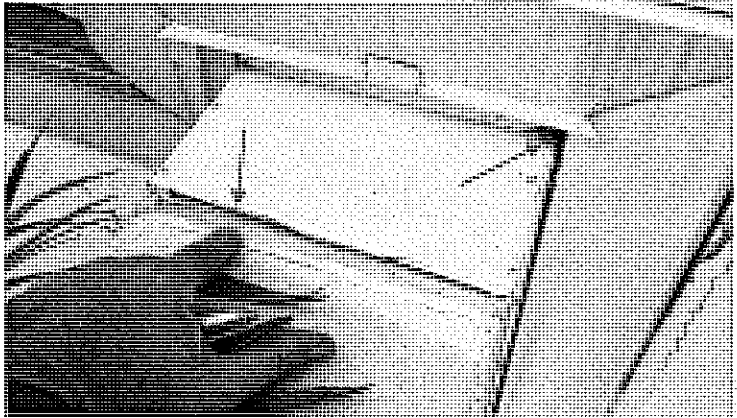
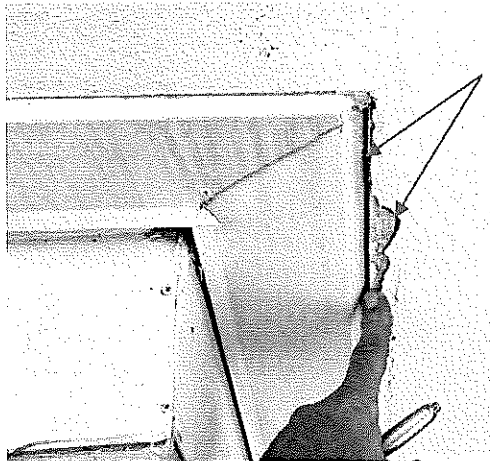
This stair presents problems in terms of moisture entry and retention of the stair landings. Exposed exterior stairs should have a slope that allows moisture to run off the tread surface and is removed by well situated drainage components. Ventilation is extremely poor in this condition which adds to the corrosion problem.

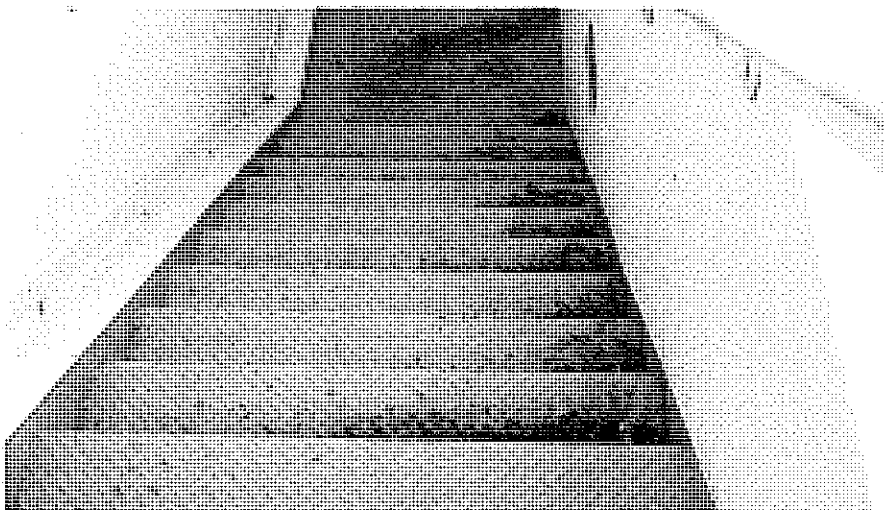
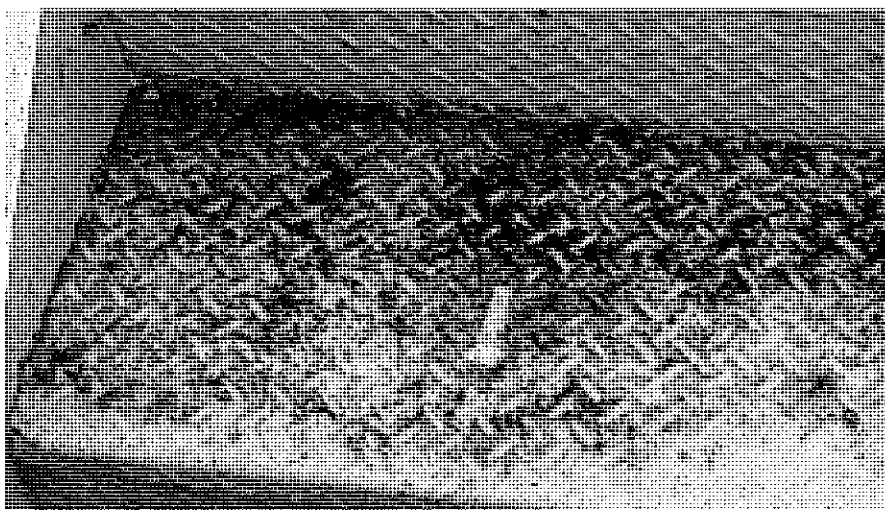
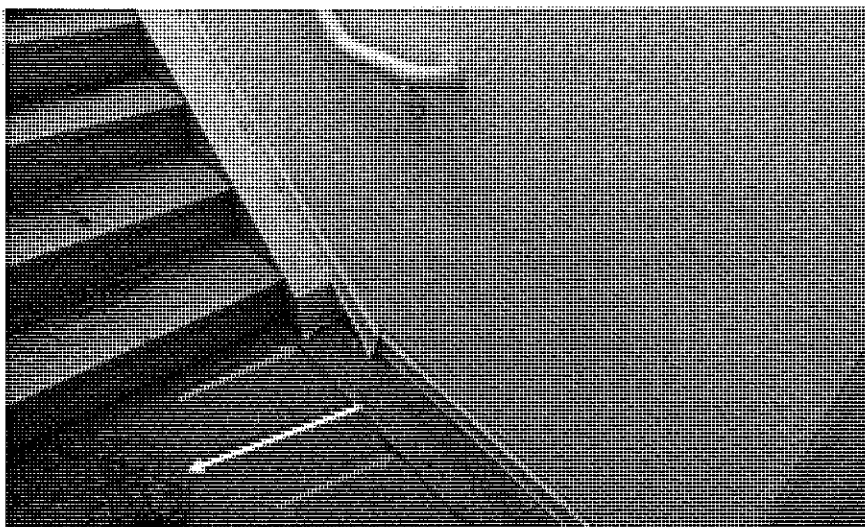
Block staining of retained water residue and organic growth resulting from retained water (yellow arrow) are visible at bottom stair landing. The cover plate at the expansion joint is moving and is a source of water entry.

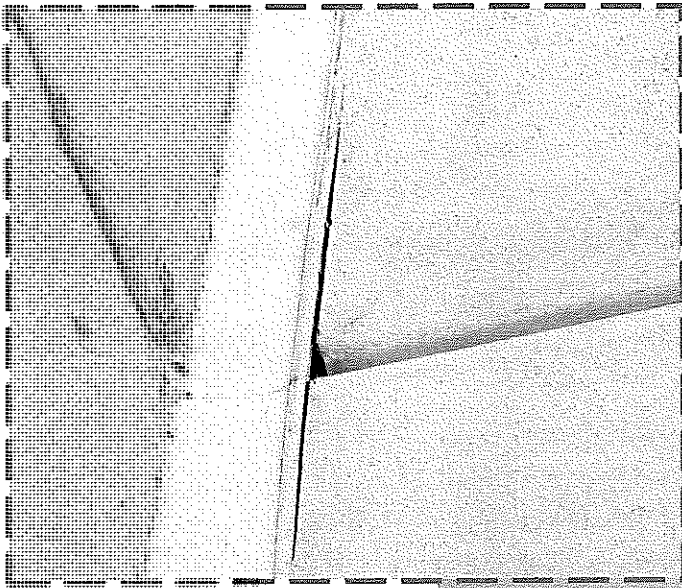
Water intrusion entering at the juncture of the landing and the east facade, where the steel plate lies on the landing surface and running up the slope up the stair stringer as well. Enlarged view below within the marina storage building.

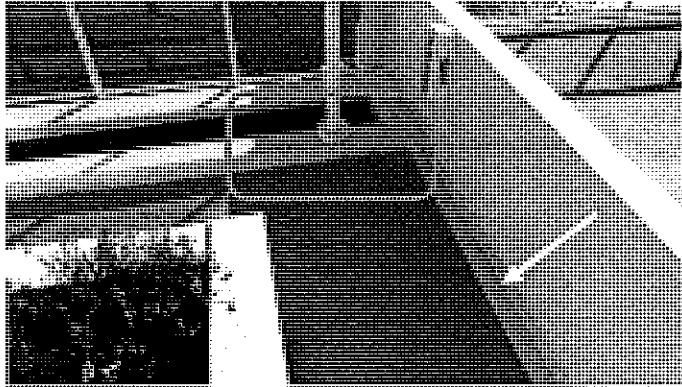
The yellow arrow shows the expansion joint at the upper walk landing of the stair. The enlarged view below shows the crack void at the metal to stucco curb juncture, and the multi-directional fracturing of the curb stucco.

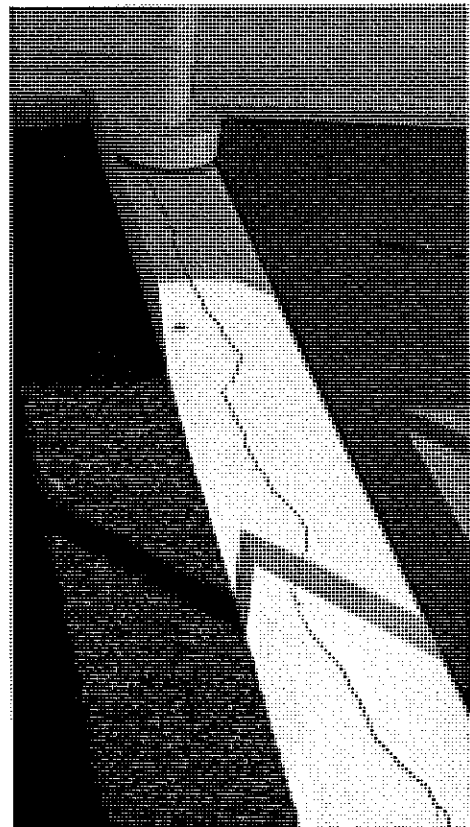
While the curb deterioration at the roof of the metal frame marina building is not on the Association property, the tennis court is considered a hereditament for unit owners, and the failure is considered related to the expansion joint problem hared by both properties.

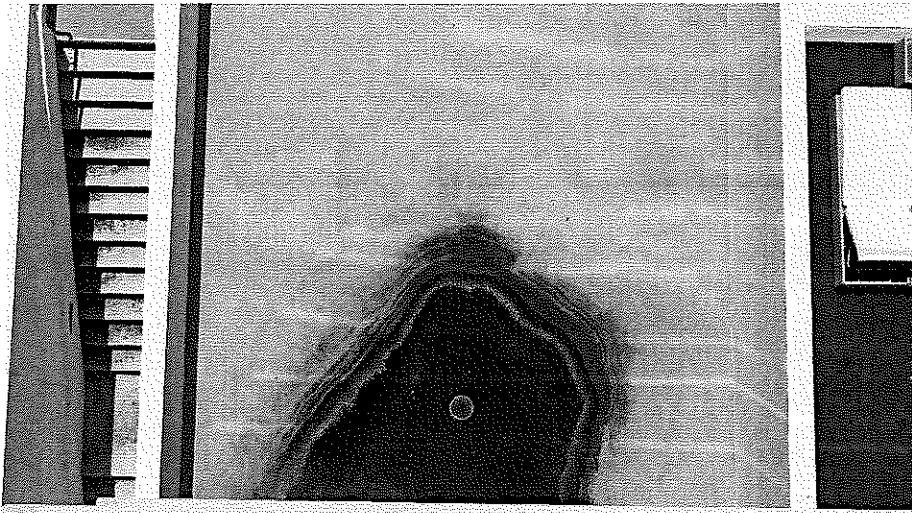
Top view of the same condition. The drain cannot remove water from the waterproof surface. The same condition is seen in the artificial turf areas, private terrace stone or tile areas and the common pool deck areas covered with patio pavers.

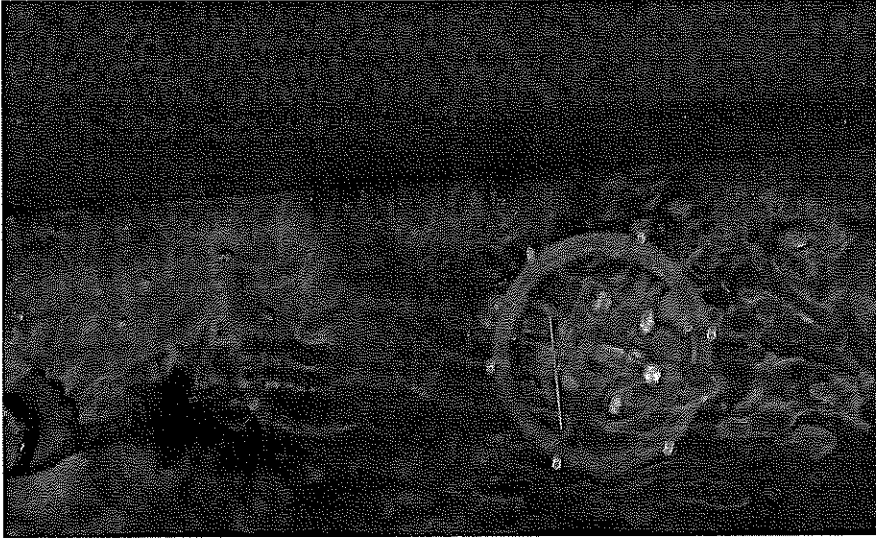
The lobby fountains have an electrical junction box located in the water filled, bottom trough, which powers the multi light underwater fixtures. These fixtures regularly short out and it is not certain whether the light fixture power load is a bit too high or if there is a leak into the junction power box, but the problem is recurrent and applies to the various lobby and outdoor fountains.

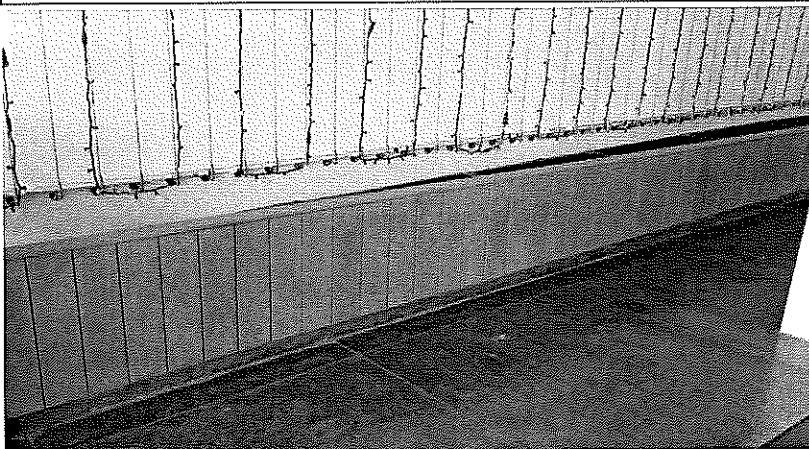
Above, the valet driveway is provided with a metal cable grid that is meant to support vines in a wall pattern. This design detail is failing due to the lack of natural light to adequately sustain the plants. Supplemental LED lights of frequency in sync with the plant type will support growth in this shaded space and is a proven approach. There are currently some strings of holiday lights in this area, so there may well be adequate electricity to supply the strings of LED grow-lights.

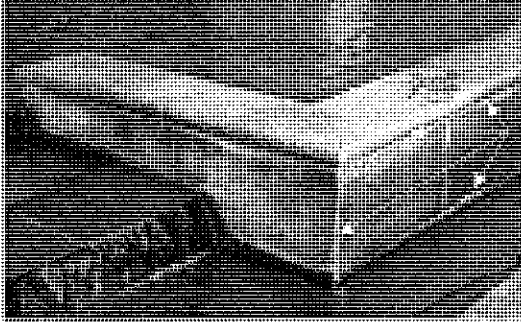
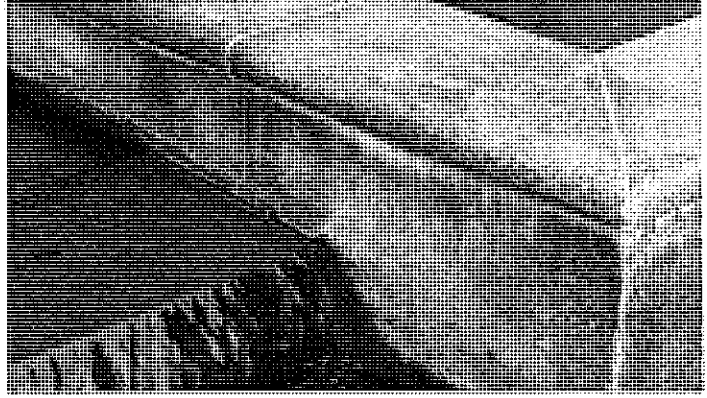
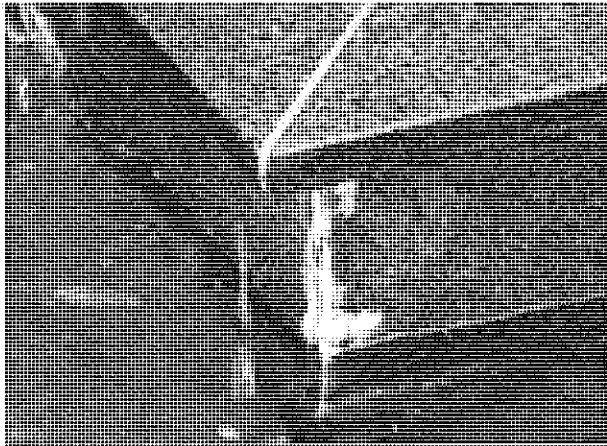
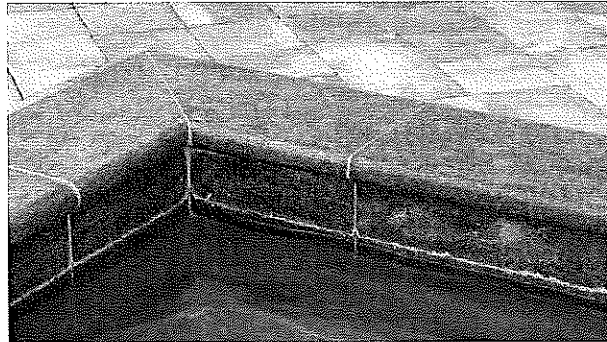
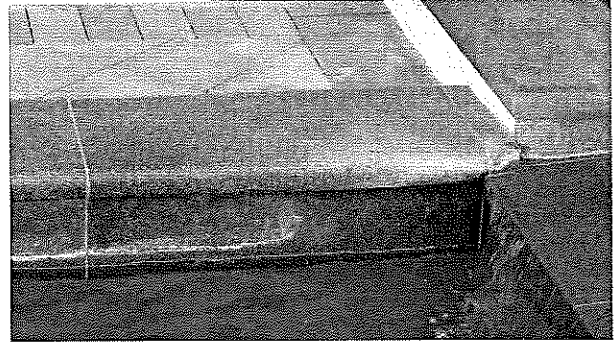
The white mineral deposits on the black fountain stone are due to deposits of water bourn minerals being deposited along joint and partially wetted surfaces. The recommended solution is to waterproof the perimeter of the fountain exterior from the surrounding concrete pavers, mortar beds sand setting bedding and joint sands to prevents the mineral deposition. The chlorinated water and marine environment cause dissolution of minerals. The fountain itself should be constructed of chemically resistant grouts, setting beds and jointing to minimize mineral efflorescence issues.

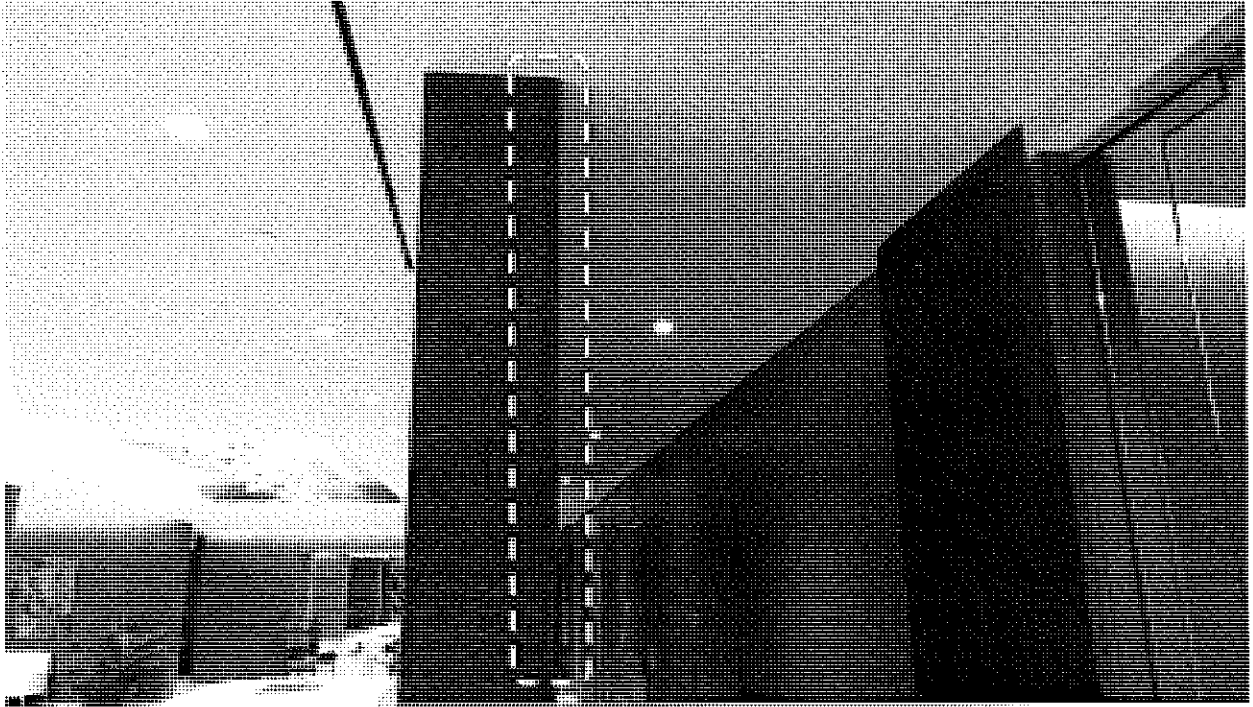
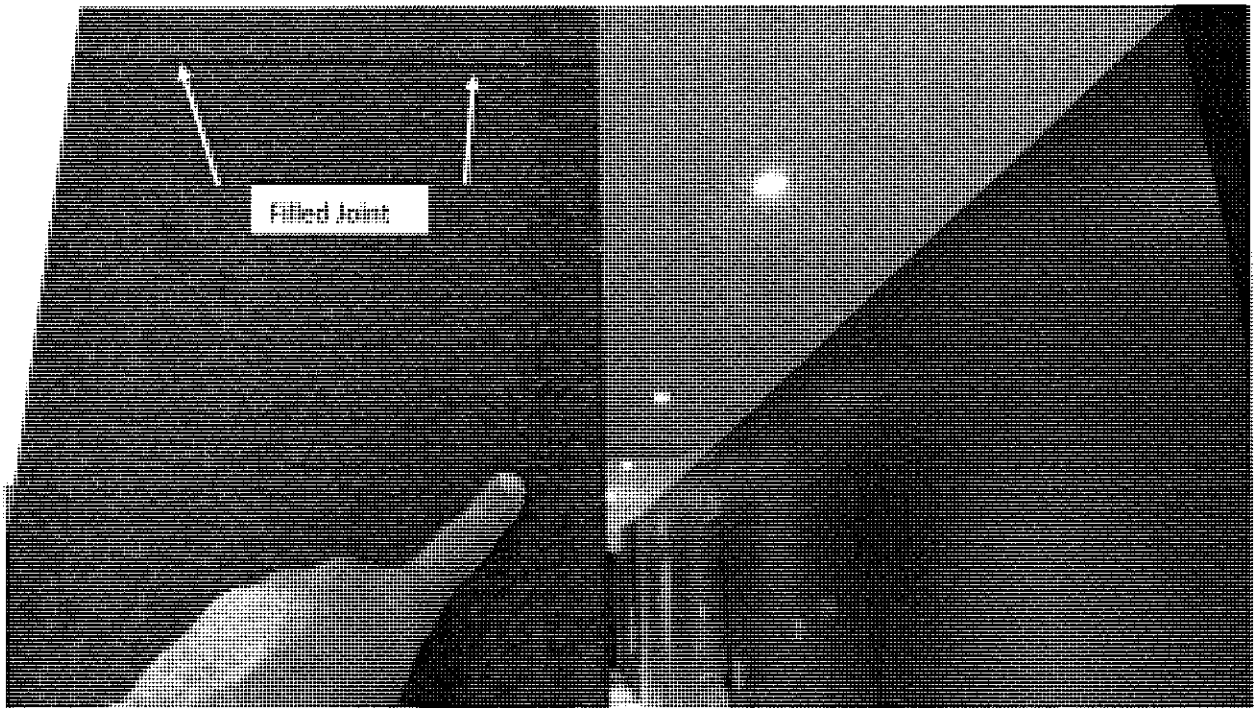
Lobby stone finish Problems have been noted where sealant material at corner joints or other joint locations have caused some darkening of adjoining stone surfaces. This has also been observed in the elevators. The issue follows corner joints (and some other joints) where a dark sealant material is used to fill the joint. This dark filler seems to cause a darkened adjoining area of the stone either as an oil seeping into the stone matrix, or a silicone type surface flow.

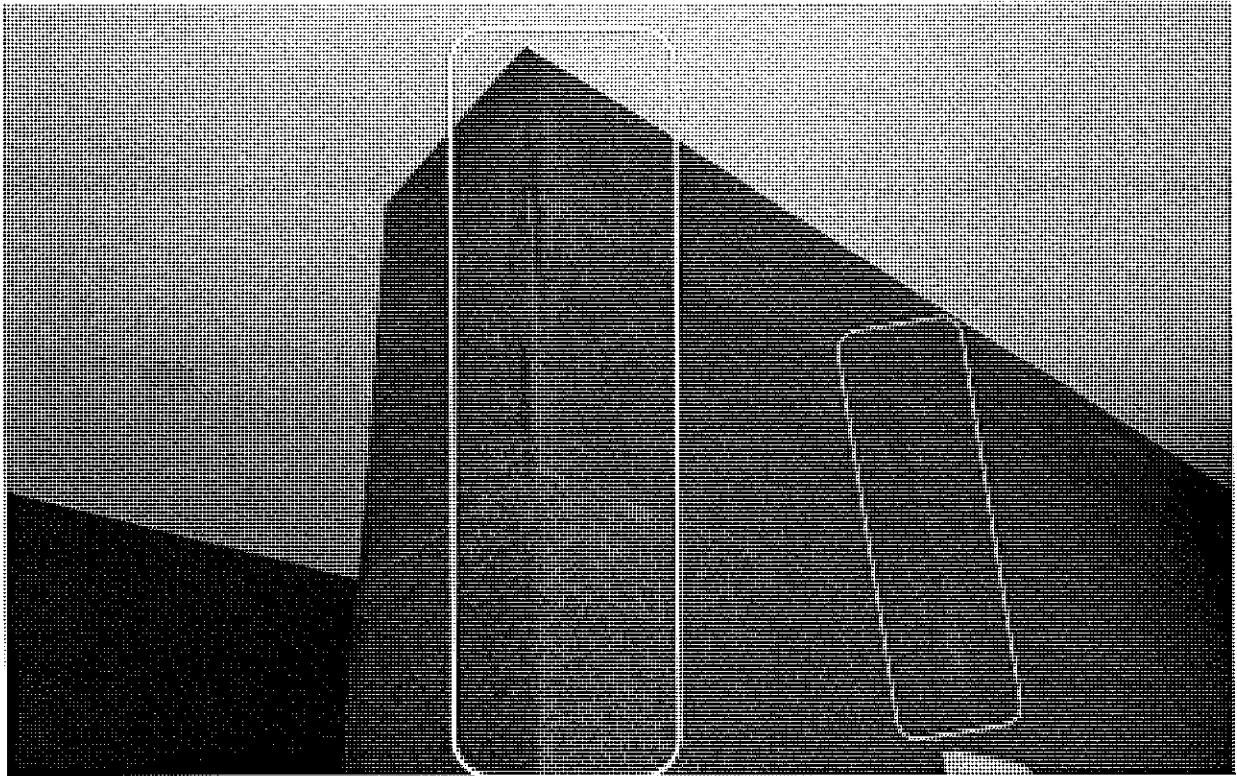
Light stone surfaces are typical around these joint locations as it appears harsh muriatic acid or other highly caustic cleaning application was used to remove the surface staining. This may also have been related to abrasive cleaners.

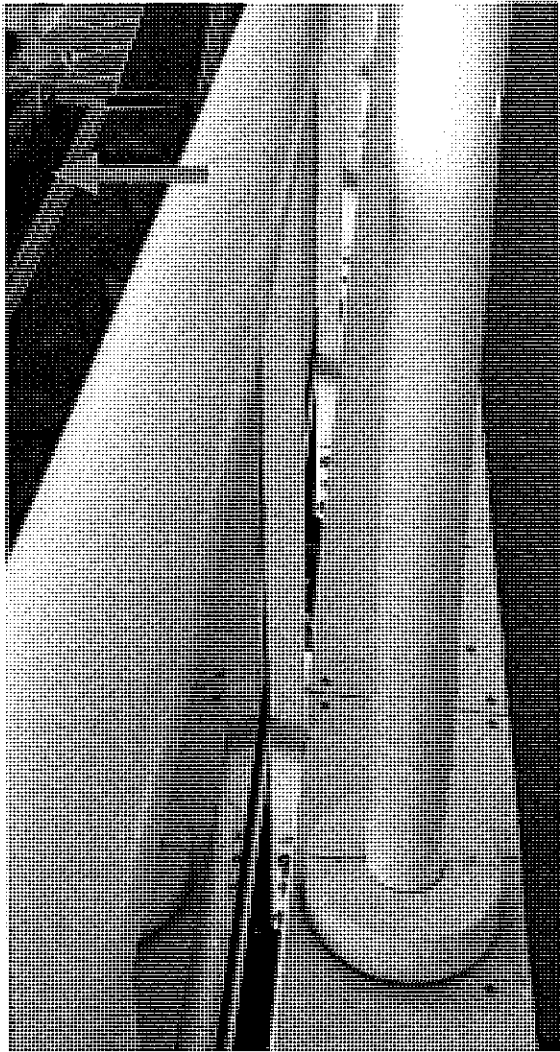
The following railing photos were taken at the tennis court walkway where it was noticed that the railing on the top of the pre-engineered steel building were loose and deflected laterally. Closer examination showed that some of the railings were not cut to the correct length. Some of the mounting brackets were spaced incorrectly or were twisted. These conditions must be refabricated and reinstalled.

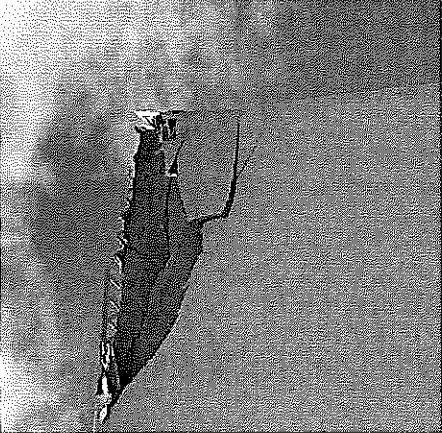
| Photo # | Photo - Inspection | Observation - Inspection |
|---|---|---|
| IMG_0650 | | <p>Lightning Strike: Cast In Place (CIP) concrete parapet cap appears to be lacking necessary bonding agent and scratch coat ribbing. Stucco also appears to have been done as a single coat.</p> |

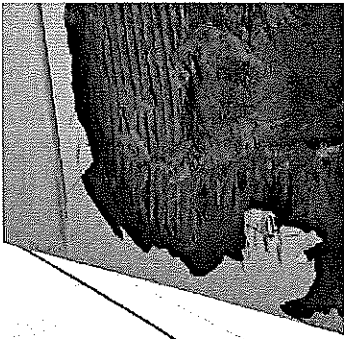
| Photo # | Photo - Inspection | Observation - Inspection |
|---|---|---|
| IMG_0660 | | <p>Appears to have one layer of stucco on scratch coat.</p> |

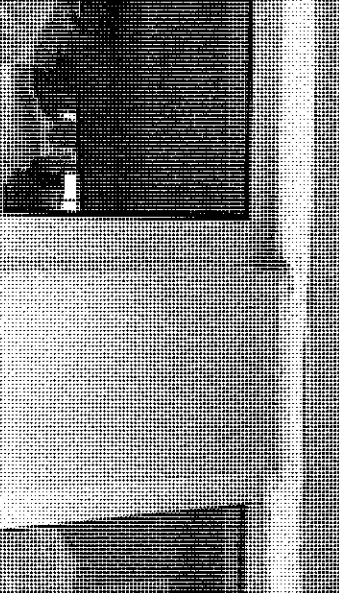
| Photo # | Photo - Inspection | Observation - Inspection |
|---|--|--|
| IMG_4561 | | <p>Open crack subject to water intrusion located at the joint of stucco &amp; PVC. Sealant at window frame and stucco should be V-grooved. Stucco appears to be unfinished (rough), this will require further investigation.</p> |

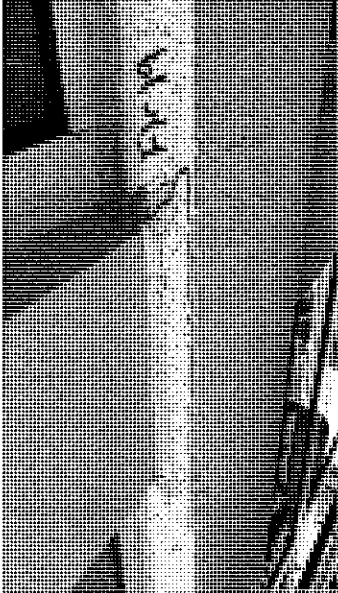
| Photo # | Photo - Inspection | Observation - Inspection |
|---|--|--|
| IMG_4558 | | <p>Cracked and delaminated stucco at sill and mull bar intersection. This will allow water intrusion and must be investigated and repaired.</p> |

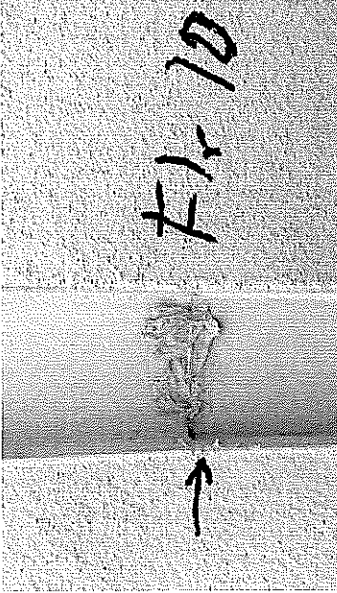
| Photo # | Photo - Inspection | Observation - Inspection |
|---|--|--|
| IMG_4547 | | <p>Inadequate sealant, does not cover entire joint.</p> |

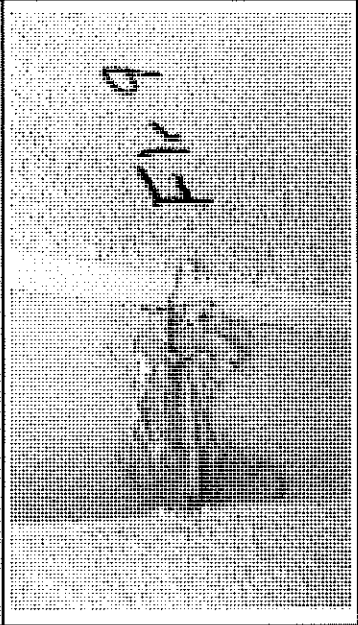
| Photo # | Photo - Inspection | Observation - Inspection |
|---|--|--|
| IMG_4542 | | <p>Poor workmanship, unacceptable surface applied sealant will fail after expansion and contraction of dissimilar materials.</p> |

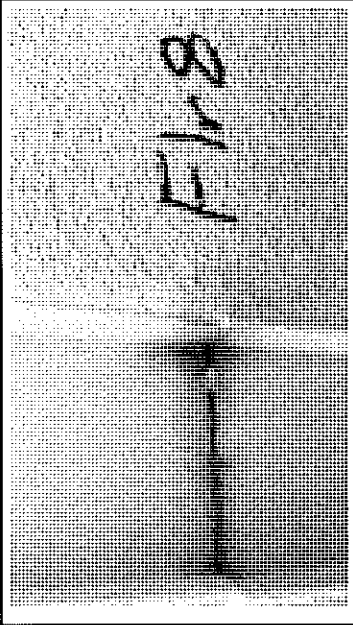
| Photo # | Photo - Inspection | Observation - Inspection |
|---|--|--|
| IMG_4502 | | <p>Typical non bedded butt joint at PVC accessories. All joints require sealant BEHIND such intersections.</p> |

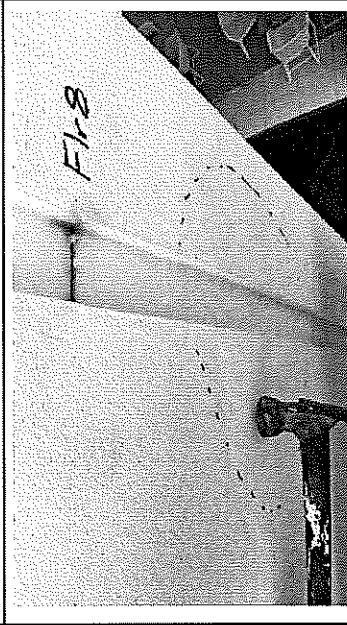
| Photo # | Photo - Inspection | Observation - Inspection |
|---|--|--|
| IMG_4496 | | <p>Circumstance of non bedded butt joint has lead to delaminating stucco below due to prolonged water intrusion.</p> |
